ENTERGY	ENGINEERING STANDARD	EN-EP-S-002-MULTI	REV. 1
	Underground Piping and Tanks General Visual Inspection	PAGE 14 OF 15

ATTACHMENT 7.2 PIPE/TANK COATING VISUAL INSPECTION CHECKLIST

Line/Tank ID & Name: 8-in Fire Protection Line Work Order: 279577-02
 System: Fire Protection Inspection Date: 5/14/2013
 Location: IP3 NW WHUT PIT Inspector: J.Peterson/S.Guarnaccia
 Coating Material: Koppers Bitumastic with tape wrap Thickness: Original-As found

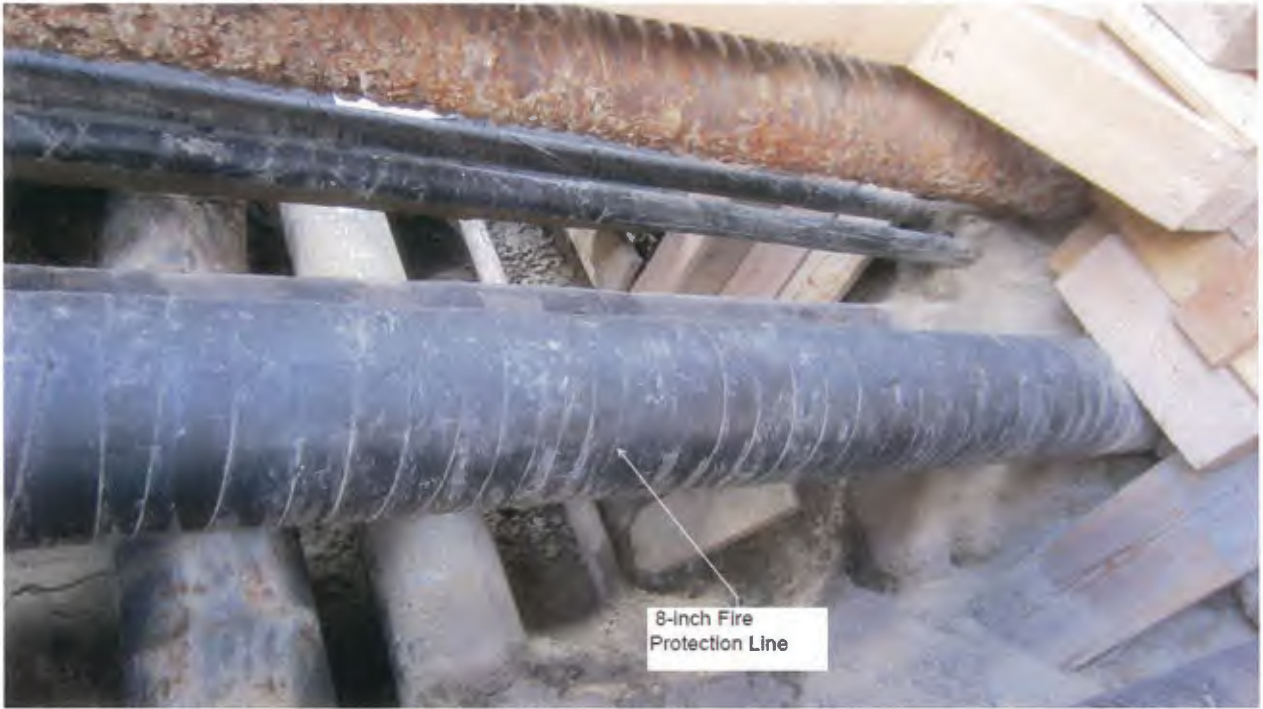
8-inch Fire Protection Line

Comments: Coated piping was wrapped with exterior tape (protective tape). Minor imperfections observed in the exterior tape wrap that did not penetrate down to the coating surface. Damaged could have occurred during excavation. Recommend wrap repair (overlap with new tape). Photos and sketch attached, Ref: Drawing 9321-F-41823.
