ENTERGY	ENGINEERING STANDARD	EN-EP-S-002-MULTI	REV. 1
	Underground Piping and Tanks General Visual Inspection	PAGE 14 OF 15

ATTACHMENT 7.2 PIPE/TANK COATING VISUAL INSPECTION CHECKLIST

Line/Tank ID & Name: 6-in Fire Protection Line Work Order: 279577-02
 System: Fire Protection Inspection Date: 5/14/2013
 Location: IP3 NW WHUT PIT Inspector: J.Peterson/S.Guarnaccia
 Coating Material: Koppers Bitumastic with tape wrap Thickness: Original-As found

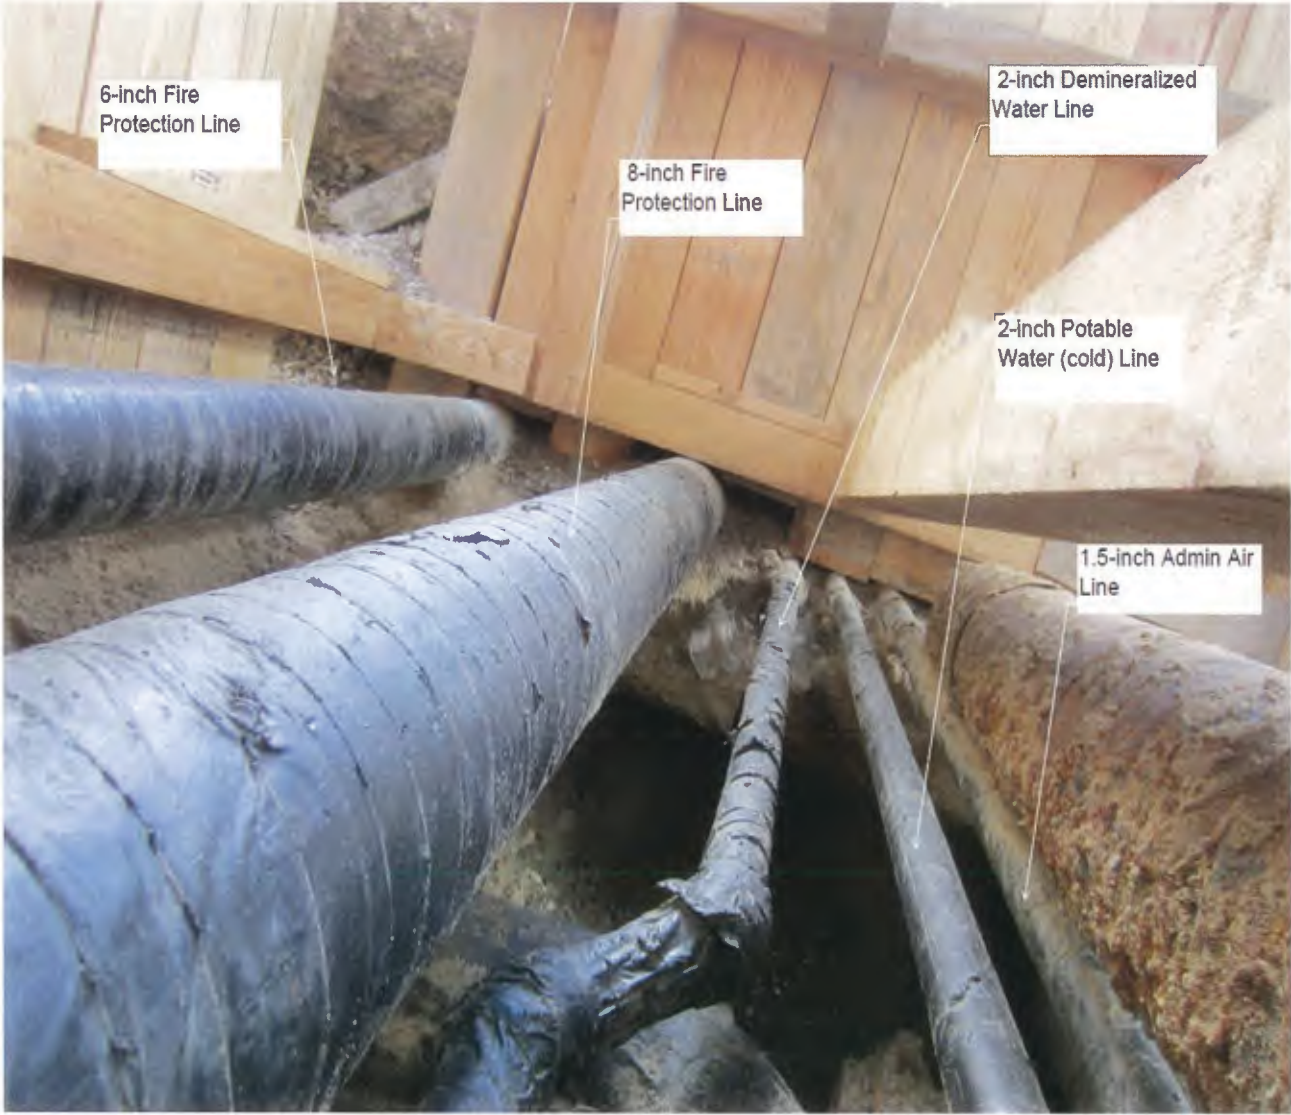
6-inch Fire Protection Line

8-inch Fire Protection Line

2-inch Demineralized Water Line

2-inch Potable Water (cold) Line

1.5-inch Admin Air Line

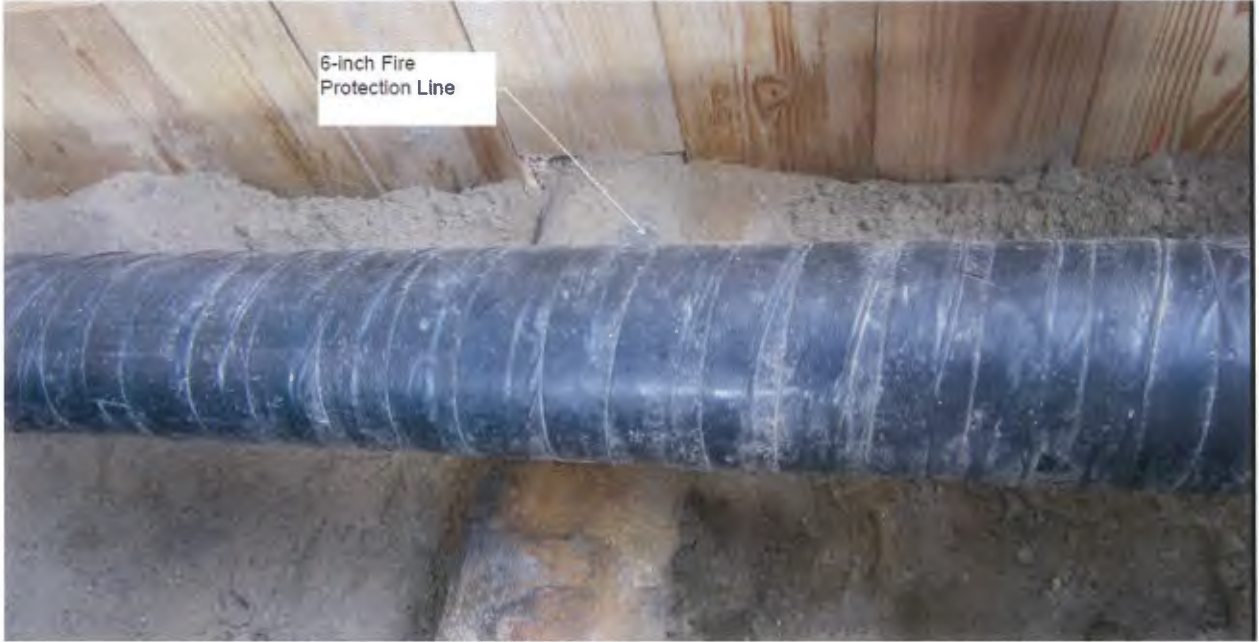
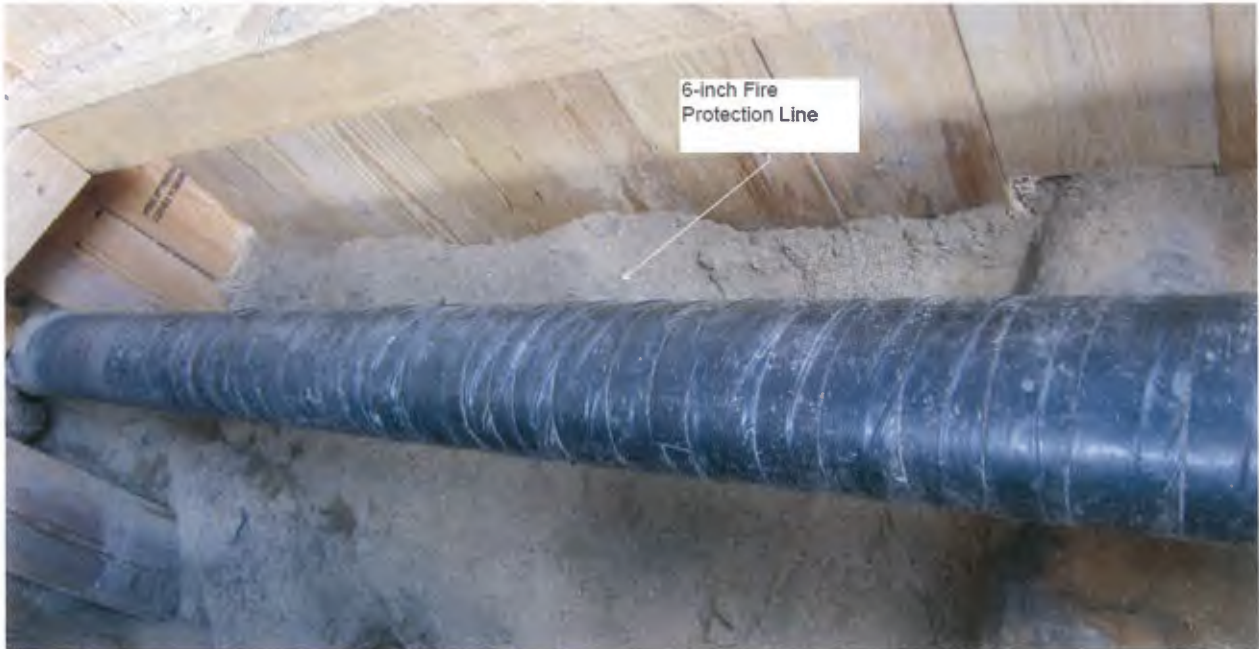
Comments: Coated piping was wrapped with exterior tape (protective tape). Minor imperfections observed in the exterior tape wrap that did not penetrate down to the coating surface. Damaged could have occurred during excavation. Recommend wrap repair (protective tape). Photos and sketch attached, Ref: Drawing 9321-F-41823.

Recommend that these anomalies be evaluated and repaired as required prior to backfill of the excavation.
