UNITED STATES
NUCLEAR REGULATORY COMMISSION
OFFICE OF NUCLEAR REACTOR REGULATION
OFFICE OF NEW REACTORS
WASHINGTON, DC 20555-0001

NRC INFORMATION NOTICE 2013-20: STEAM GENERATOR CHANNEL HEAD AND
TUBESHEET DEGRADATION

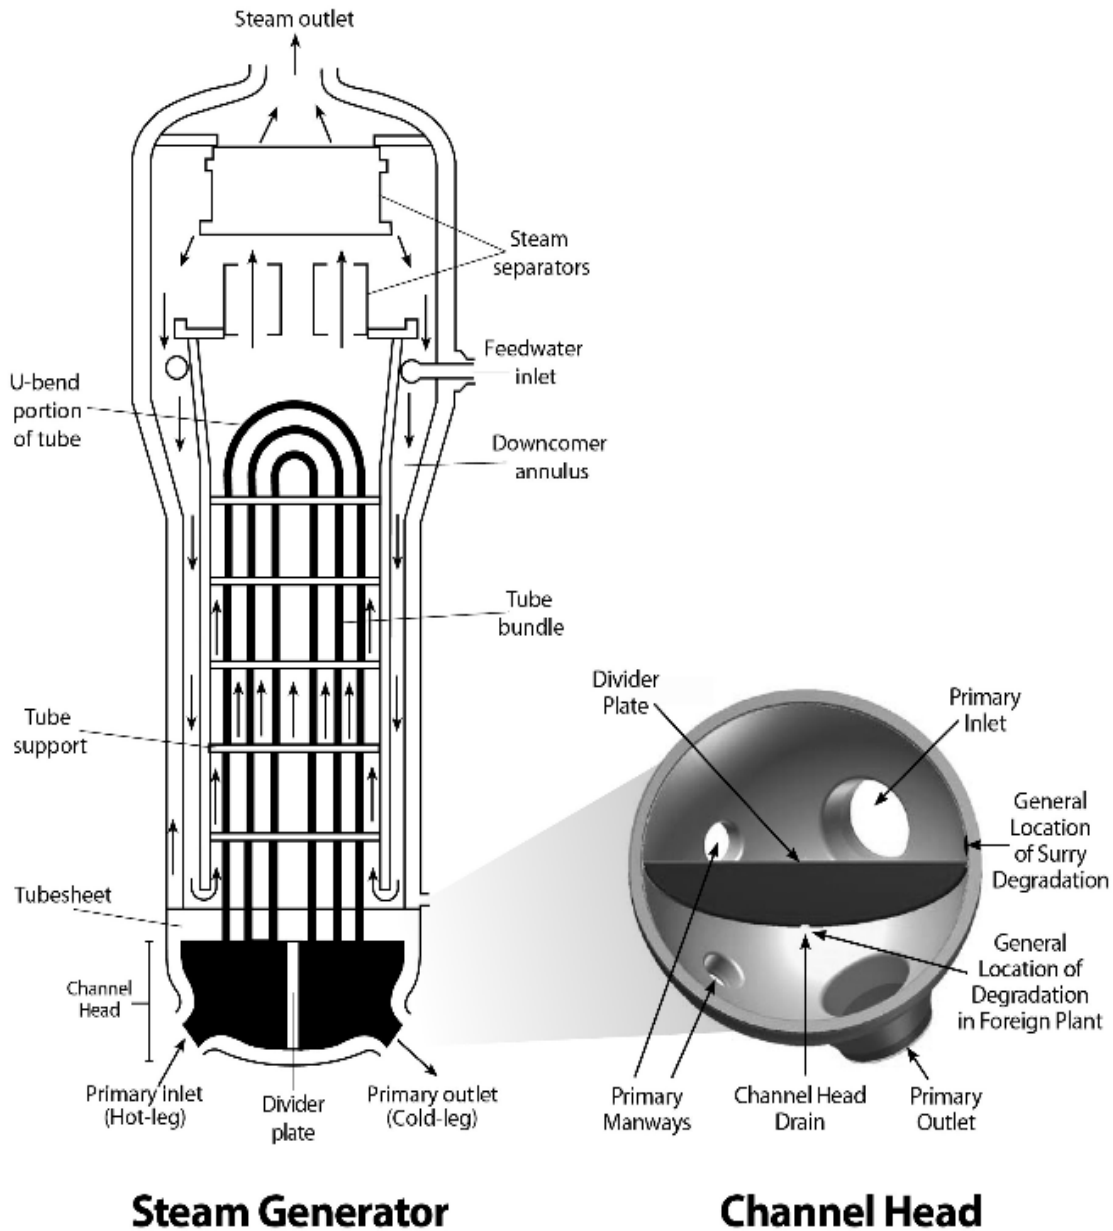
Figure 1: Steam Generator Channel Head Assembly

The primary side of a recirculating steam generator consists of several components, including the channel head, divider plate, tubesheet, and tubes (refer to Figure 1). The channel head is hemispherically shaped and is divided into two chambers by a divider plate. One chamber receives the primary coolant from the reactor through the primary inlet (hot-leg) nozzle, and the divider plate channels this coolant through the tubes. After exiting the tubes, the primary coolant enters the other chamber of the channel head and exits the steam generator through the primary coolant outlet (cold-leg) nozzle(s) so that it can be pumped back into the reactor.
