Stator Drop Root Cause Evaluation (Non-Proprietary)

Entergy Operations, Arkansas Nuclear One (ANO)

Root Cause Evaluation Report

Unit 1 Main Turbine Generator Stator

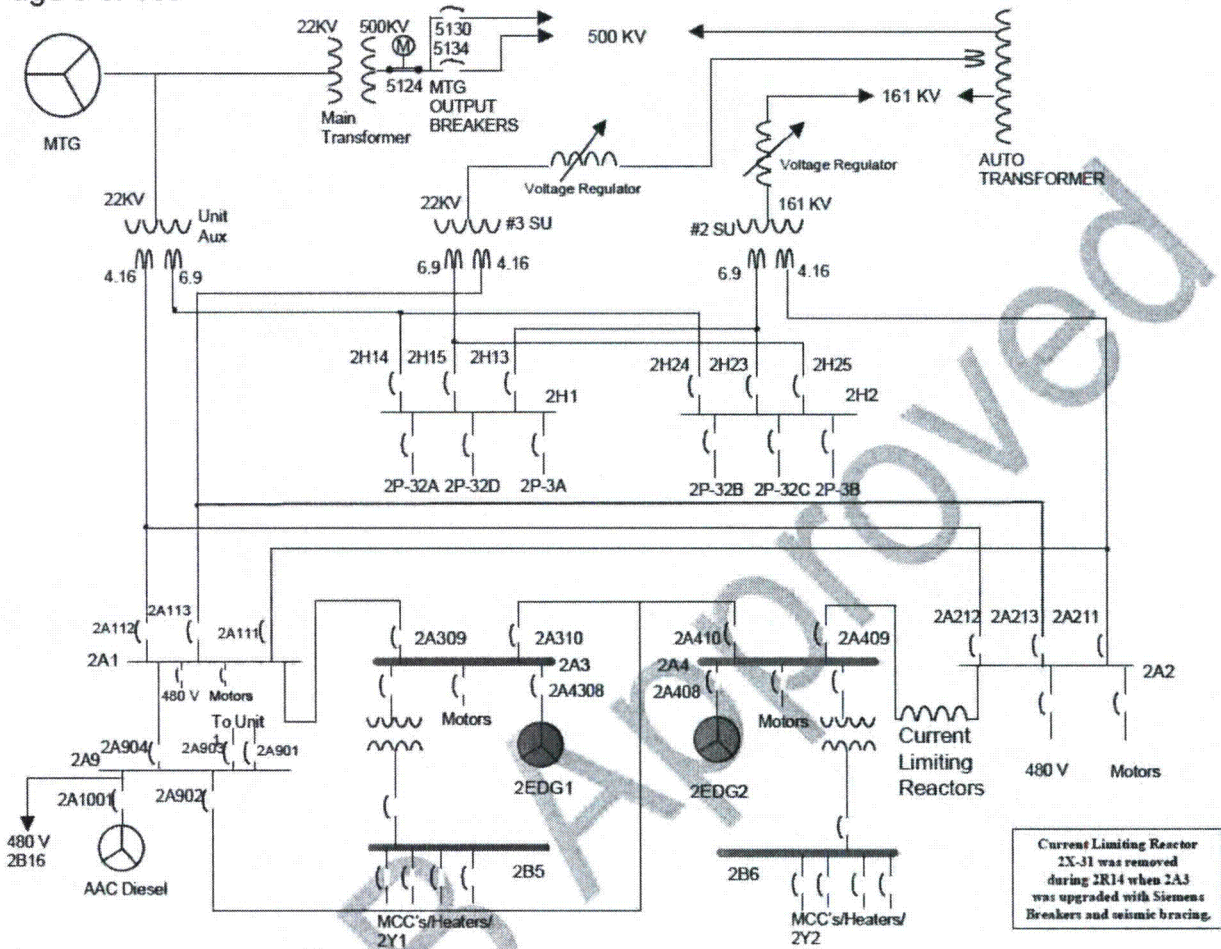
Figure 1. ANO-2 High Voltage Distribution System

Immediate attempts were made by Operations personnel to isolate fire water spraying from the broken fire water piping into the train bay area. A field operator was dispatched to shut down the fire water pumps in the ANO-1 intake structure. Power to the electric fire pump was lost due to damage to the A-1 switchgear. The field operator did not immediately recognize a temporary electric motor-driven fire water pump was in service at this time supplying water to the header (CR-ANO-C-2013-01072). The temporary fire water pump was subsequently secured. Spray from the fire water piping rupture, migrated into the ANO-2 switchgear area. The fire water that had pooled on the floor in the switchgear area entered the 2A1 switchgear at the location of the 2A-113 breaker cubicle causing an electrical fault at approximately 0923 on the 2A-1 4160V supply bus from start-up transformer #3 (SU3). This fault resulted in a protective relaying lockout of SU3 which tripped all SU3 feeder and load breakers (CR-ANO-2-2013-00565). Switchgear 2A-2 was deenergized following the SU3 lockout resulting in a loss of offsite power to 2A-2 and 2A-4. The 2K-4B emergency diesel generator started as designed and supplied safety bus 2A-4. Start-up transformer #2 (SU2) feed to 2A-2 breaker 2A-211 was in pull-to-lock per OP-2107.001 *Electrical System Operation*, (normal configuration). Switchgear 2A-1 successfully slow transferred its feed to SU2 and provided power to 2A-1 and safety bus 2A-3. Switchgear 2A-1 remained energized throughout the event. Figure 1 depicts the ANO-2 high voltage distribution system.

Loss of SU3 6900V buses 2H-1 and 2H-2 caused the loss of power to the two running Reactor Coolant Pumps (RCP) and the one running circulating water pump. Accordingly, the plant operators commenced a natural circulation cooldown using the atmospheric dump valves.
