**Ultrasonic Phased Array
Assessment of the Interference
Fit and Leak Path of the
North Anna Unit 2 Control Rod
Drive Mechanism Nozzle 63 with
Destructive Validation**

Manuscript Completed: January 2012
Date Published:

Prepared by
S. L. Crawford, A. D. Cinson, P. J. MacFarlan, B. D. Hanson,
R. A. Mathews

Pacific Northwest National Laboratory
P.O. Box 999
Richland, WA 99352

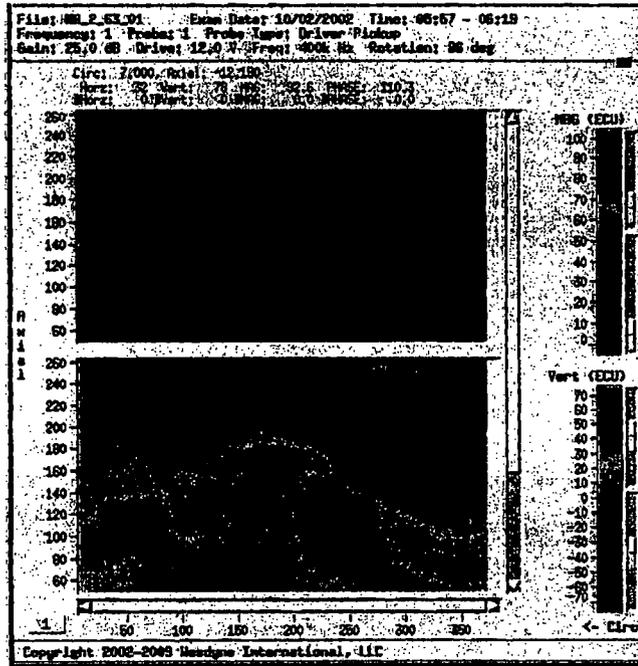
Figure 5.19 Eddy Current Data (Messtech International) Showing Two Axial Flaws. The horizontal axis represents the nozzle circumference in degrees. The vertical axis represents the nozzle axis in millimeters.

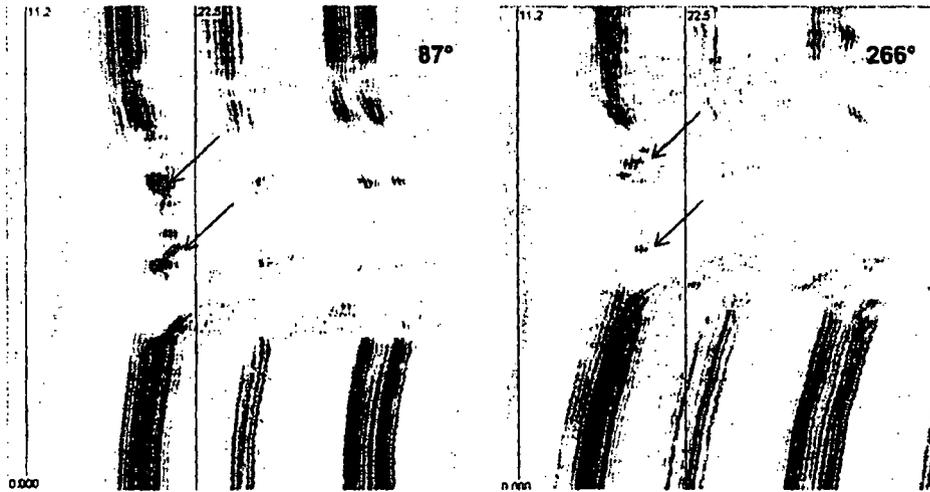
Figure 8.12 B-scan Views of the Data at 87 Degrees on the Left and 266 Degrees on the Right, Corresponding to the Cut and Exposed Surfaces in Figure 8.9. The horizontal axis in each image represents 40 mm (1.6 in.) in metal and the vertical axis represents 155 mm (6.1 in.) approximately. Flaw indications in the Alloy 600 tube-to-weld interface are noted with arrows.
