March 13, 2012

SUBJECT: Review of Draft NUREG/CR – XXXX Entitled, "Ultrasonic Phased Array Assessment of the Interference Fit and Leak Path of the North Anna Unit 2 Control Rod Drive Mechanism Nozzle 63 with Destructive Validation"

**Ultrasonic Phased Array
Assessment of the Interference
Fit and Leak Path of the
North Anna Unit 2 Control Rod
Drive Mechanism Nozzle 63 with
Destructive Validation**

Manuscript Completed: February 2012

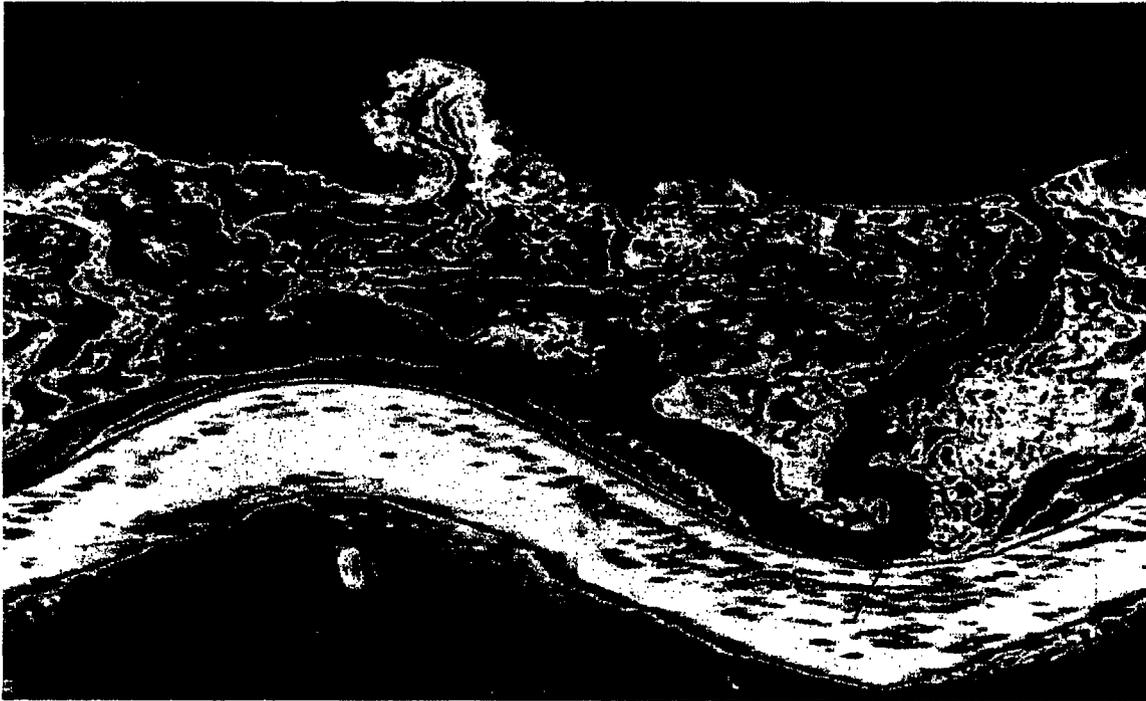
Figure 5.3 PA Ultrasonic Data from the Interference Fit in Nozzle 63 Acquired After the Second Brushing of the Nozzle ID. The horizontal axis represents the full 360-degree area and the vertical axis represents 360 mm (14.17 in.). Black arrows indicate primary leak path. The left edge marks the -90 degree location and the right edge the 270 degree location.

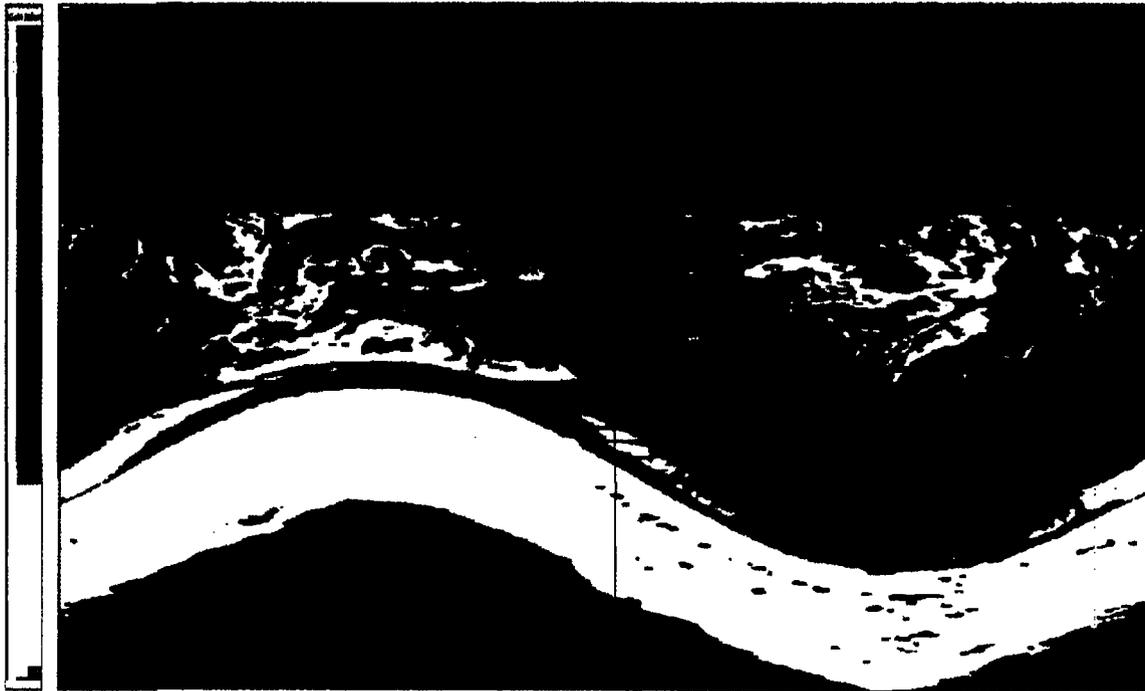
Figure 5.7 A Tri-Color Representation of the Interference Fit Data. The dark blue represents a leak path or gap, the light blue represents the interference fit and counter bore regions and the white represents the weld and suspected boric acid presence in the interference fit.

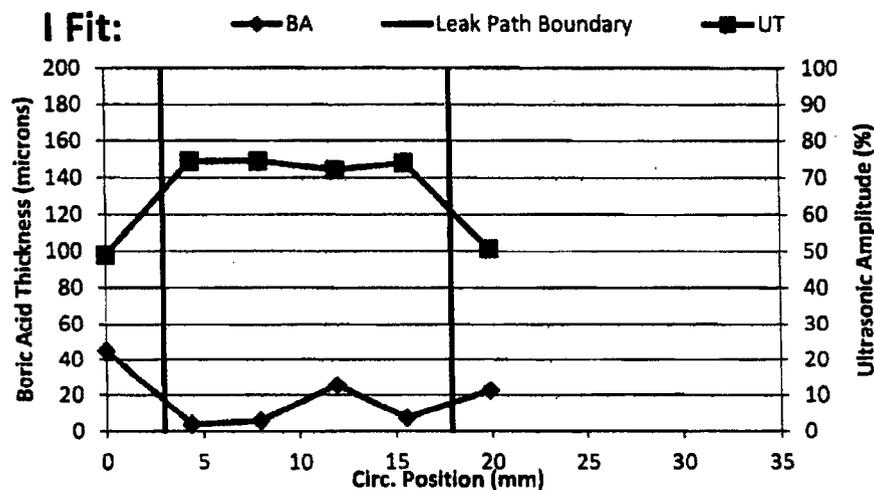
Figure 8.4 Ultrasonic and Boric Acid/Corrosion Layer Thickness Along a Line Across the Main Leak Path in the Interference (I) Fit

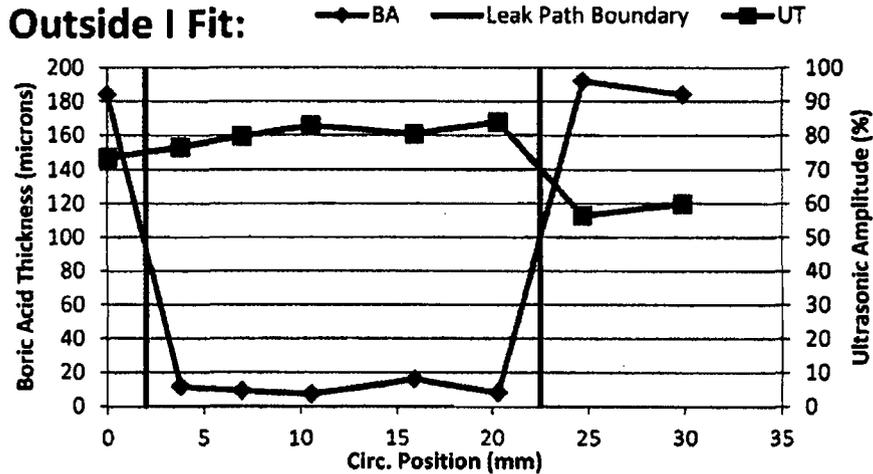
Figure 8.5 Ultrasonic and Boric Acid/Corrosion Layer Thickness Along a Line Across the Main Leak Path Outside the Interference Fit

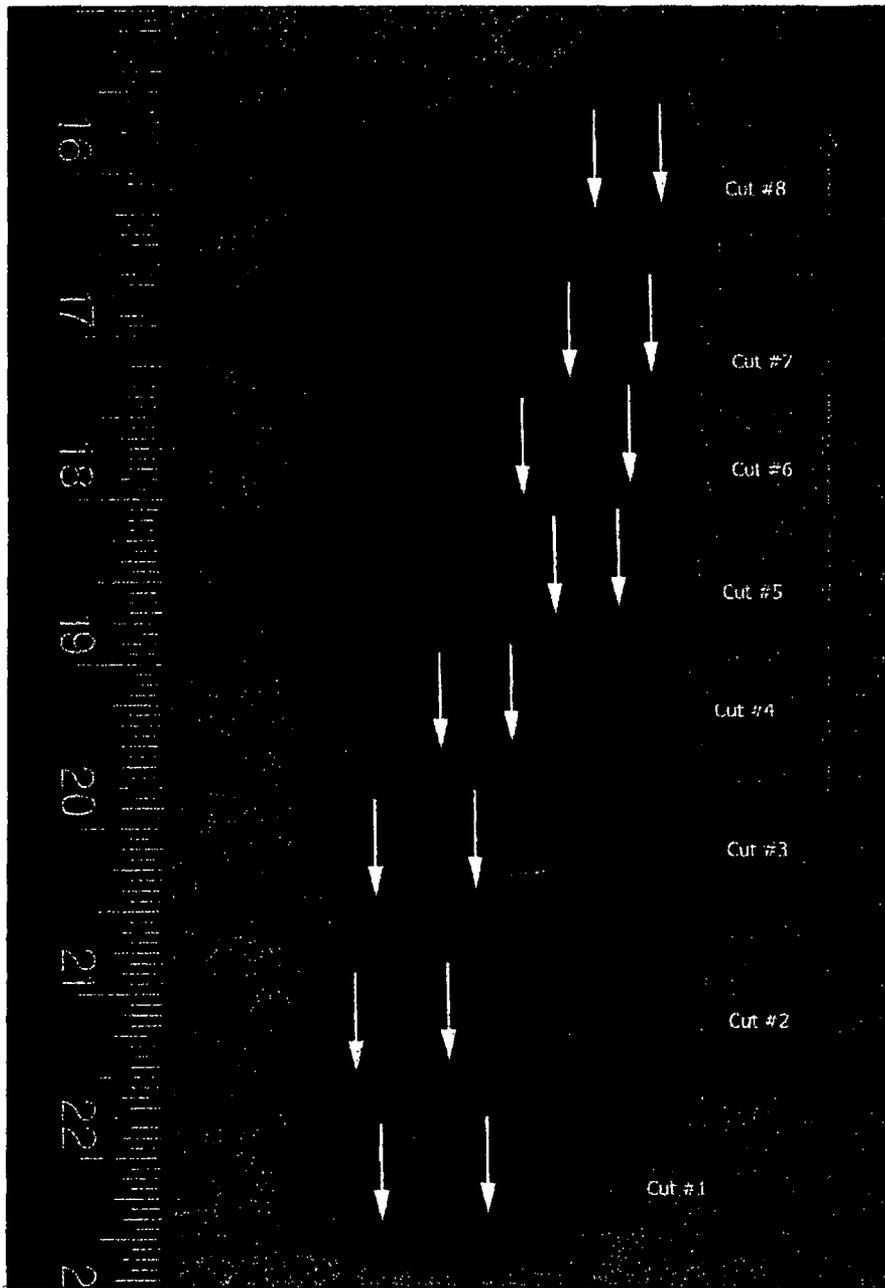
Figure 8.10 Leak Path Replica with Cuts and Pieces Identified. The interference fit region is noted with the black line and is contained in pieces 4 through 9.
