**UNITED STATES
NUCLEAR REGULATORY COMMISSION**
REGION III
2443 WARRENVILLE ROAD, SUITE 210
LISLE, IL 60532-4352

August 6, 2013

SUBJECT: PALISADES NUCLEAR PLANT - NRC INTEGRATED INSPECTION REPORT
05000255/2013003

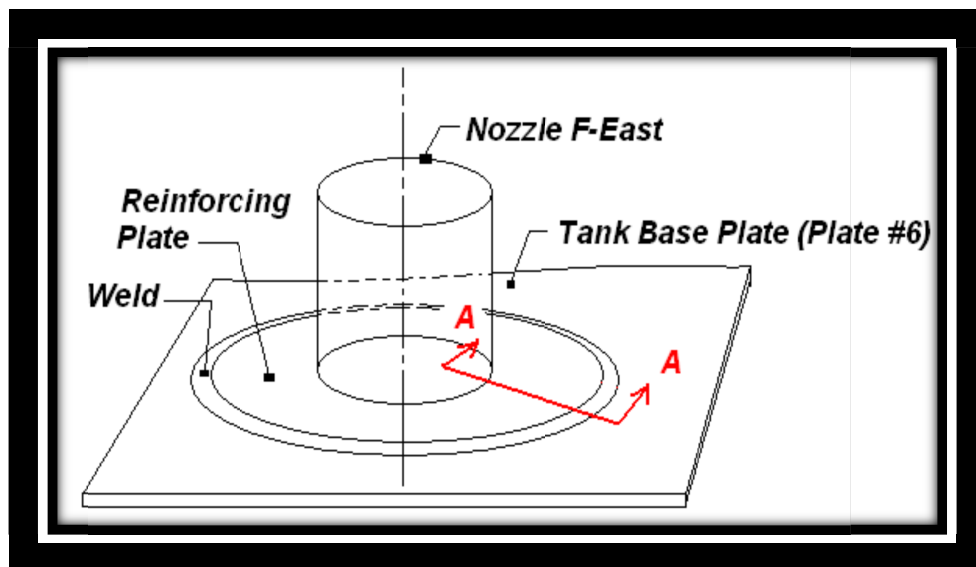
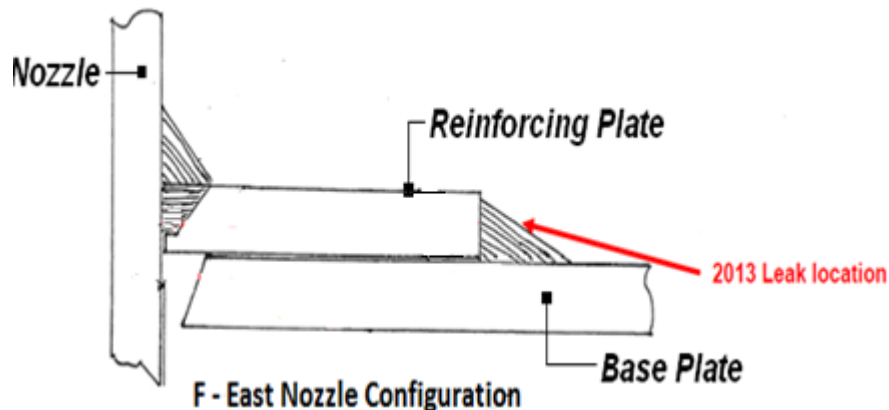
Section A-A

The fillet weld 12C1 connected the tank floor plate to the 23.5 inch diameter by 5/16 inch thick aluminum alloy 6061-T651 reinforcement plate around the 18 inch diameter F-east nozzle. The weld repair was made by manual gas tungsten arc welding (GTAW) with aluminum alloy R5356 filler material. The tank floor plate was constructed of 5454 series aluminum alloy (see figures below- not to scale).

During vacuum box testing of welds inside the SIRWT, the licensee identified a 3/16 inch long circumferentially oriented crack in the F-east nozzle reinforcement plate weld. The licensee removed a 6-inch diameter section of this weld containing the flaw utilizing a hole-saw. The removed sample was sent to the licensee's vendor, Babcock and Wilcox (B&W) Technical Services Group, for destructive examination. In the B&W report titled, "Laboratory Analysis of a Leaking Tank Weld from Palisades," the vendor identified the following:

- "The laboratory data indicated the cracking responsible for the tank weld leakage was mechanical overload that initiated at the weld lack of fusion adjacent to the repair plate and propagated through the weld metal in a ductile fashion. At the leak location, the lack of fusion measured ~80 percent. The average weld fusion was approximately 50 percent in other areas examined. This condition significantly reduced the strength of the welded joint and lead to the leakage."

- The floor plate, repair plate, and weld materials appeared to be consistent with specified requirements.
- "Also noted during the cross section examinations was significant weld porosity near the floor plate lack of fusion region and between the weld beads. Hydrogen causes porosity in aluminum welds. Hydrogen has a high solubility in molten aluminum, but very low solubility in solid aluminum. Hydrogen dissolved in the weld puddle during welding is released during solidification. The relatively high freezing rate of aluminum can prevent the hydrogen from rising to the surface of the weld puddle, causing porosity. Moisture on the work surface and/or electrode is typically the source of the hydrogen, but it can also originate from foreign materials such as oil, paint, dirt, etc. Lack of fusion is caused by improper work surface preparation and/or using too low a welding current."

The licensee staff believed the F-east reinforcement plate weld failure was due to application of a low welding current and/or high weld deposition rate and not due to improper surface preparation. This conclusion was based on informal tests conducted by the weld vendor during which lack of fusion defects were created by varying the weld techniques (current, voltage and travel speed). The licensee believed this testing demonstrated that it was possible to get lack of fusion defects on a clean plate. The weld vendor had not recorded the weld parameters used during these informal tests and the extent of lack of fusion was not measured. Therefore, it was not possible for the inspectors to use this information to evaluate the portion of the lack of fusion attributed to poor weld technique and compare it to the lack of fusion attributed to inadequate pre-weld cleaning. Specifically, the B&W Technical Services Group report documented that the average lack of weld fusion was approximately 50 percent and peaked at 80 percent thru-wall (along the vertical weld leg) across the section of weld removed from the failed weld 12C1. Further, improper welding techniques alone could not explain the source of hydrogen induced "significant weld porosity" as identified in the B&W Technical Services Group report on the failed weld. As discussed in the technical references listed above, the source of hydrogen in aluminum weld metal is caused by breakdown of contaminants (grease, oil, and/or water) present at the weld joint surface. Therefore, the inspectors concluded that the welder failed to thoroughly/adequately pre-weld clean the base metal and the licensee failed to adequately control the vendor welding process in a manner that would ensure complete weld fusion.

In response to the 2013 leakage event, the licensee subsequently replaced the SIRWT floor and included instructions in the floor replacement work order that required pre-weld cleaning with acetone or other approved solvents. The licensee entered the failure to perform adequate pre-weld cleaning and control the vendor welding process in a manner which would ensure proper weld fusion into the CAP as CR-PLP-2013-03185.
