**UNITED STATES  
NUCLEAR REGULATORY COMMISSION**

**SUBJECT: D. C. COOK NUCLEAR POWER PLANT, UNITS 1 AND 2 – NRC INTEGRATED  
INSPECTION REPORT 05000315/2013003 and 05000316/2013003**

Enclosure: Inspection Report 05000315/2013003; 05000316/2013003  
w/Attachment: Supplemental Information

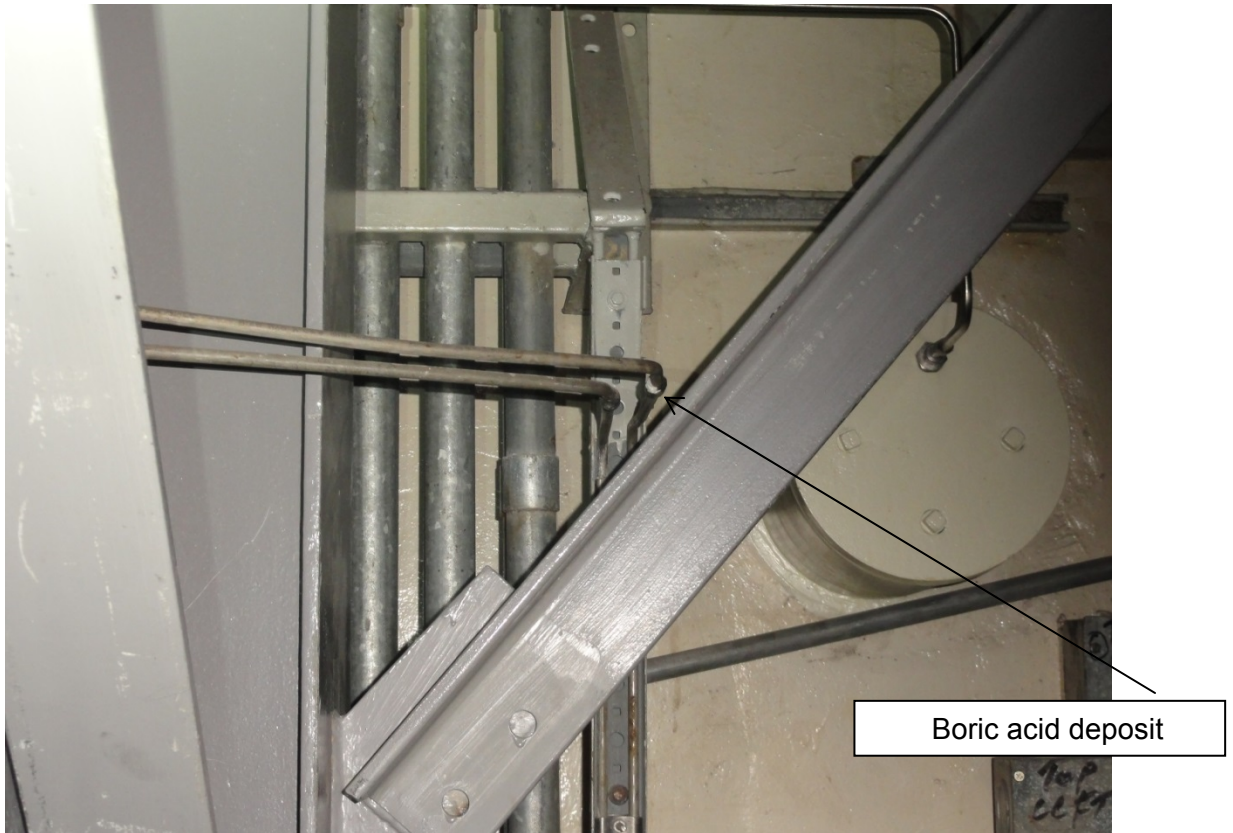
Figure 1

Discussion: On May 17, 2013, while performing a containment walkdown at Normal Operating Pressure/Normal Operating Temperature, the inspectors noted a boric acid deposit on a 3/8" line. Based on the location, the inspectors concluded that the boric acid resulted from a through wall crack. As seen in Figure 1, the boric acid deposit occurred near a weld and there were no other plausible boric acid sources. The inspectors informed the licensee of the deposit and the licensee cleaned the boric acid. The licensee examined the area and performed a penetrant test to locate the precise location of leak. The test did not reveal a flaw; however, the licensee could not locate another source of the boric acid.

The licensee removed the section of pipe with the flaw and replaced it. However, the licensee did not retain the removed section of pipe. Based on the presence of the boric acid and lack of alternate boric acid sources, the inspectors concluded that a through wall flaw existed through that portion of the reactor coolant pressure boundary. The inspector reviewed the licensee's requirements for boric acid inspections. PLI-5032, Boric Acid Corrosion Control Programs, requires that Boric acid leakage conditions be identified and documented. However, the licensee failed to identify deposit during the refueling outage.

Contrary to this requirement, between March 27 and May 17, 2013, the licensee failed to implement Step 4.2 of procedure PMI-5032. Specifically, the licensee failed to identify a boric acid deposit on RCPB piping between 1-NFP-220-V1 and loop flow instrument NFP-220. The boric acid occurred due to a through-wall leak near a weld. Because the licensee corrected the condition, there was no safety consequence.

For corrective action, the licensee replaced the 3/8” piping section mentioned above.
