**Comparison of an Ultrasonic Phased Array Evaluation with Destructive Analysis of a Documented Leak Path in a Nozzle Removed from Service**

AD Cinson, SL Crawford, PJ MacFarlan, BD Hanson, and RA Mathews  
Pacific Northwest National Laboratory<sup>1</sup>, Richland, WA, USA

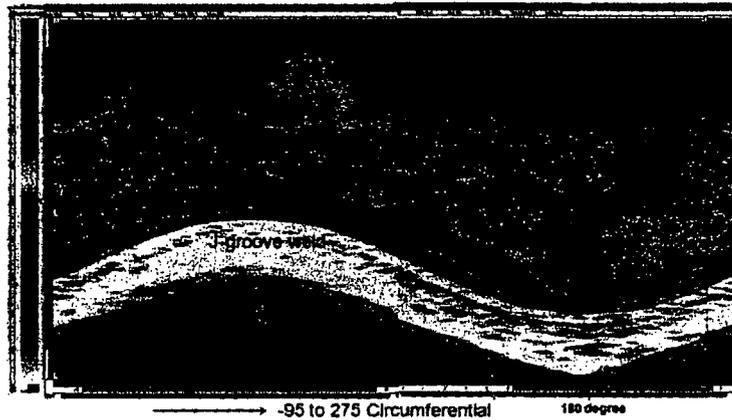
The investigation of the interference fit region on Nozzle 63 shows a large variety in the reflected ultrasonic responses. Some responses are strong in amplitude, indicating an air gap and noted as red-orange in color, while others are weak in reflected amplitude, indicating a tight interference fit and noted as white-blue. A search in the data image for a high-amplitude river pattern connecting the weld to the top of the interference fit region reveals the primary leak path. This leak path originates at approximately the 180-degree location (downhill point on the nozzle) and is marked in Figure 6. The lower amplitude

Figure 6 – A composite 360-degree ultrasonic data image from Nozzle 63. The vertical axis represents 360 mm (14.17 in.)

(blue) cluster regions near the leak path in the interference fit indicate the potential presence of boric acid as was observed in the calibration specimen. Boric acid deposits have been noted in actively leaking nozzles [1, 2].
