Crystal River Nuclear Plant
15760 W. Power Line Street
Crystal River, FL 34428

Subject: Crystal River Unit 3 – Licensee Event Report 50-302/2013-001-00

4. TITLE
Valid Actuation of an Emergency Diesel Generator Due to a Spurious Fault on a Breaker Non-Segregated Bus Duct

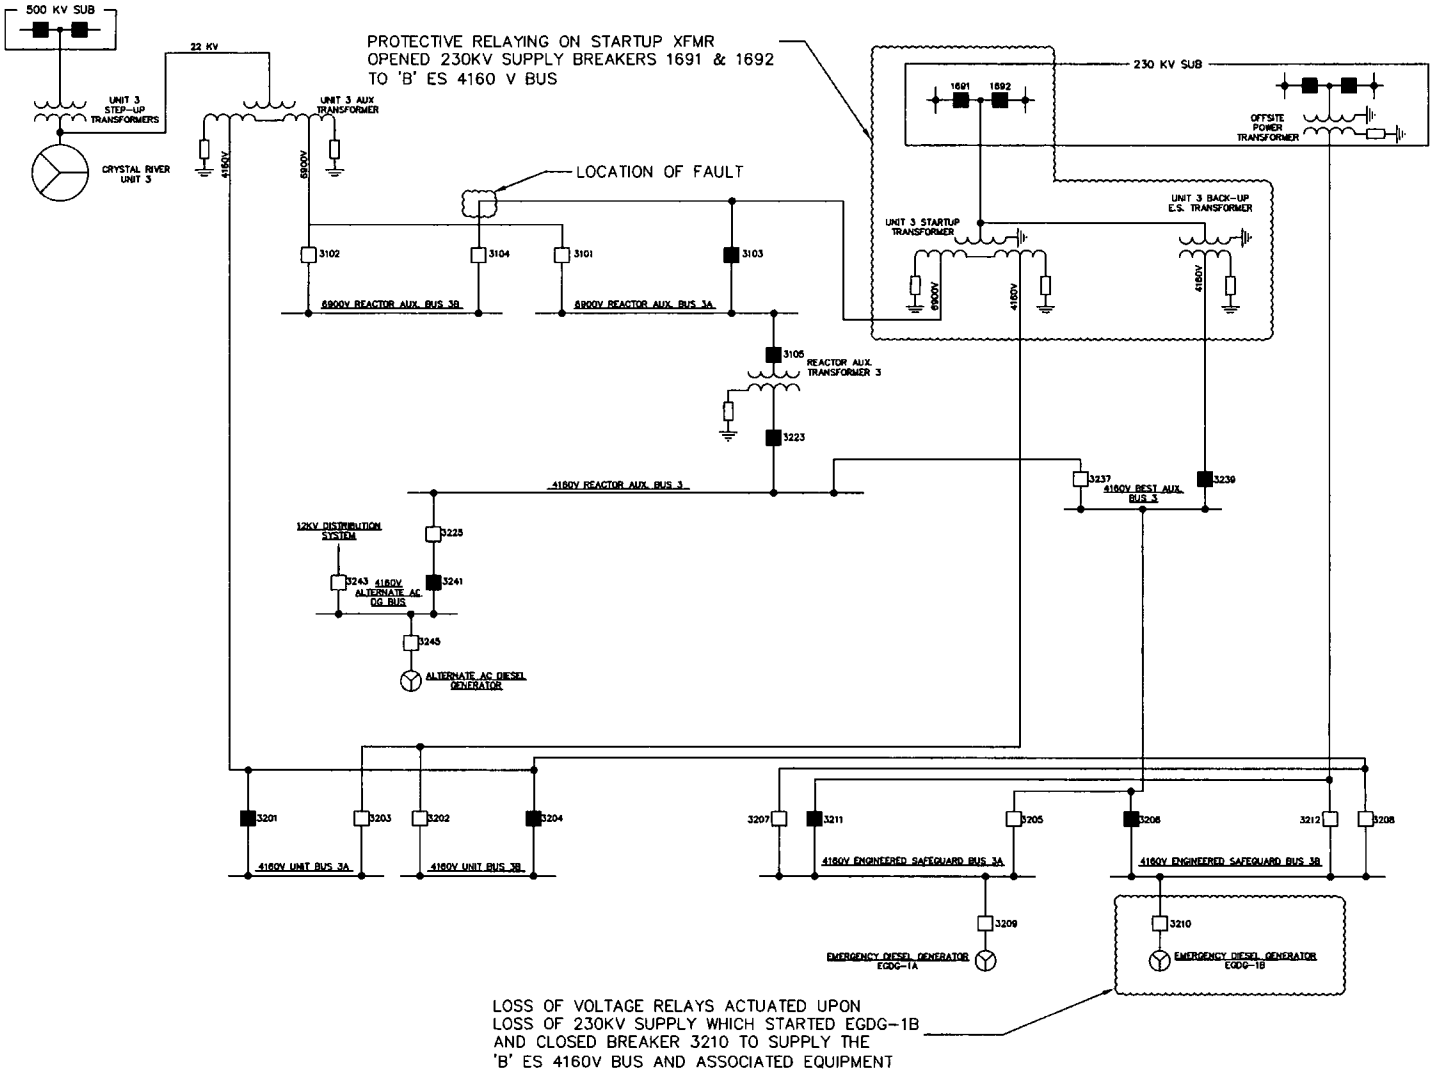
Figure 1

At 21:29, on June 1, 2013, Duke Energy Florida, Inc., (DEF) Crystal River Unit 3 (CR-3) was in NO MODE (core permanently off loaded for decommissioning) at 0 percent RATED THERMAL POWER when a spurious fault above (on the line side of) Breaker 3104 (Startup Transformer (SUT) [EB, XFMR] feed to the "B" Unit 6.9 kilovolt (kV) non-segregated bus (MTBD-13A [EA, NSBU])) [EA, BKR] occurred. At the time of the fault, Breaker 3104 was open; therefore, no overcurrent condition occurred on the load side of the breaker. Protective relaying de-energized the SUT and the Backup Engineered Safeguards Transformer (BEST) [EB, XFMR], which de-energized the "B" Engineered Safeguards (ES) 4160 volt (V) bus [EB, BU]. The "B" Emergency Diesel Generator (EGDG-1B) [EK, DG] started and re-energized the "B" ES 4160V bus. (Figure 1 is a simplified distribution diagram that shows the breaker alignment immediately prior to the event.)

MTBD-13A is fed from the SUT which is supplied by the 230kV offsite power switchyard bus [EA, BU]. All three SUT differential relays [EA, 87] actuated. This caused the SUT lockout relays (LORs) [EA, 86] to operate, which in turn, operated the BEST master relay LORs. The appropriate breakers were opened by the LORs, including 230kV Breakers 1691 and 1692 [EA, BKR]. All relays operated as designed. EGDG-1B automatically started on a valid signal and loaded, as designed.

Figure 1: Breaker Alignment Shown Immediately Prior to Event
