## **An Ultrasonic Leak Path Assessment of a Pressurized Water Reactor Control Rod Drive Mechanism Nozzle**

P.G. Oberson,<sup>a</sup> D.S. Dunn,<sup>a</sup> A.D. Cinson,<sup>b</sup> S.L. Crawford,<sup>b</sup> P.J. MacFarlan,<sup>b</sup> B.D. Hanson<sup>b</sup>

<sup>a</sup> U.S. Nuclear Regulatory Commission, Washington, DC, 20555, USA

<sup>b</sup> Pacific Northwest National Laboratory, Richland, WA, 99352, USA

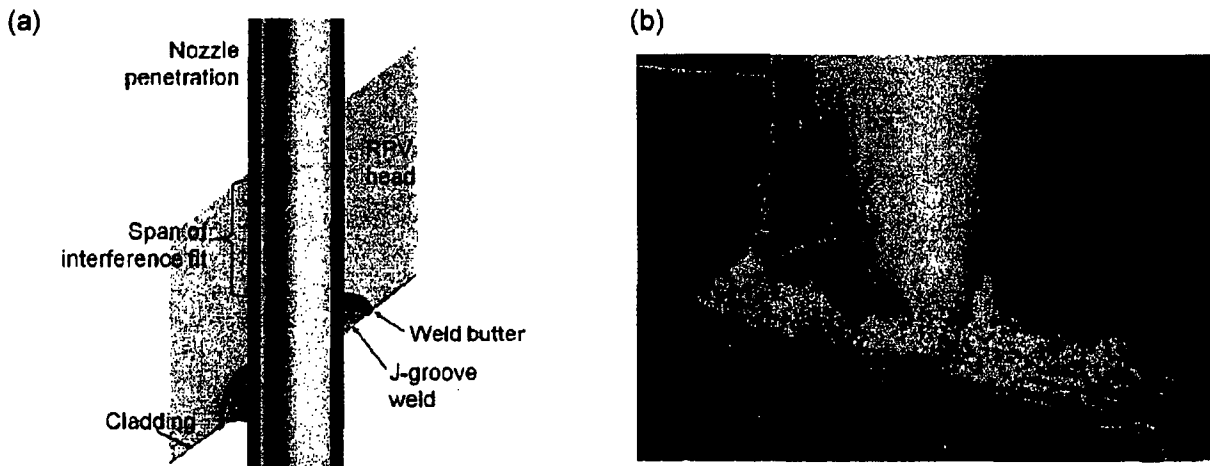
**Figure 1. (a) Schematic illustration of CRDM penetration in a PWR, (b) Boric acid deposits on top of a RPV head near a leaking CRDM penetration [6].**

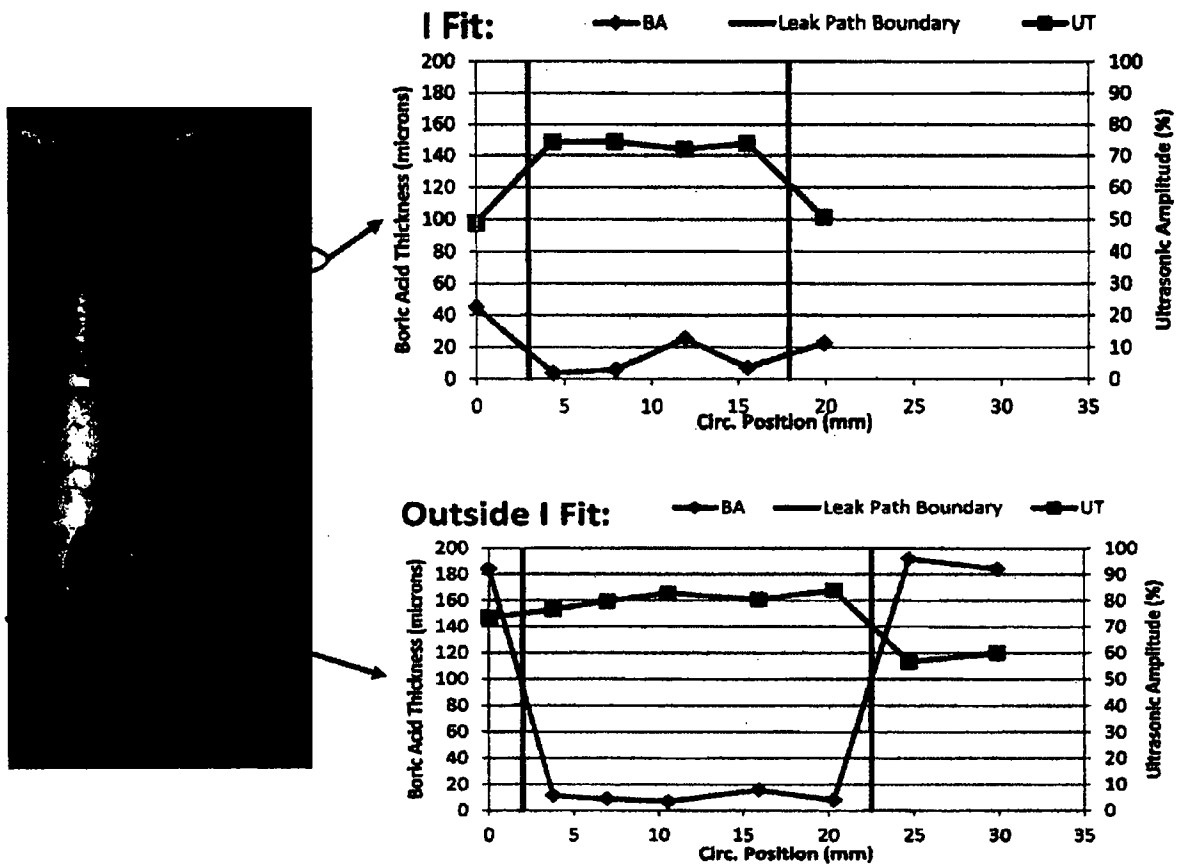
Figure 7 shows the surface deposit thickness measurement and amplitude of the UT response at a number of points across the leak path. The series of measurements across the leak path in the vertical span of the interference fit, (designated "I Fit") in Figure 7, shows that there is minimal deposit thickness within the leak path and the amplitude of the UT response, given as a percentage of full screen height, is relatively high. Outside the leak path, on both sides, the deposits are thicker and the amplitude of the UT response decreases. A similar pattern holds for the measurements across the leak path below the span of the interference fit (designated "Outside I Fit"), though the deposits are somewhat thicker. This response can be explained if it is assumed that the active flow of primary water prevents the formation of deposits directly in the leak path and that the deposits would tend to accumulate to the sides. Because there are no deposits in the leak path, an air gap is maintained between the nozzle OD and the RPV head which gives a high amplitude UT response. Outside the leak path, the deposits serve to couple the nozzle and RPV head, allowing greater transmission of ultrasonic energy, and thus a lower amplitude UT response.

**Figure 7. Measurements of the surface deposit thickness (BA) and amplitude of the UT response (UT) across the leak path for locations in the vertical span of the interference fit (I Fit) and below the interference fit (Outside I Fit). The vertical black lines on the graphs represent the side boundaries of the leak path.**

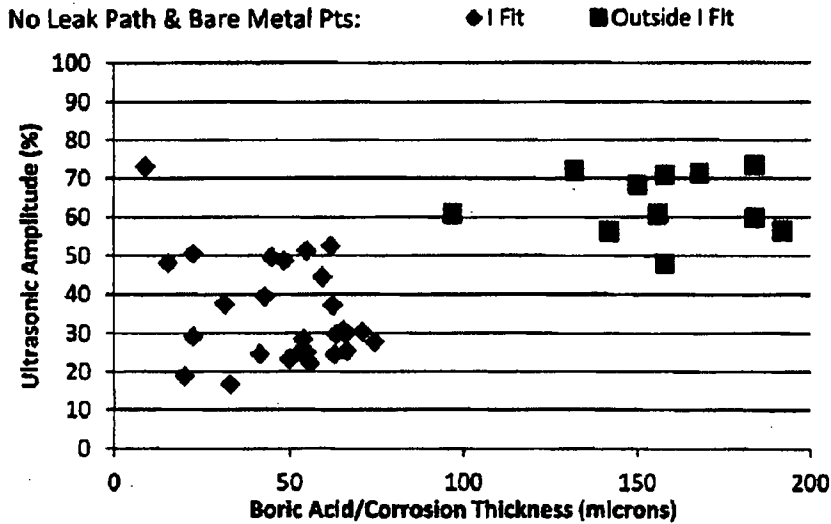
The deposit thicknesses were also measured for various other locations in the annulus, both within and outside the vertical span of the interference fit. The correlation between the deposit thickness and the amplitude of the UT response is shown in Figure 8. The data pattern indicates that within the span of the interference fit, the deposits tend to be thinner, with the locations giving a relatively low amplitude UT response. Outside the span of the interference, the deposits are generally thicker, with locations giving higher amplitude UT response. From these responses, it is postulated that at reactor operating temperature, a gap may open in the annulus between the nozzle and RPV head because of differing thermal expansion coefficients. If leakage occurs, primary water may flow throughout the annulus by the path of least resistance. As the reactor cools down, the gap between the nozzle and RPV head will close, trapping primary water that will leave deposits as it evaporates. It is likely that in the span of the interference fit, the gap between the nozzle OD and the RPV head is narrower than outside, which would significantly compact any deposits left behind. Thus deposits in the span of the interference will tend to be thin and dense relative to deposits outside. The thin and dense deposits should more efficiently couple the nozzle and RPV head allowing greater transmission of ultrasonic energy and a lower amplitude UT response.

**Figure 8. Measurements of the surface deposit thickness and amplitude of the UT response for points inside and outside the span of the interference fit (I Fit).**
