An Ultrasonic Leak Path Assessment of a Pressurized Water Reactor Control Rod Drive Mechanism Nozzle

P.G. Oberson,^a D.S. Dunn,^a A.D. Cinson,^b S.L. Crawford,^b P.J. MacFarlan,^b B.D. Hanson^b

^aU.S. Nuclear Regulatory Commission, Washington, DC, 20555, USA

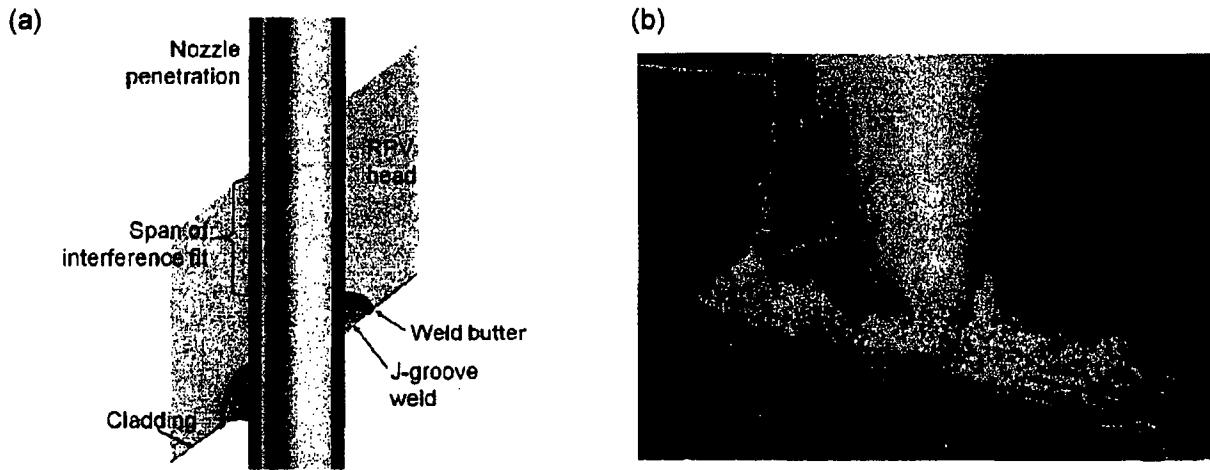
Figure 1. (a) Schematic illustration of CRDM penetration in a PWR, (b) Boric acid deposits on top of a RPV head near a leaking CRDM penetration [6].

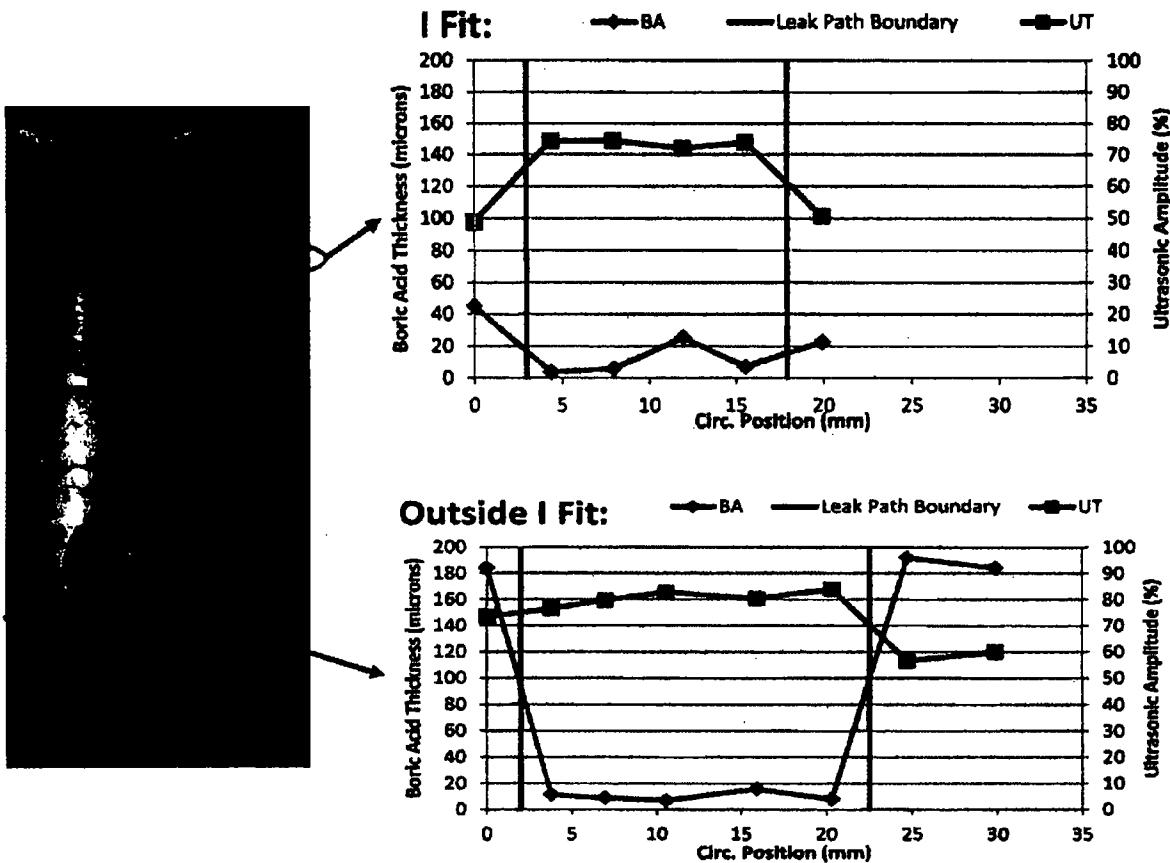
Figure 7 shows the surface deposit thickness measurement and amplitude of the UT response at a number of points across the leak path. The series of measurements across the leak path in the vertical span of the interference fit, (designated "I Fit" in Figure 7, shows that there is minimal deposit thickness within the leak path and the amplitude of the UT response, given as a percentage of full screen height, is relatively high. Outside the leak path, on both sides, the deposits are thicker and the amplitude of the UT response decreases. A similar pattern holds for the measurements across the leak path below the span of the interference fit (designated "Outside I Fit"), though the deposits are somewhat thicker. This response can be explained if it is assumed that the active flow of primary water prevents the formation of deposits directly in the leak path and that the deposits would tend to accumulate to the sides. Because there are no deposits in the leak path, an air gap is maintained between the nozzle OD and the RPV head which gives a high amplitude UT response. Outside the leak path, the deposits serve to couple the nozzle and RPV head, allowing greater transmission of ultrasonic energy, and thus a lower amplitude UT response.

Figure 7. Measurements of the surface deposit thickness (BA) and amplitude of the UT response (UT) across the leak path for locations in the vertical span of the interference fit (I Fit) and below the interference fit (Outside I Fit). The vertical black lines on the graphs represent the side boundaries of the leak path.

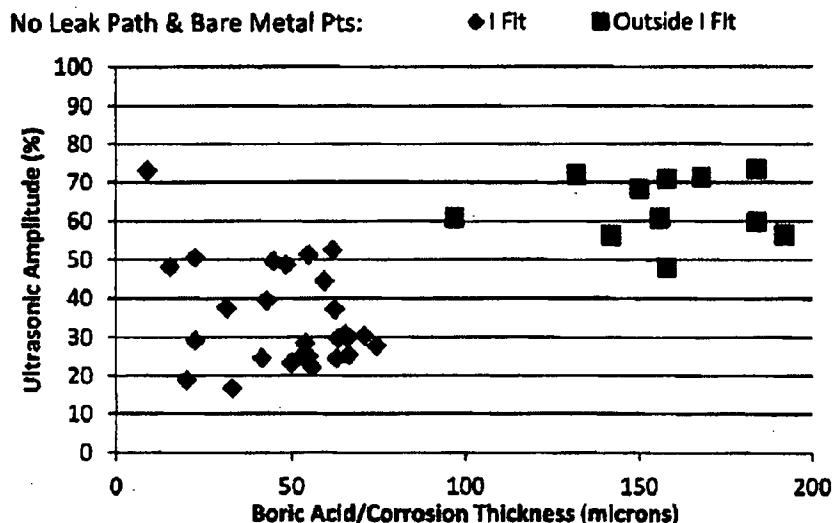
The deposit thicknesses were also measured for various other locations in the annulus, both within and outside the vertical span of the interference fit. The correlation between the deposit thickness and the amplitude of the UT response is shown in Figure 8. The data pattern indicates that within the span of the interference fit, the deposits tend to be thinner, with the locations giving a relatively low amplitude UT response. Outside the span of the interference, the deposits are generally thicker, with locations giving higher amplitude UT response. From these responses, it is postulated that at reactor operating temperature, a gap may open in the annulus between the nozzle and RPV head because of differing thermal expansion coefficients. If leakage occurs, primary water may flow throughout the annulus by the path of least resistance. As the reactor cools down, the gap between the nozzle and RPV head will close, trapping primary water that will leave deposits as it evaporates. It is likely that in the span of the interference fit, the gap between the nozzle OD and the RPV head is narrower than outside, which would significantly compact any deposits left behind. Thus deposits in the span of the interference will tend to be thin and dense relative to deposits outside. The thin and dense deposits should more efficiently couple the nozzle and RPV head allowing greater transmission of ultrasonic energy and a lower amplitude UT response.

Figure 8. Measurements of the surface deposit thickness and amplitude of the UT response for points inside and outside the span of the interference fit (I Fit).
