**PSEG Nuclear LLC**

Salem Generating Station, Units 1 and 2  
Renewed Facility Operating License Nos. DPR-70 and DPR-75  
NRC Docket Nos. 50-272 and 50-311

Subject: **Response to Request for Additional Information – Relief Request  
SC-I4R-133, Alternative Repair for Service Water System Piping**

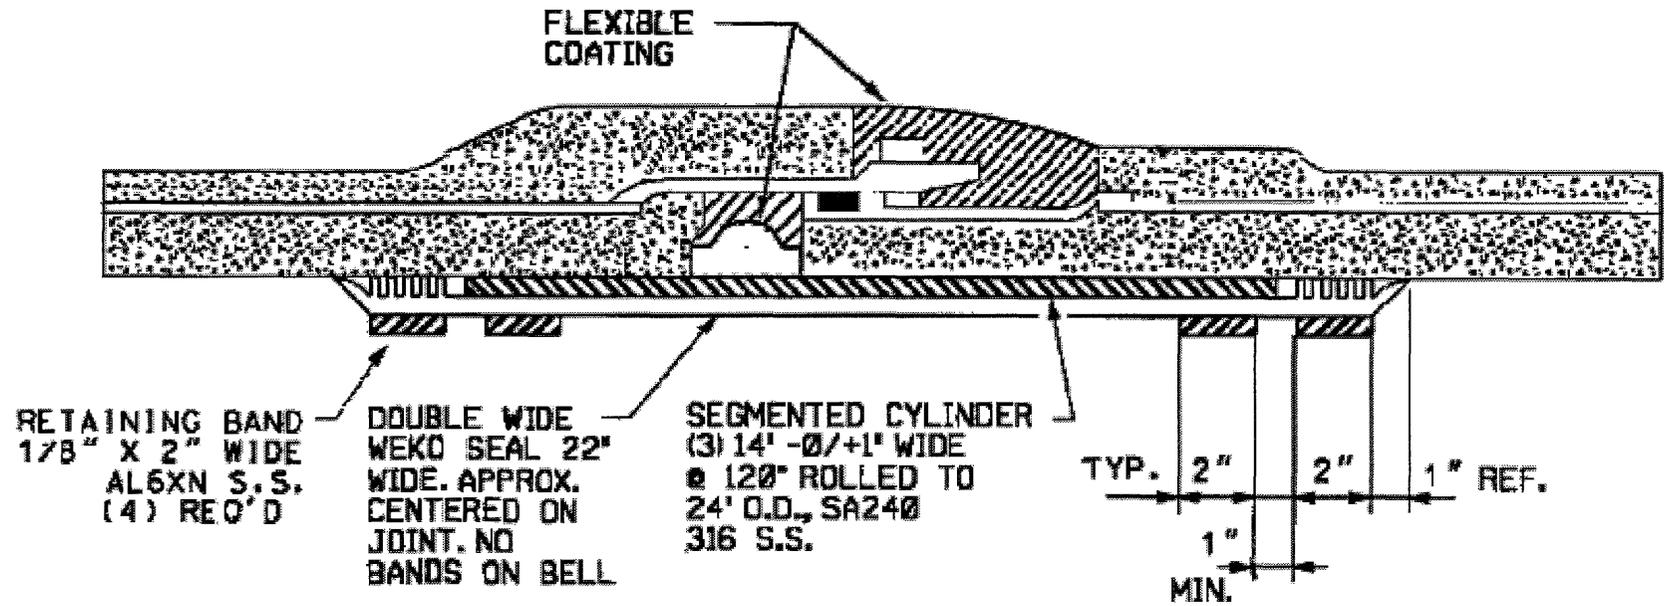
Figure 1. Detailed Drawing of WEKO Seal

Detailed design drawings with plant-specific dimensions of the bell-and-spigot joint before the repair using the WEKO seal are not available. Figure 1 of Attachment 1 provides specific dimensions for the WEKO seals.

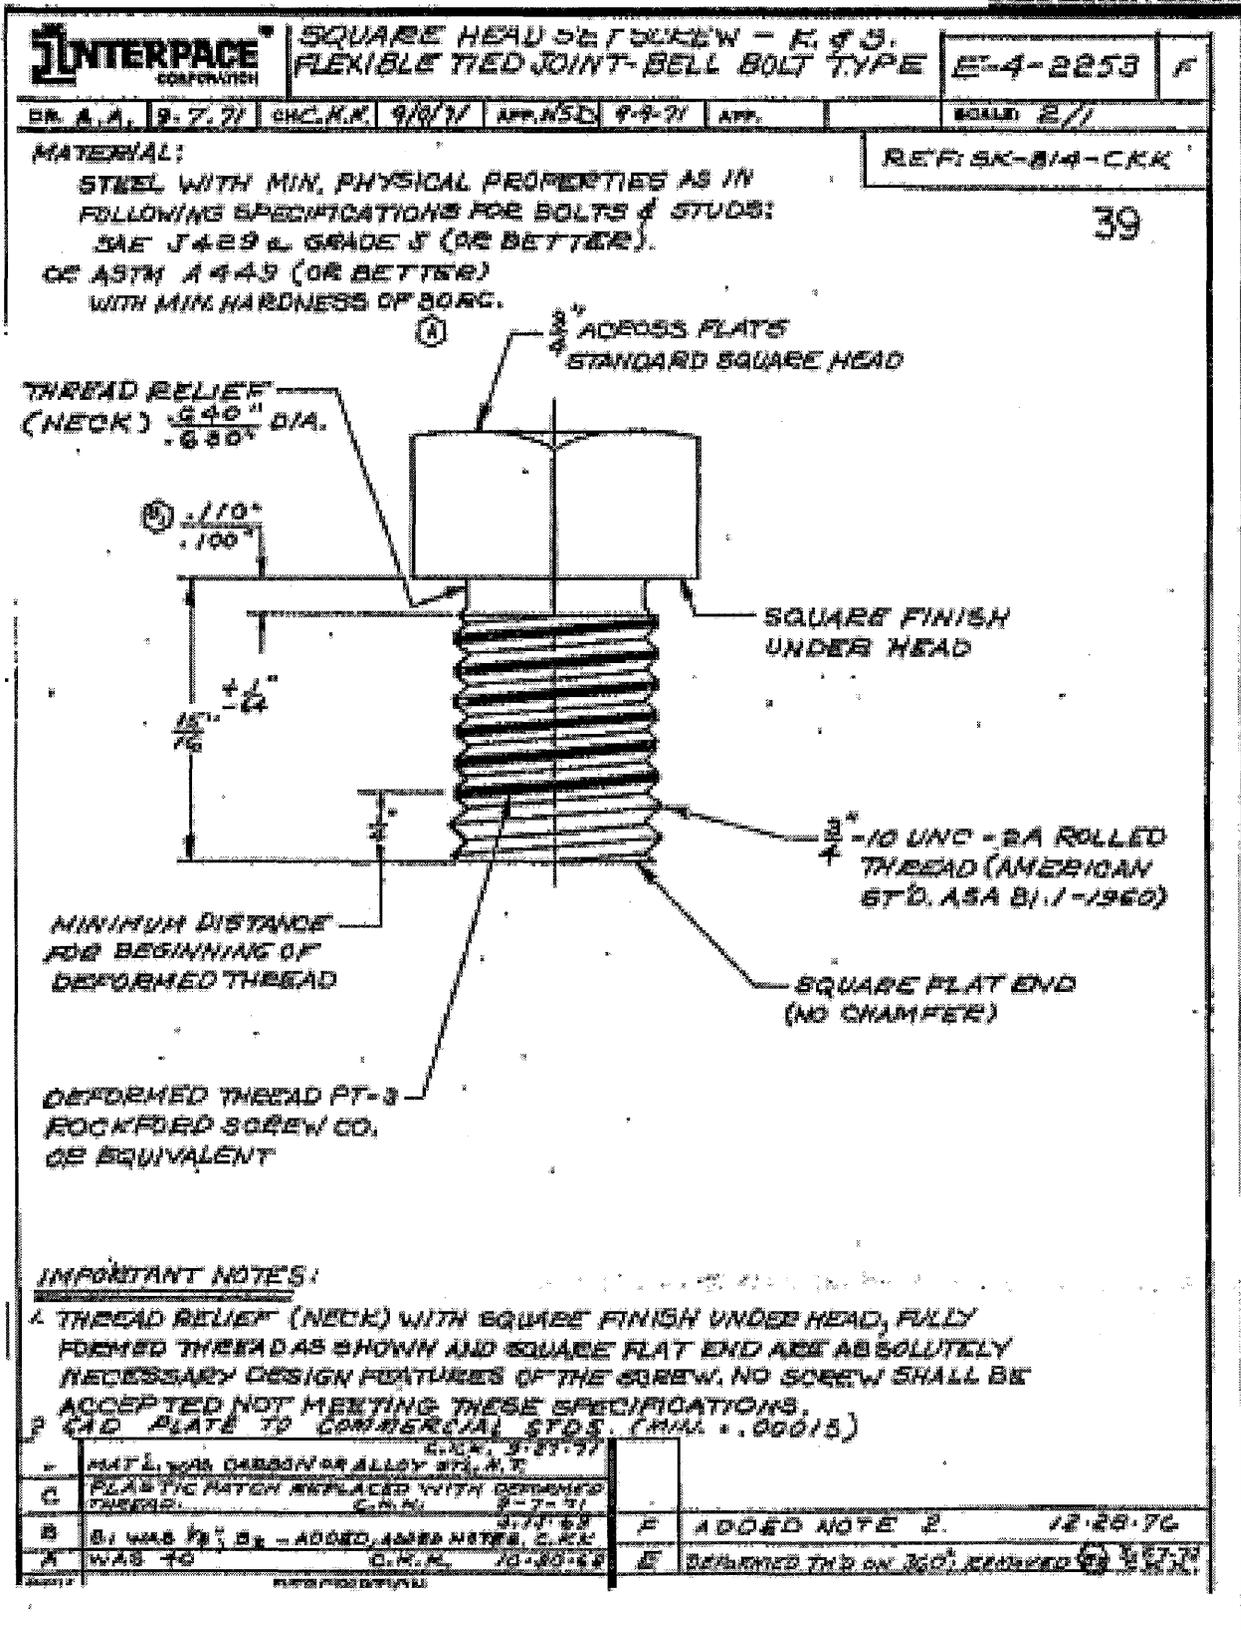
Figure 2. Detailed Drawing of Set Screws

- g. The bell bolts (i.e., set screws) are not torqued and are unloaded during normal operating conditions. The two mating pipe segments are normally positioned such that the bell bolts do not engage the bolt stop. In the event of failure of the harness assembly, the bell bolts are threaded through the bell ring and function as shear pins to prevent excessive joint extension.

In addition, the portion of the bell that houses the bell bolts is not exposed to service water due to the presence of the gasket; therefore, degradation in that region is not likely.
