SUBJECT: NRC OBSERVATIONAL SITE VISIT AT THE MAYBELL WEST,  
COLORADO DISPOSAL SITE

Report: 040-09090/13-001

Facility: Maybell West Disposal Site

## NRC Trip Report

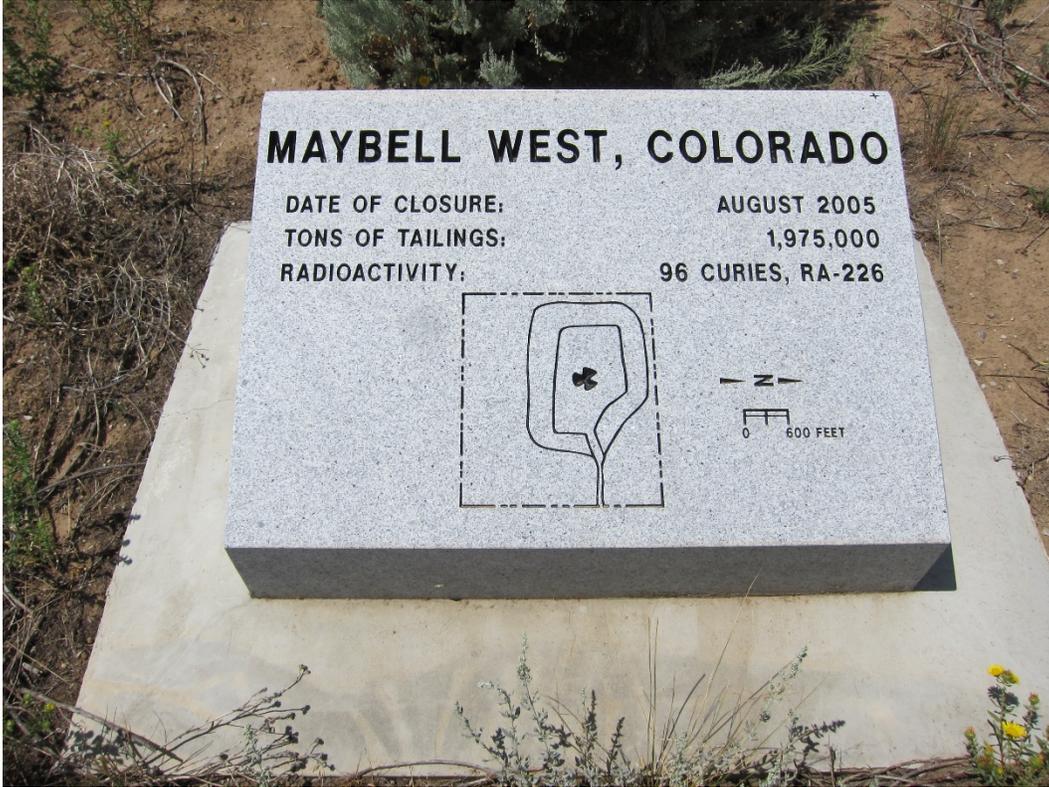
Figure 1: Site marker SMK-1 located at entrance of Maybell West disposal cell

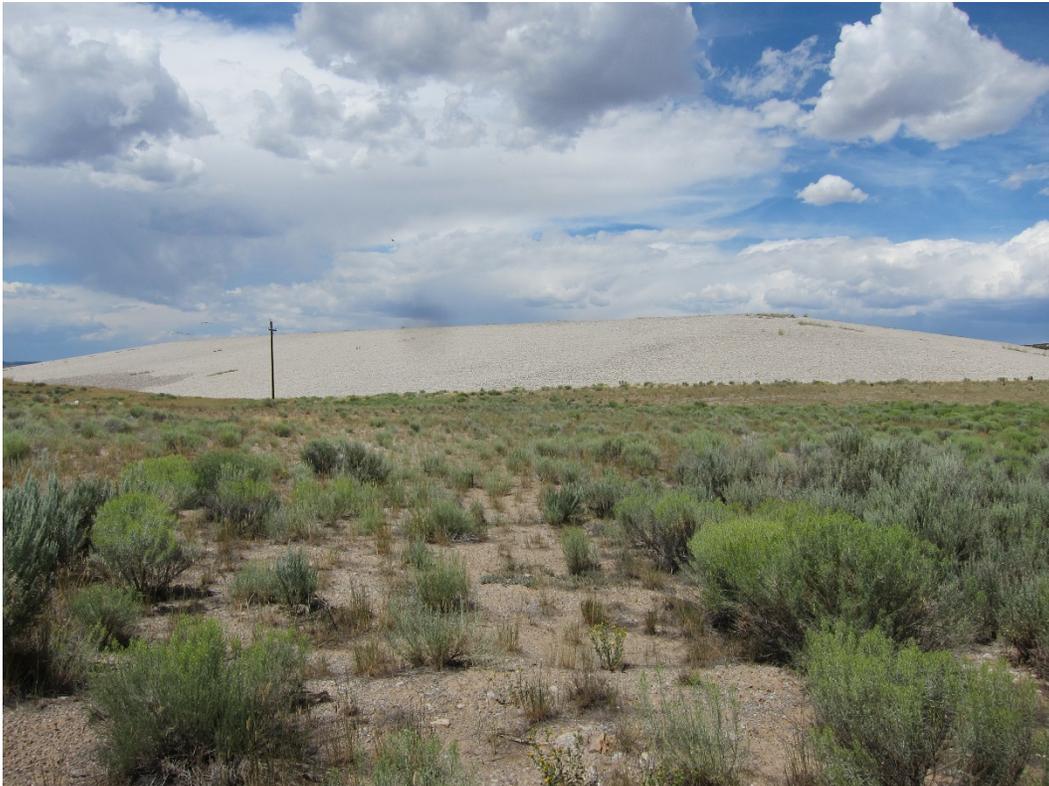
Figure 2: Maybell West disposal cell as seen from entrance gate (looking northwest)

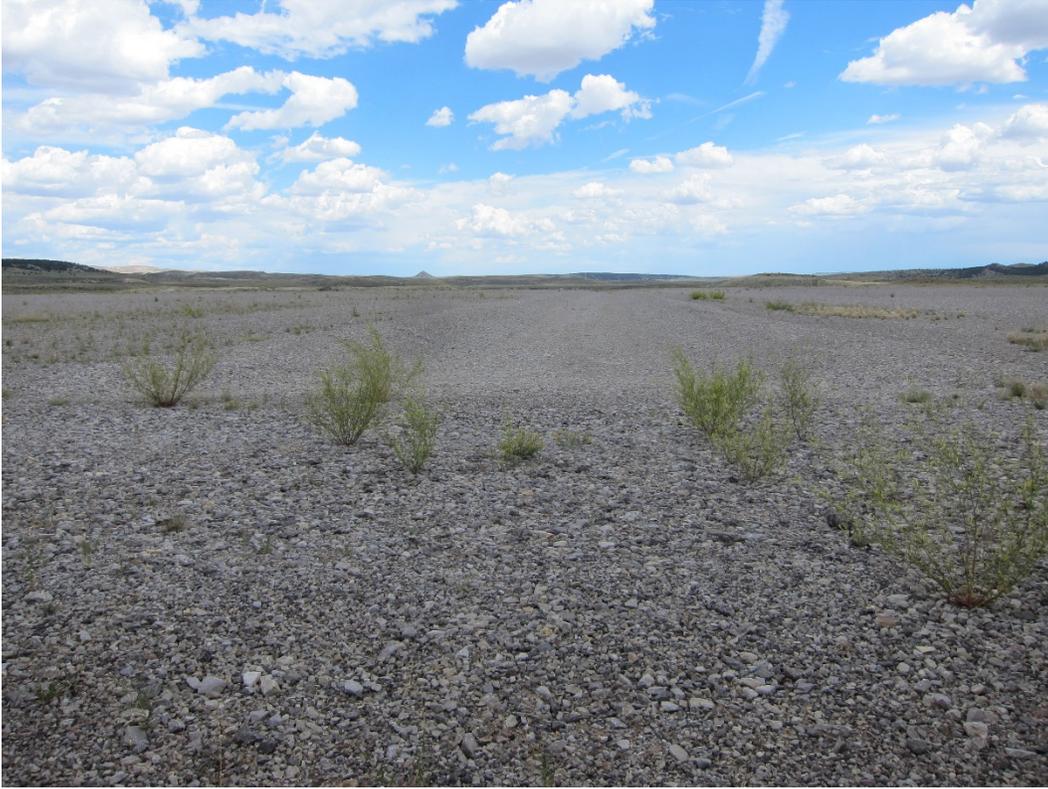
Figure 3: Center drainage channel on top of Maybell West disposal cell (looking east)

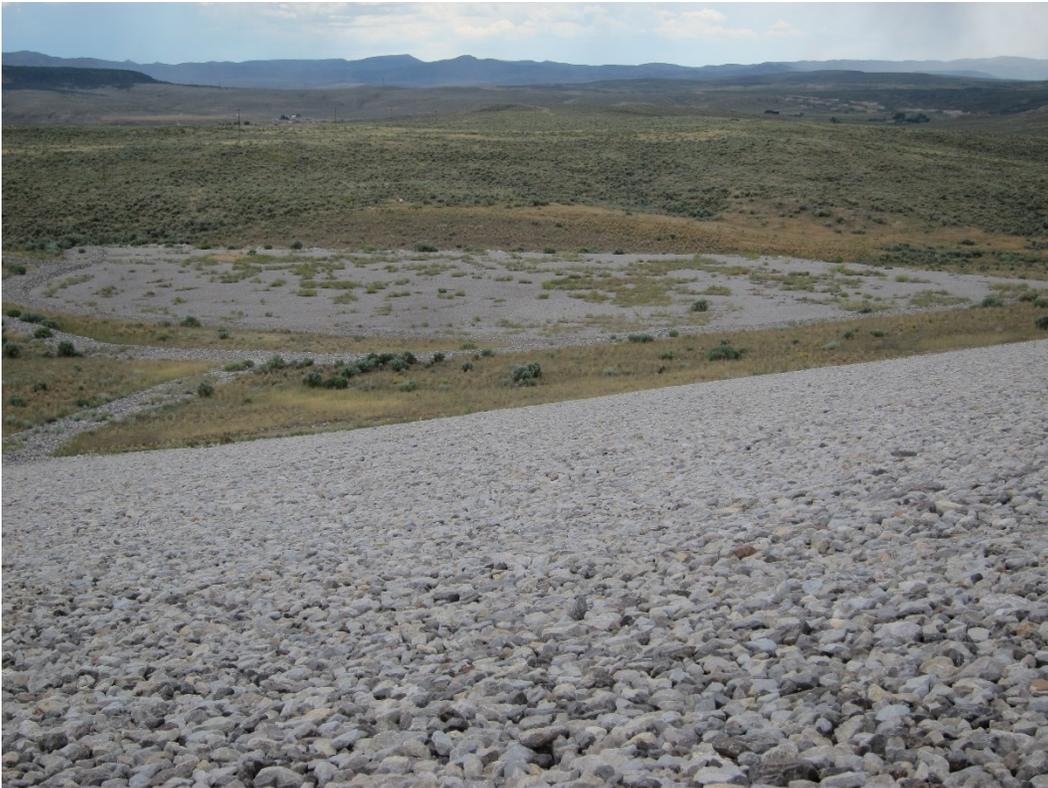
Figure 4: Ancillary cell, as seen from top of Maybell West disposal cell (looking south)
