Post-Test Examination Results from Integral, High-Burnup, Fueled LOCA Tests at Studsvik Nuclear Laboratory

This report presents and discusses the results of the U.S. Nuclear Regulatory Commission's integral loss-of-coolant accident (LOCA) testing program conducted at Studsvik Nuclear AB in Sweden. In this program, refabricated, high burnup irradiated fuel rodlets were subjected to LOCA conditions. In total, six single-rod LOCA tests were conducted in the Hot Cell Laboratory at Studsvik Nuclear AB. This report documents the test conditions, rodlet response, and post-test examinations for all six tests. The purpose of this document is to make this information available for comparison to related or complementary experimental programs. The observations of fuel fragmentation, relocation, and dispersal in this experimental program may be of particular interest for comparison to related or complementary experimental programs.

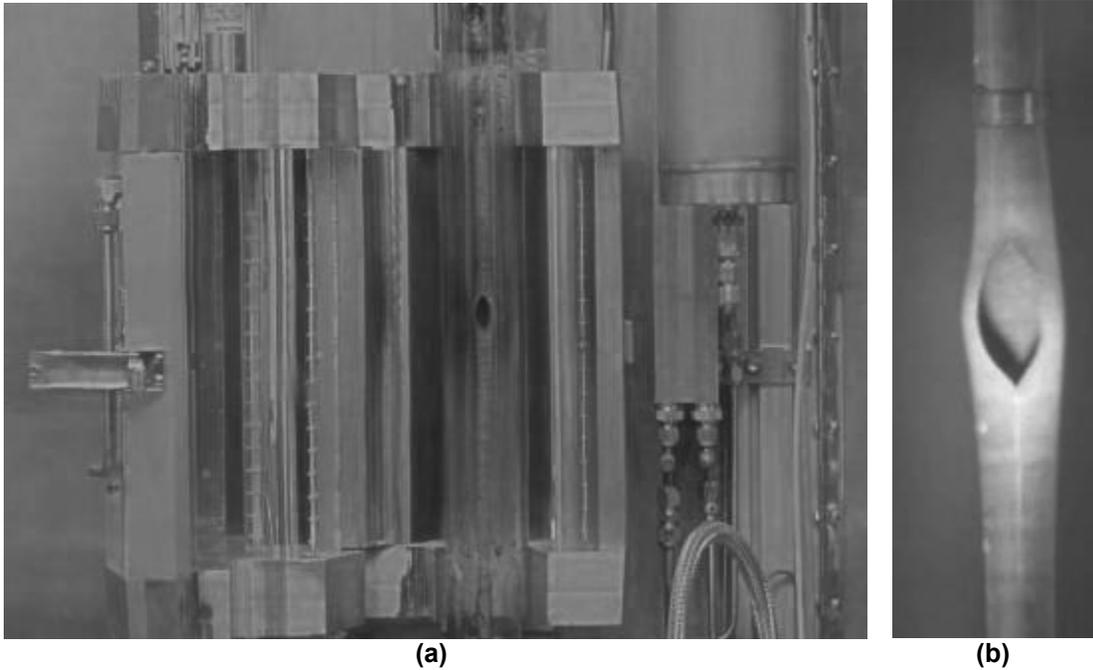
After the simulated LOCA transient was complete, the fuel rod was examined. Figure 2-3 provides two photos of the fuel rod after the transient. The rupture opening was measured to be 10.5 millimeters wide and 23.9 millimeters in length. It is significant to note that when the rupture opening was examined after the transient, no fuel could be seen in the region. In fact, a wire probe was used to measure the length of voided cladding after all experimental steps (LOCA transient, bending, and shaking) and the probe traveled unobstructed approximately 66 millimeter above and approximately 82 millimeter below the rupture center. The technique to measure the voided cladding is illustrated below in Figure 2-4.

Figure 2-3 Rod segment from Test 189 (a) in test rig after transient and (b) a closeup of the rupture opening after the transient

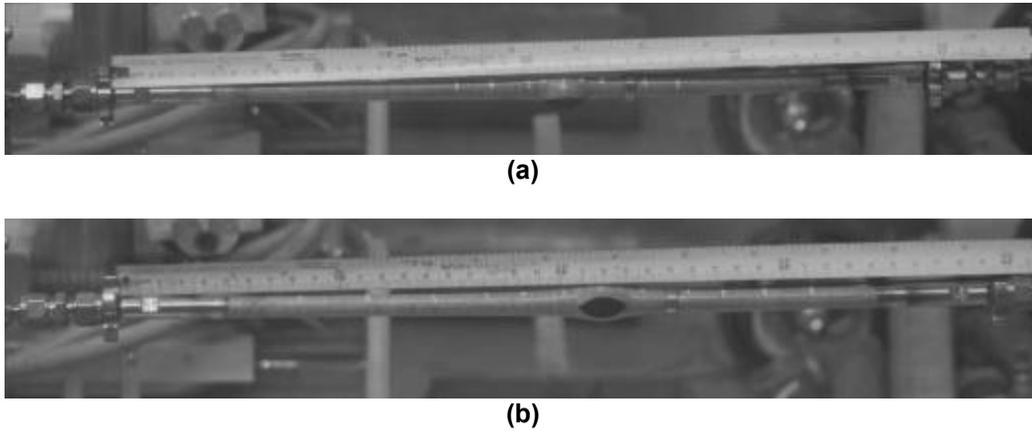
The rod did not experience distortion or bending during the LOCA transient, which can be seen in Figure 2-5. Profilometry measurements were made, and they are shown in Figure 2-6. In Figure 2-6, the initial diameter and rupture length are also indicated. The mid-wall rupture strain value for Test 189 was calculated to be 48 percent.

Figure 2-5 Rod segment from Test 189 showing no significant rod bending (a) in plane with the rupture or (b) out of plane with the rupture

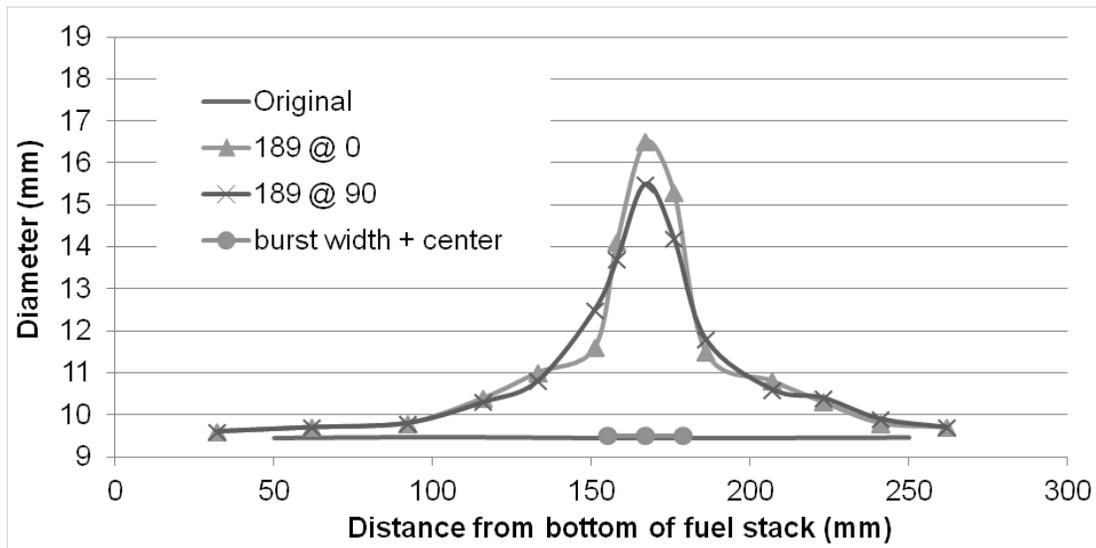
Figure 2-6 Profilometry measurements of segment 189 post-transient. The rupture length is also indicated.

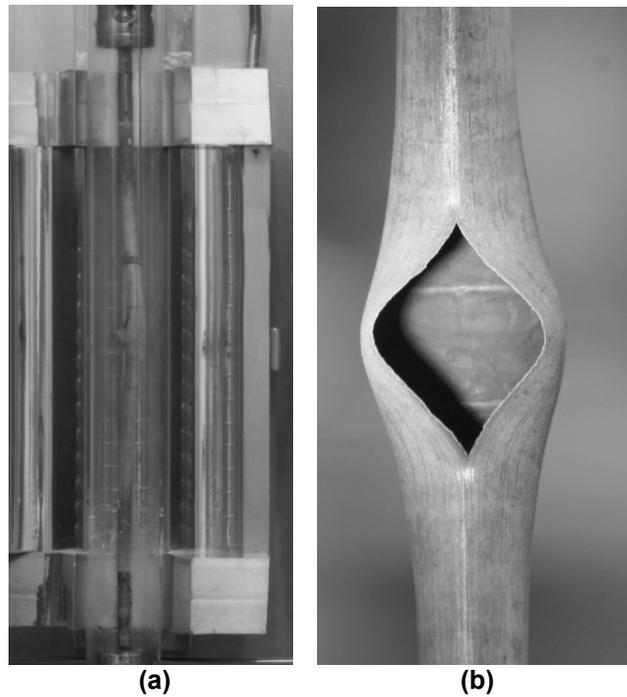
After the simulated LOCA transient was complete, the fuel rod was examined. Figure 2-10 provides two photos of the fuel rod after the test. The rupture opening was measured to be 17.5 millimeters wide and 21.6 millimeters in length along the axial direction. In Figure 2-10 (b), inside the rupture opening, it appears that the pellet-pellet interfaces can be seen on the inside cladding wall.

Figure 2-10 Rod segment from Test 191 (a) in test rig after transient and (b) a closeup of the rupture opening after the transient

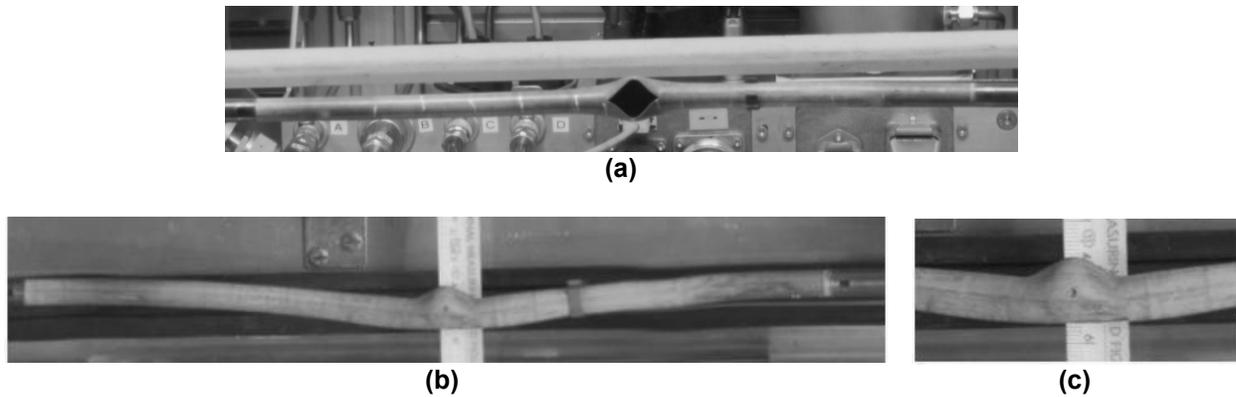
The rod experienced distortion (or bending) during the LOCA transient, which can be seen in Figure 2-11. The bending was in plane with the rupture (Figure 2-11 b & c) and the segment remained straight out of plane with the rupture (Figure 2-11 a). The distortion of this fuel rod was addressed with a small modification to the test train; the modification proved effective as later test segments did not experience significant bending.

Figure 2-11 Rod segment from Test 191 showing (a) no significant rod bending out of plane with the rupture and (b) & (c) noticeable bending in plane with the rupture

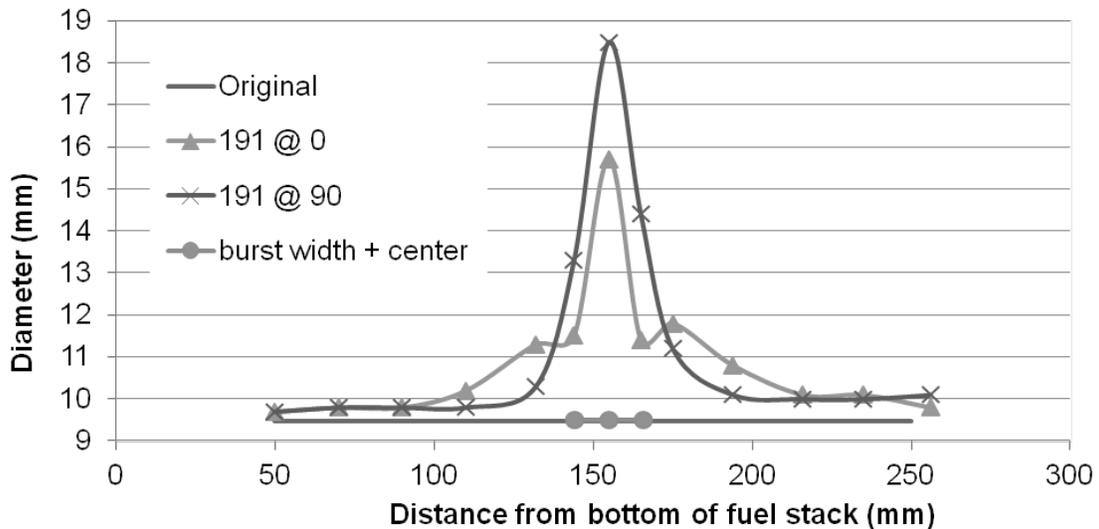
Profilometry measurements were made and they are shown in Figure 2-12. In Figure 2-12, the initial diameter and rupture length are also indicated. The mid-wall rupture strain value for Test 191 was calculated to be 56 percent.

Figure 2-12 Profilometry measurements of segment 191 post-transient. The rupture length is also indicated.

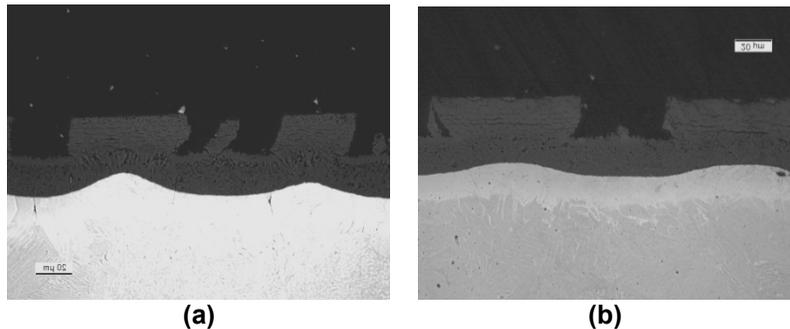
Figure 2-16 Two high-resolution images of the cladding outer diameter from the metallography examination in the rupture region of the rodlet tested in LOCA Test 191 at (a) 45° and (b) 225°

Here, it is useful to recall that the calculated CP-ECR was 13 percent, with a hold time at 1,185 degrees C (2,165 degrees Fahrenheit) of 25 seconds. In Figure 2-16, the initial oxide thickness can be seen to have cracked and separated in this high strain (56 percent) area, and the transient oxidation layer is seen beneath the damaged initial oxide layer. In Figure 2-17, it appears that some fuel fragments remain on the inner diameter and that the initial fuel-cladding bonding layer has also cracked and separated. An inner diameter transient oxidation layer is seen, which appears to approximately the same thickness at the outer transient oxidation layer. These observations are expected at this location because it is in the rupture node and exposed to a steam environment after rupture.

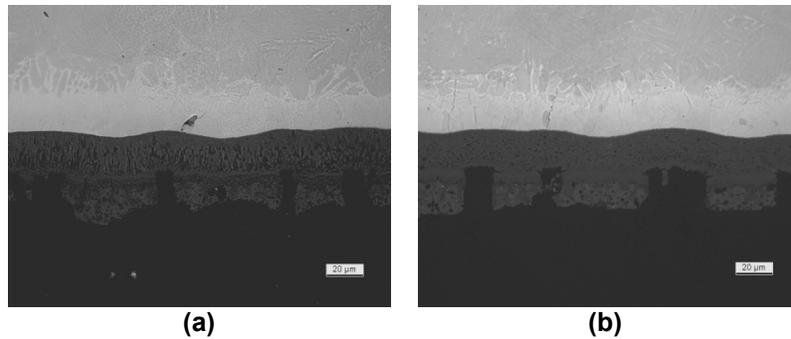
Figure 2-17 Two high-resolution images of the cladding inner diameter from the metallography examination in the rupture region of the rodlet tested in LOCA Test 191 at (a) 0° and (b) 135°

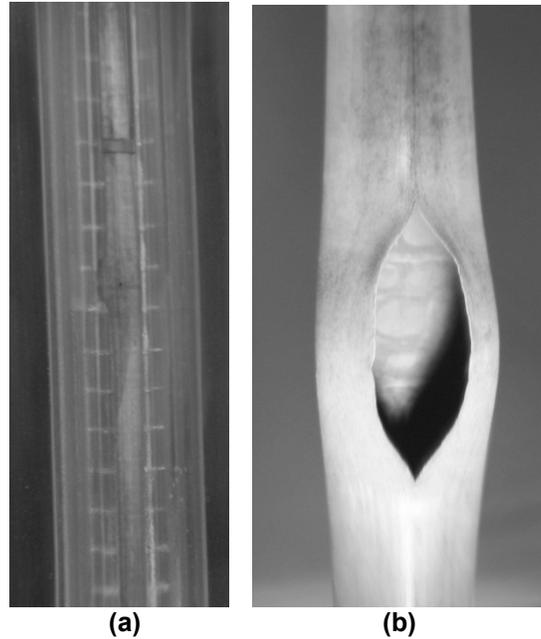
Figure 2-22 Rod segment from Test 192 (a) in test rig after transient and (b) a closeup of the rupture opening after the transient

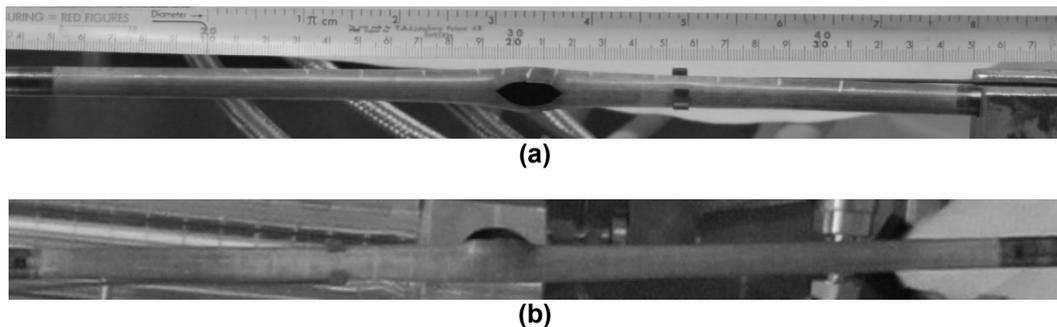
Figure 2-23 Rod segment from Test 192 showing no significant rod bending (a) out of plane with the rupture or (b) in plane with the rupture

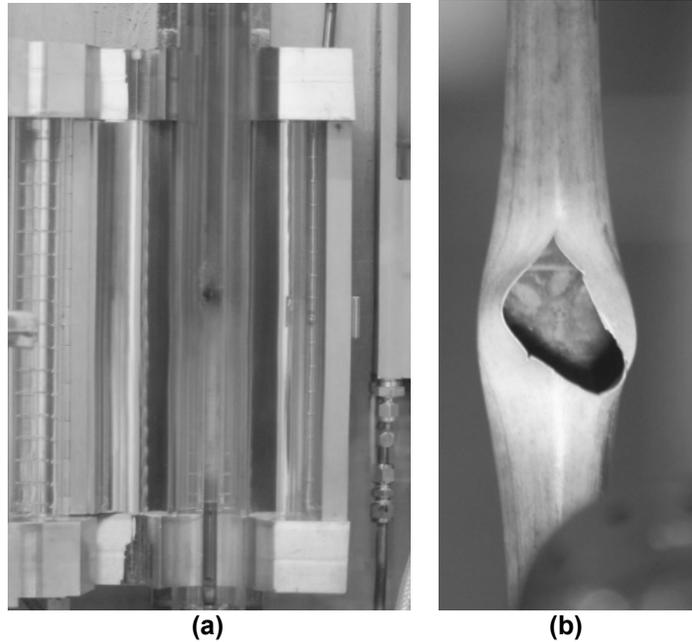
Figure 2-44 Rod segment from Test 193 (a) in test rig after transient and (b) a closeup of the rupture opening after the transient

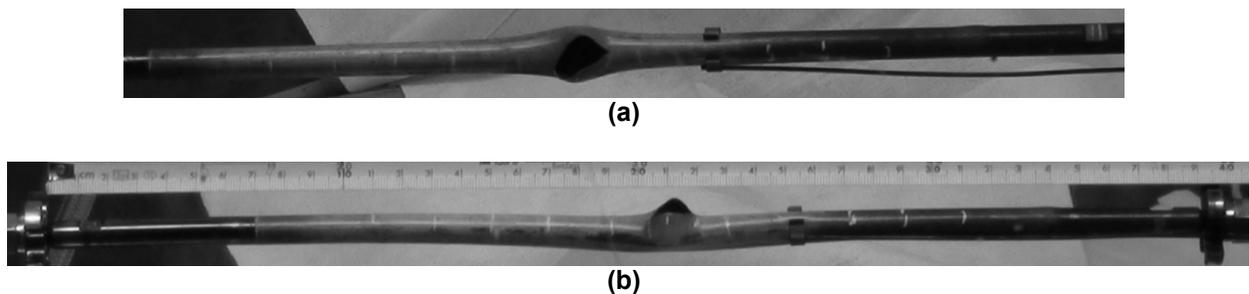
Figure 2-45 Rod segment from Test 193 showing no significant rod bending (a) in plane with the rupture and (b) minor bending out of plane with the rupture

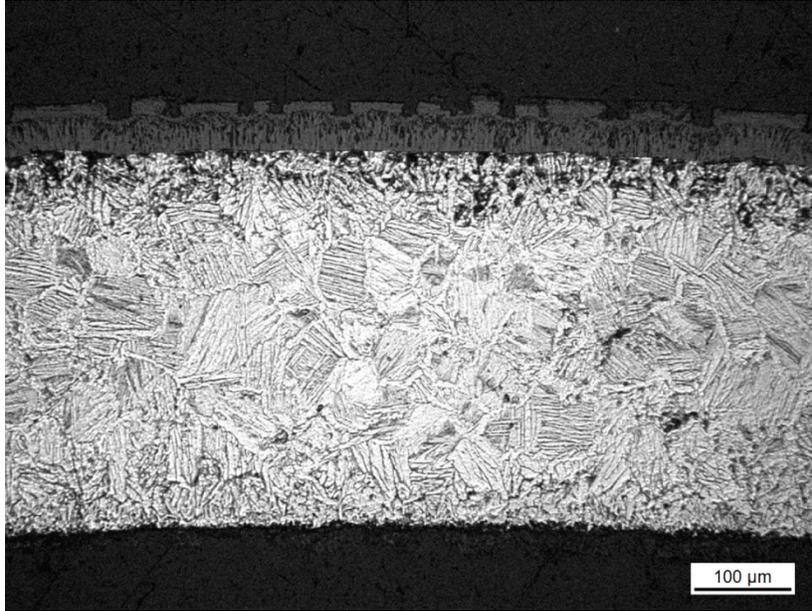
Figure 2-55 Etched cross section revealing hydrogen microstructure in the cladding in the rupture region of Test 193

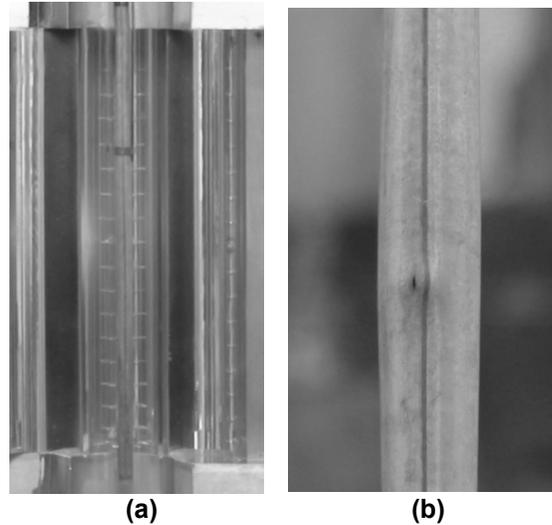
Figure 2-60 Rod segment from Test 196 (a) in test rig after transient and (b) a closeup of the rupture opening after the transient

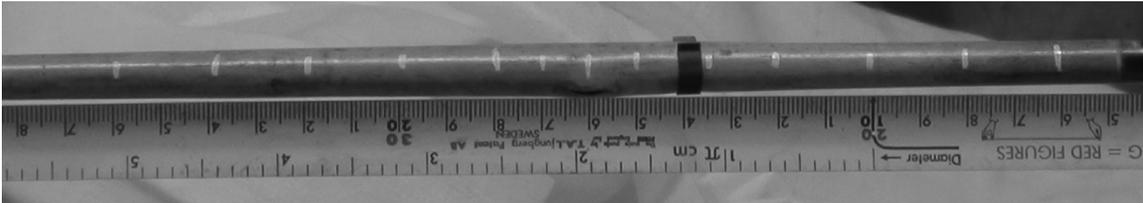
Figure 2-76 Rod segment from Test 198 showing no significant rod bending
