Augmented Inspection - Wolf Creek Generating Station Loss of Offsite Power and Notification of Unusual Event

Summary

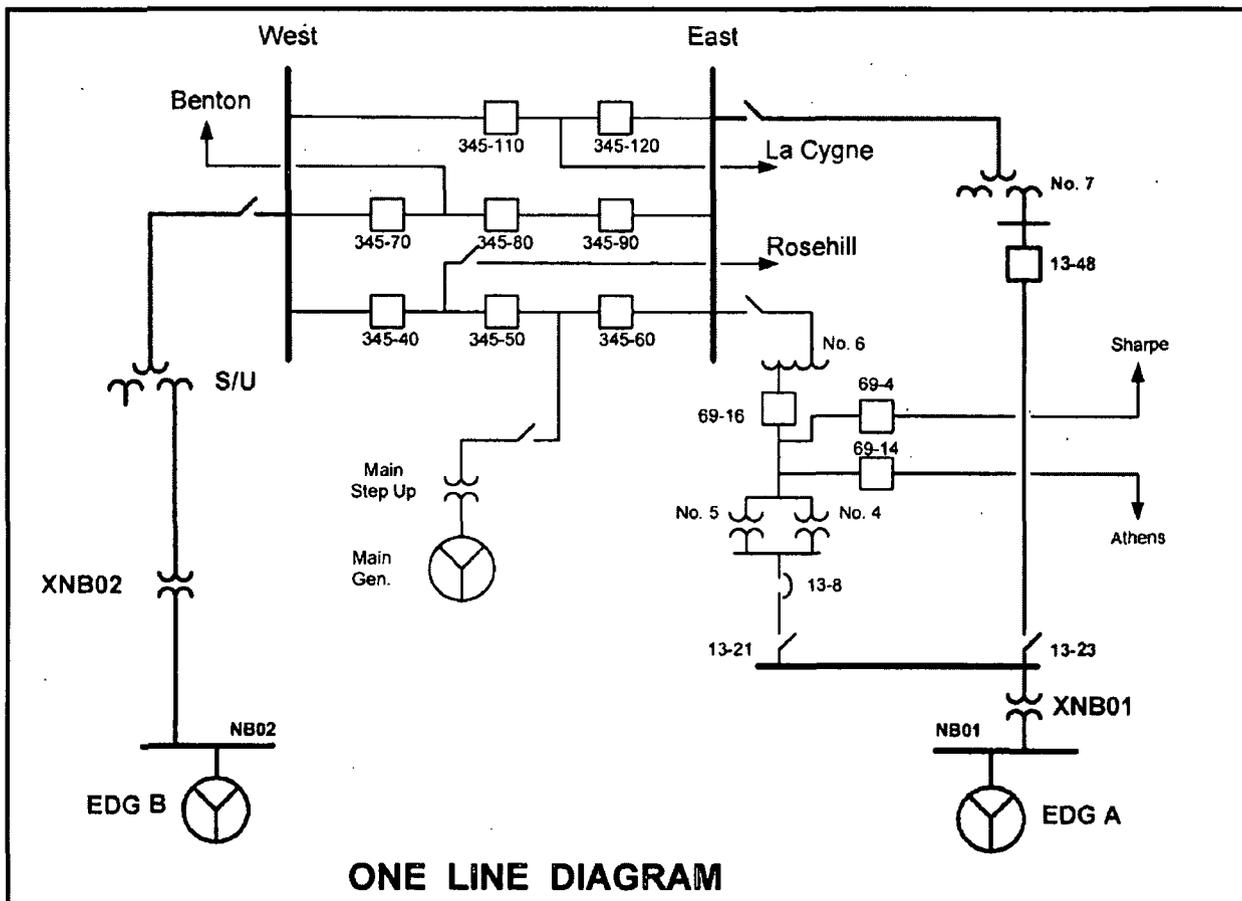
Wolf Creek Electrical Distribution System

On January 13, 2012 at 2:03 p.m., the main generator output breaker 345-60 (see figure below) at Wolf Creek Generating Station failed and isolated the east switchyard bus, resulting in a turbine trip and subsequent reactor trip. A fast bus transfer did not occur as expected due to the actuation of the differential current relay for the startup transformer and the west bus was isolated. This resulted in both EDGs starting and loading. A Notification of Unusual Event (NOUE) was declared at 2:15 p.m. due to the loss of offsite power (LOOP).
