3455 FOSTORIA WAY • SAN RAMON, CA 94583 • (925) 866-1212 • FAX (925) 866-1716

Dear Mr. Traiforos:

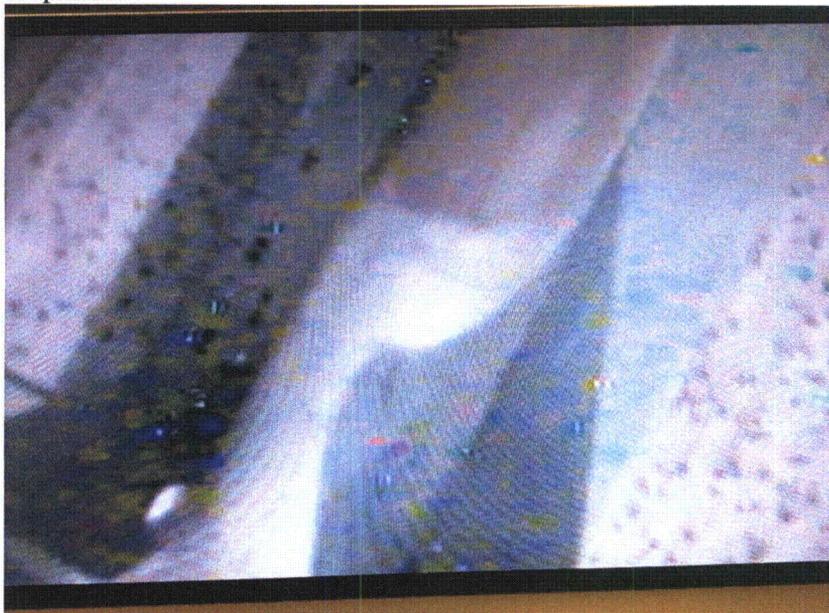
S/N 612E: This element had been removed from the core in 2005 and had been stored in the wall storage rack since then. The visible separation was not apparent in the 2012 inspection:

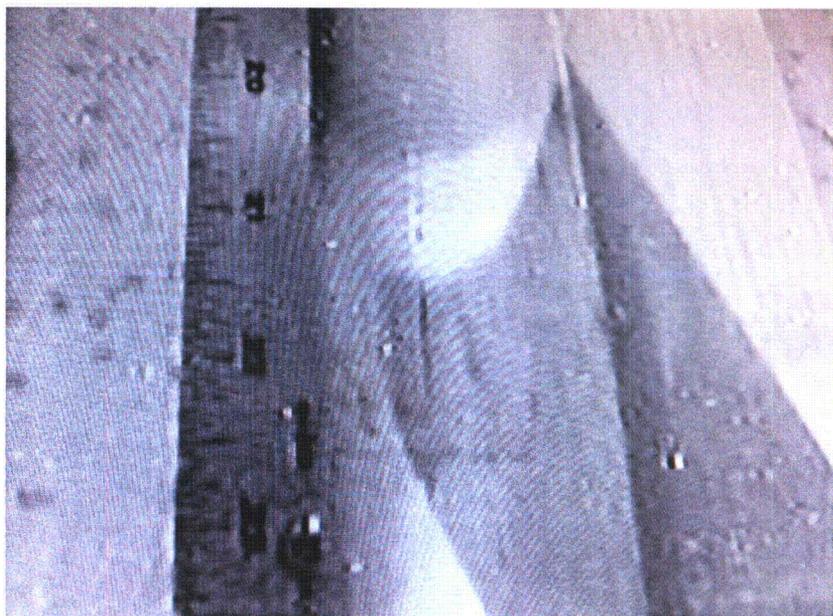
It is clearly visible now in 2013 in the same position:

Please note that the elements are mounted in our inspection fixture which we have been using since 2012. The two different inspections have the camera (which is on a pole that we move up and down) in a somewhat different angle position for each inspection effort, so the view is not precisely the same for the four still shots taken off of the video. We attempted to get the best still shot we could to show the worst view of the crack for each year. On the full video, the crack can appear longer in 2013 when the light hits it right.

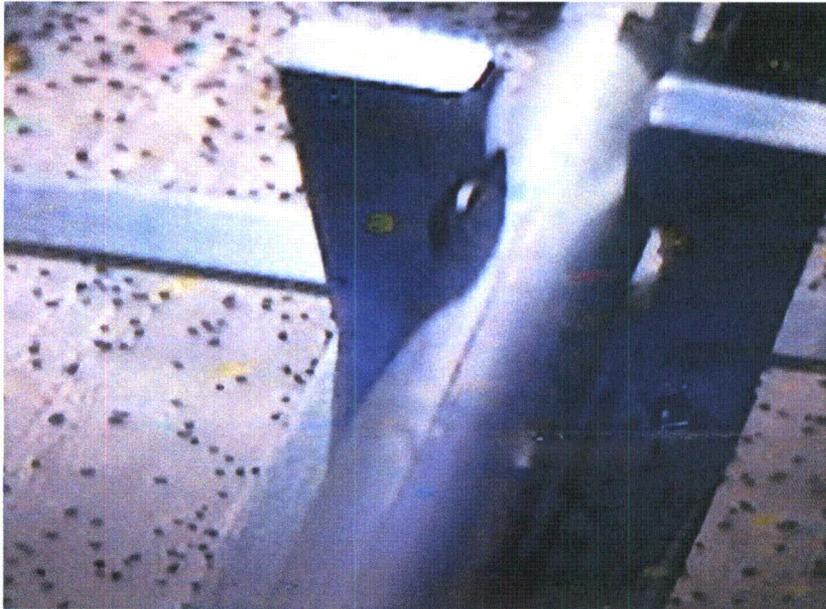
S/N 630E: This element was previously one of the elements that would not fit through the upper grid plate prior to the fuel removal work done in 2012. There was a vertical line on the elements in 2012 which evidently caused much discussion among the fuel inspection crew at the time. Also present poolside was Craig Bassett of the NRC. The 2012 video (which has no audio discussion since the camera is underwater) lingers for a long time on the area in question. After shining the light around in different areas, it was decided that there was no depth for light to go into, and therefore because of the straightness of the line, it was probably just a vertical scrape caused by rubbing the element against the storage rack or grid plate while lifting it upward. All of our previous cracks were more jagged than this:

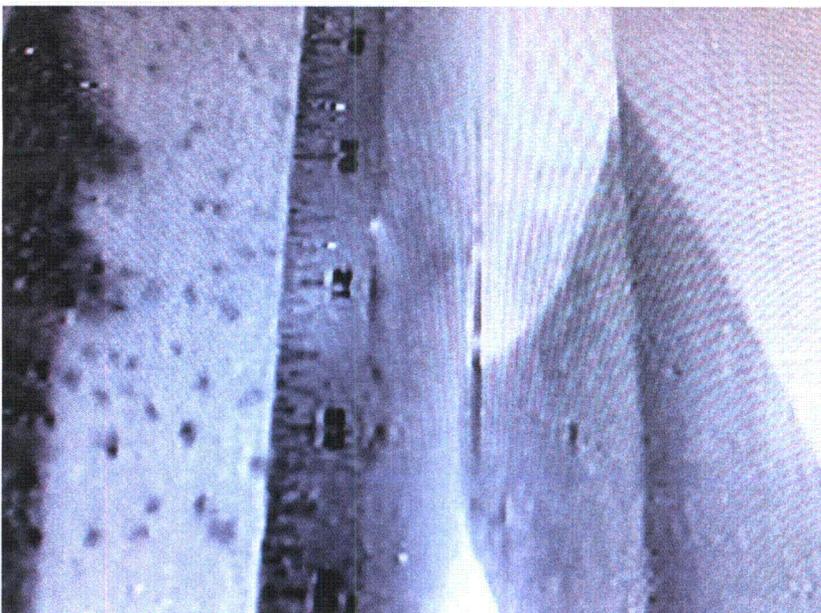
In 2013, the vertical line appears wider, and there is now some depth similar to a groove. Please note that the last picture is upside down from the others; we paused the video shot and took the pictures with an iPhone. For some reason, the computer flipped the image when I converted it from an iPhone to a jpeg image, but you can see the mark right down the middle. It is obvious there has been a change that has developed over the year. There is also a little pea of material in the center of the crack in two places, perhaps just an area where the clad did not open up:

Both of these elements still appear to have very good structural integrity. There is no obvious evidence that either of these cracks has gone all the way through the clad. Moving the lighting around does not appear to show a deep area where light penetrates only when directly in front of the crack, therefore it seems to us that the crack is not as deep yet as some others we have seen. Since July of 2012, these elements have been stored in subcritical assembly storage racks. Therefore, these elements have not received any kilowatt hours or even been in close proximity to other elements or a neutron source while these changes have been occurring. The pool water chemistry is still extremely good, less than 2 micromhos of conductivity.

As you know, in December of 2012, we canned all of our elements that had any cracks in them, for a total of 22 canned elements so far. We do have 2 additional cans available right now, but unless the NRC would like us to consider otherwise, we would prefer not to can these elements at this time. If we can these elements, we will not be able to inspect them again without removing them from the conditioned cans. Putting them in the cans where they are in a dry environment will change the conditions for these elements. We would like to observe these elements over the next year in the same environment to see how the areas might change. This is a good opportunity to get information about cracking in aluminum elements while the elements are clearly still structurally sound. Our pool water counts remain low as they have since we canned up the other elements, so we don't believe that they are leaking any significant isotopes.
