From: [Ossing, Michael](#)
To: [Lamb, John](#)
Cc: [Kilby, Gary](#); [Nicholson, Larry](#); [Ossing, Michael](#); [Walsh, Kevin](#); [Connolly, James](#); [Collins, Michael](#); [Vehec, Thomas](#); [Dodds, Ralph](#)
Subject: Seabrook Station Relief Request RA-13-001
Date: Friday, August 30, 2013 7:26:29 PM
Attachments: [Relief Request RA-13-001.doc](#)

**SEABROOK STATION UNIT 1 10 CFR 50.55a Relief Request RA-13-001
Proposed Alternative in Accordance with 10 CFR 50.55a(a)(3)(i)**

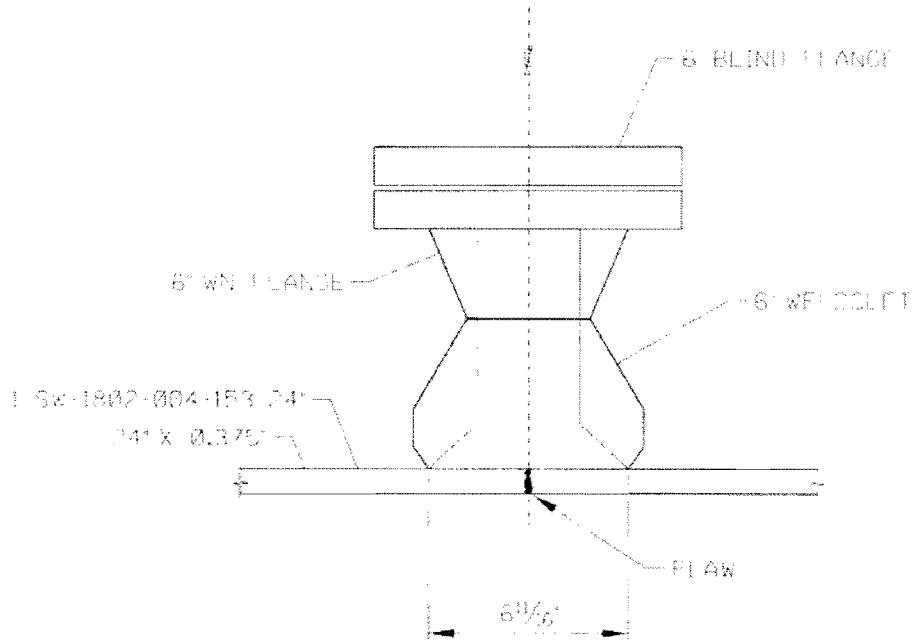
Figure 1: Proposed 6-inch NPS Weldolet, Weld Neck Flange, and Blind Flange

The component in question is 24-inch Nominal Pipe Size (NPS) carbon steel piping with a nominal wall thickness of 0.375-inch. The application of this alternative is to perform a temporary, non-Code repair to the SW piping. This non-Code repair will consist of the addition of a 6-inch nominal diameter weldolet, weld-neck flange, and blind flange over the identified localized flawed area. The general configuration for the repair is shown in Figure 1.

On August 7, 2013 an Ultrasonic Test (UT) examination was performed at an identified through wall leak on line SW-1802-004-153-24". The area was identified by discovery of a slow (several drops per minute) leak. The examination revealed that the through wall leak at this location was the result of a single isolated flaw that appears to be related to corrosion. Encoded UT data was collected at this location and was used to evaluate the through wall leakage area. A 3-inch by 6-inch area surrounding the flaw was selected for the encoded examination. This encoded area encompassed the entire flawed area. Normal intermittent responses could not be received in an area specifically bounded by where the inside surface response was initially lost. This resulted in a conservative bounded flaw area of 2.327-inches circumferentially by 1.500-inches axially. Wall thickness readings could not be obtained within this region. However, it was identified that there is an abrupt increase in thickness to nominal wall (0.375 inch) and above outside this region.

During the angle beam exam, the flaw could be seen in all four directions which is not typical for planar flaws. For structural evaluation purposes the flaw was considered non-planar. At the time of the August 7, 2013 examination no visible through wall hole was identified. On August 20, 2013 an increase in through wall flow was identified. A subsequent UT examination was performed. It concluded that the bounding area of 2.327-inches by 1.500-inches remained the same with no reportable thickness recorded in this area. However, a visible through wall hole estimated to be 0.250-inches in diameter was identified. In accordance with ASME Code Case

A flaw evaluation, in accordance with ASME Code Case N-513-3, was performed with the through wall flaw size assumed to be the bounding area of 2.327-inches by 1.500-inches. The evaluation concluded that structural integrity is maintained. This evaluation is provided in Reference 2, a copy of which is attached. In accordance with Code Case N-513-3, augmented inspections were scheduled to be performed to determine the extent of condition.

NextEra Energy proposes the encapsulation of the identified pipe wall flaw by the addition of a 6-inch NPS weldolet, weld neck flange, and blind flange as depicted on Figure 1.

wall. Periodic UT inspections of no more than 30 day intervals around the installed weldolet will be performed to identify wall loss propagating outside the encompassed area.
