Re: Summary of Bi-weekly Inspection of Lost Creek ISR LLC's Permit 788

Wyoming Department of Environmental Quality (WDEQ)- Land Quality Division (LQD)
Inspection Memorandum

File: Lost Creek ISR, LLC – Permit 788

Date of Inspection: August 21, 2013

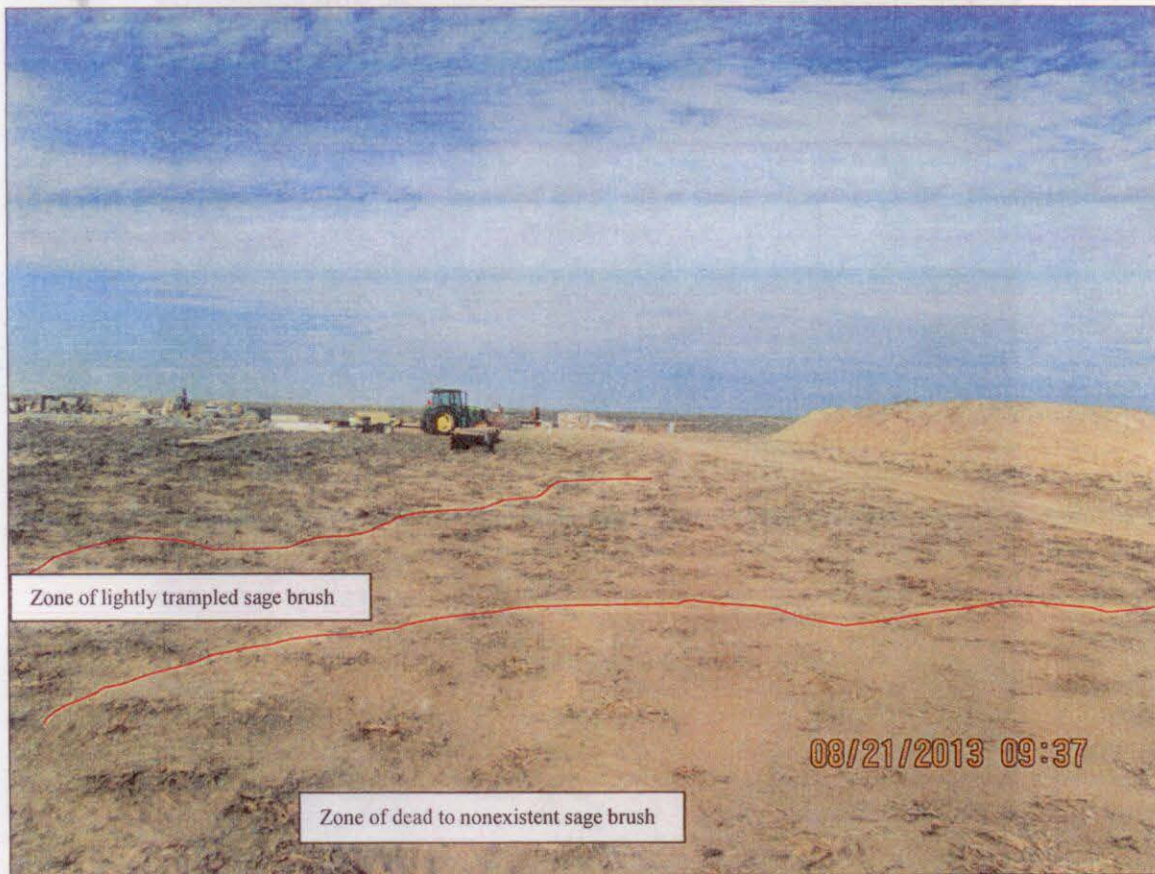
The ground underneath where equipment had been stored in the “field laydown area” displayed varying degrees of dead vegetation, trampling, and plant/soil compaction. In some areas, the sage brush appeared to be non-existent or dead. While in other areas, the sage brush was slightly trampled but still alive. Mr. Stonaker and Ms. Bautz agreed that the areas with dead to non-existent sage brush would be scarified and seeded this fall; while the areas with lightly trampled but still living sage brush would merely be seeded via broadcast methods and hand raking. In both types of ground (dead sage and living sage) the grasses were essentially destroyed.

Photo Number 1: This depicts a portion of the “field laydown area” north of MU1, from which equipment has been removed. The area of dead to nonexistent sage brush can be seen in the foreground of this photo. Then there is a transition into an area of lightly trampled sage brush within the two red lines. Beyond that area is intact sage brush. This view is looking west.

To that end, LCI personnel have removed the majority of equipment from the “field laydown area” and relocated it to the DDW-4 drill pad. In turn, the driller’s equipment that had been staged at DDW-4 was relocated to the DDW-3 drill pad. Only a minor amount of equipment needs to be removed from the “field laydown area” before fall 2013 reclamation.

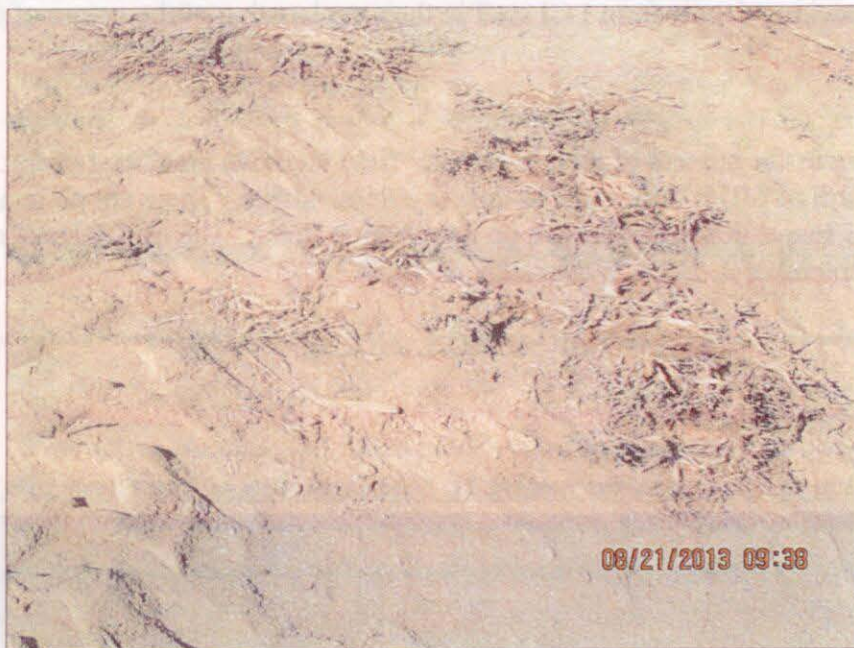
Photo Number 2: This typifies the areas in the "field laydown area" where the sage brush is dead to nonexistent.

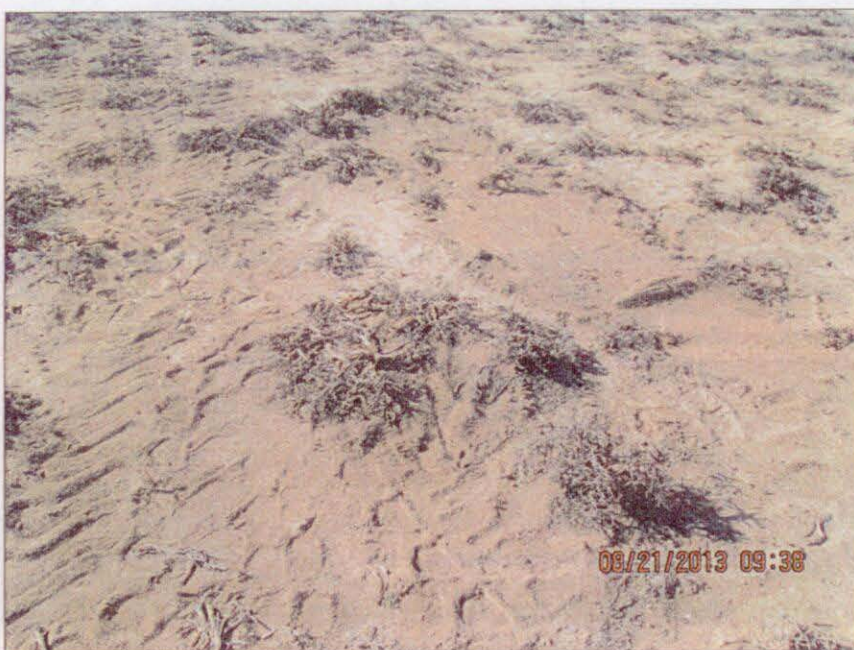
Photo Number 3: This typifies the areas in the "field laydown area" where the sage brush is lightly trampled but still alive.

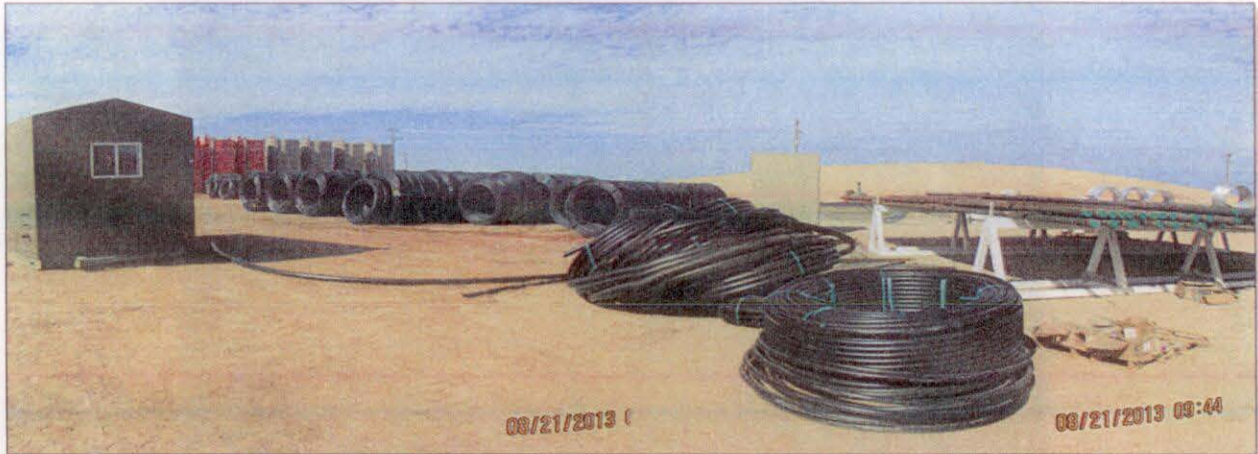
Photo Number 4: This depicts a portion of the DDW-4 drill pad where equipment that came from the "field laydown area" is now stored.

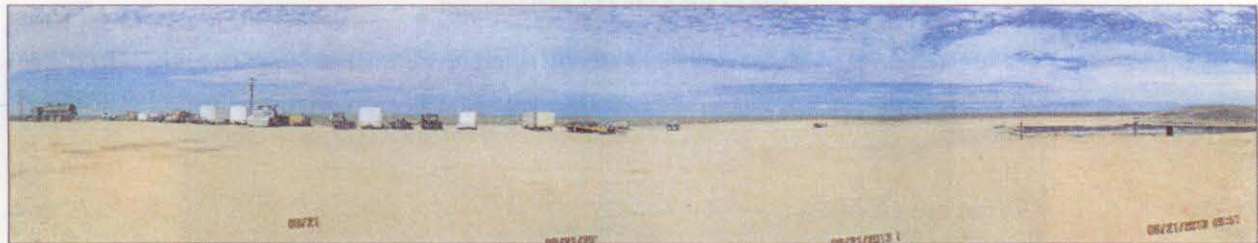
Photo Number 5: This is a panoramic view of DDW-3 drill pad looking from southwest (left) to northeast (right). The equipment stored here is drillers' equipment and was moved from the DDW-4 drill pad.

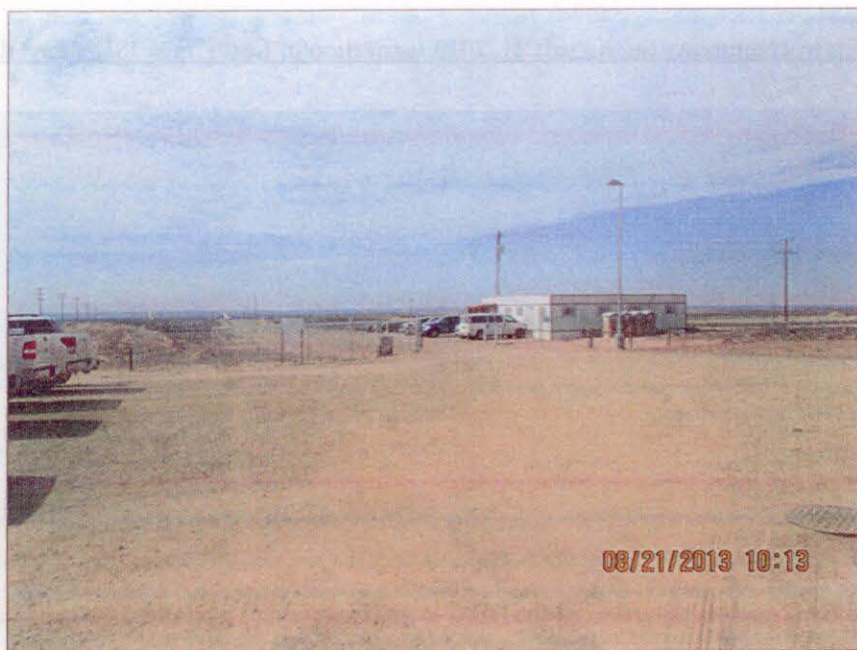
Photo Number 6: This is a view looking south from the parking lot on the south side of the Plant Building looking toward the old temporary office trailers. It is currently being used as an office by the project's contractors. However, LCI personnel anticipate that this array of trailers will probably be removed from the site in time for fall reclamation.

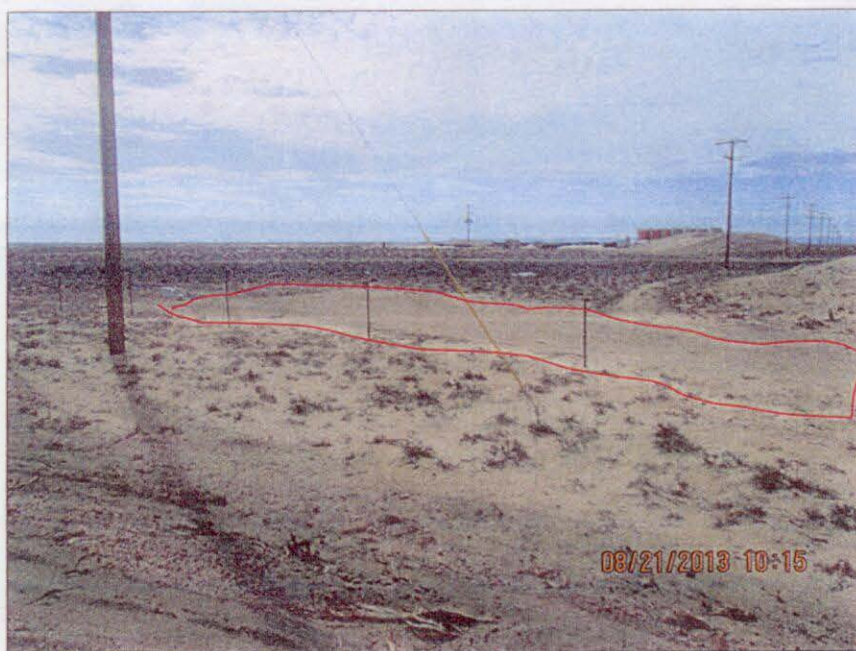
Photo Number 7: This depicts a small disturbed area (outlined in red) just north and east of the topsoil stockpile that is south of the Plant Site. It should be seeded this fall.
