**CAMECO RESOURCES
CROW BUTTE OPERATION**

Subject: Source Materials License SUA-1534
Docket No. 40-8943
Mechanical Integrity Testing (MIT) Failure at Well P-5338

On August 22, 2013, during routine 5-year Mechanical Integrity Testing (MIT), well number P-5338 in Mine Unit 10, Wellhouse 54 failed the MIT criteria. Using isolation techniques, it was determined that the failure is the casing joint at the 320-foot level. Shar Sapp, of the NDEQ field office in Chadron and Ron Burrows, NRC Project Manager were notified concerning this well on August 22, 2013.

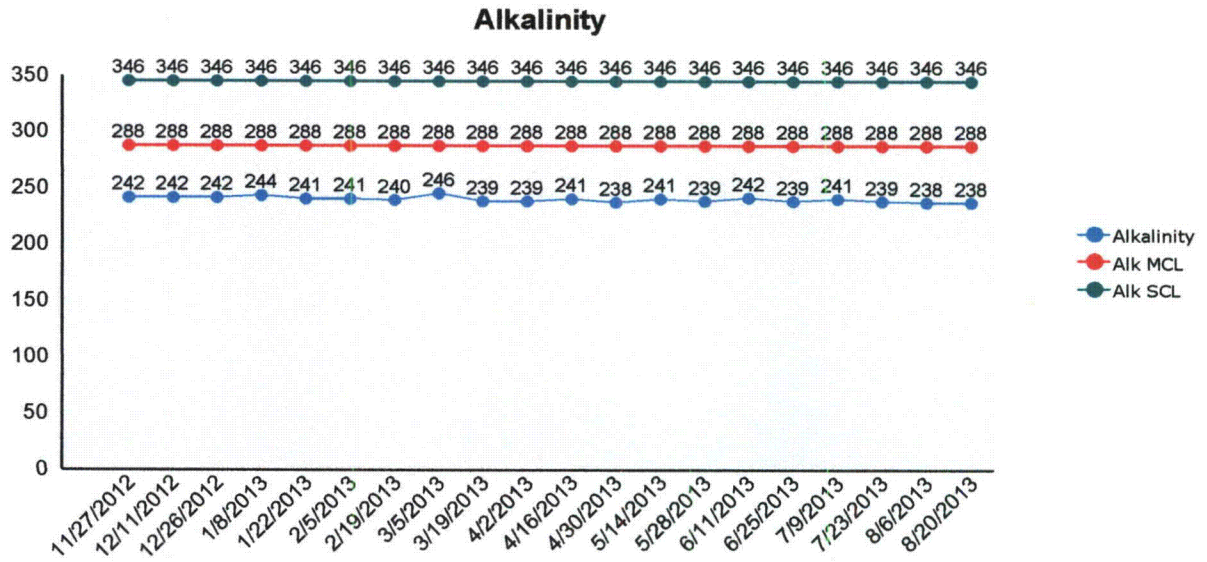
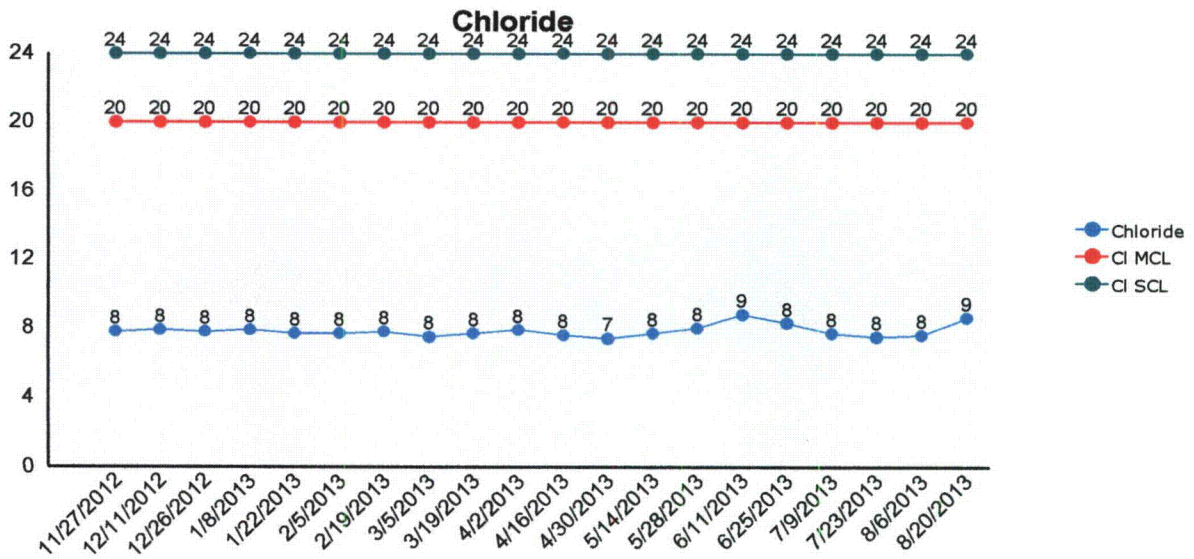
SM10-018

The nearest Shallow Monitor (SM) well to P-5338 is SM10-18. I have enclosed the latest results from this Shallow Monitors for your review.
