Re: **Summary of Bi-weekly Inspection of Lost Creek ISR LLC's Permit 788**

Wyoming Department of Environmental Quality (WDEQ)- Land Quality Division (LQD)
Inspection Memorandum

File: Lost Creek ISR, LLC – Permit 788

Date of Inspection: September 4, 2013

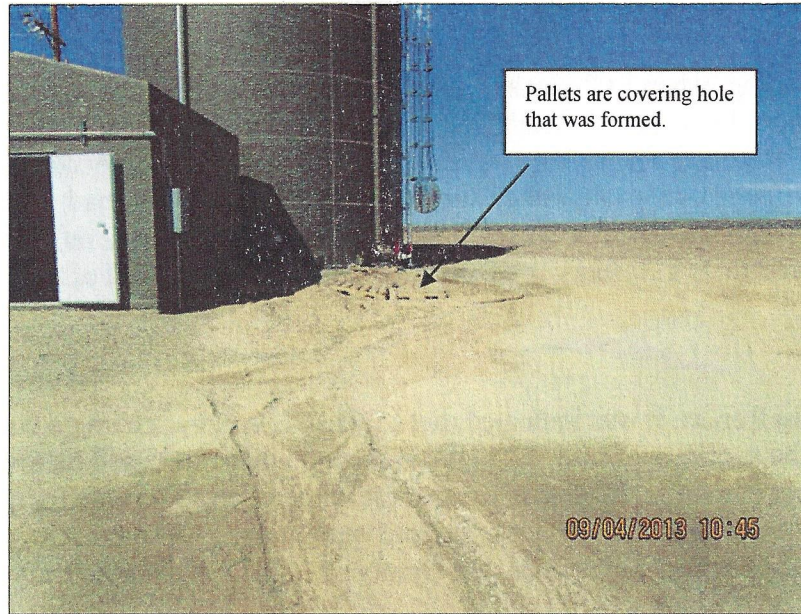
The water that overflowed out of the storage tank caused some piping immediately adjacent to the storage tank and some rilling about 30 feet east of the storage tank (see attached photo addendum) resulting in a trench with the following approximate dimensions: 2' x 2' x 5'. The water then flowed downhill another 10 feet to an earthen drainage channel, then under the Plant Site's northeast entrance route (which is the alternate/emergency access route to the Plant Site) via a culvert, and then flowed another 50 feet (still within the drainage channel) before seeping into the ground. No erosion occurred in the drainage channel itself. The erosion was limited to the piping (hole) next to the tank and the rills about 30 feet east of the tank.

Photo Number 1: This depicts the fire-suppression water storage tank in the northwest corner of the plant site. The area covered with pallets is where some piping occurred (forming a 3' deep hole) where water pooled after overflowing out of the hose that was used to fill the storage tank from its associated water supply well.

- 1) Repair the erosion caused by the overfilling of the 80,000 gallon water suppression storage tank in the Plant Site and
- 2) Remove the trash that was observed around the Plant Site perimeter.

The attached photo addendum depicts the areas that incurred erosion due to this overflow. LCI is encouraged to reconsider the drainage needs around the water storage tank. If sumps or a lined drainage channel are needed to accommodate future mishaps with overfilling the tank, LCI staff should proceed with their construction. Any alterations made to this area to address the erosion that occurred as a result of this overflowing event can be addressed in the Annual Report.

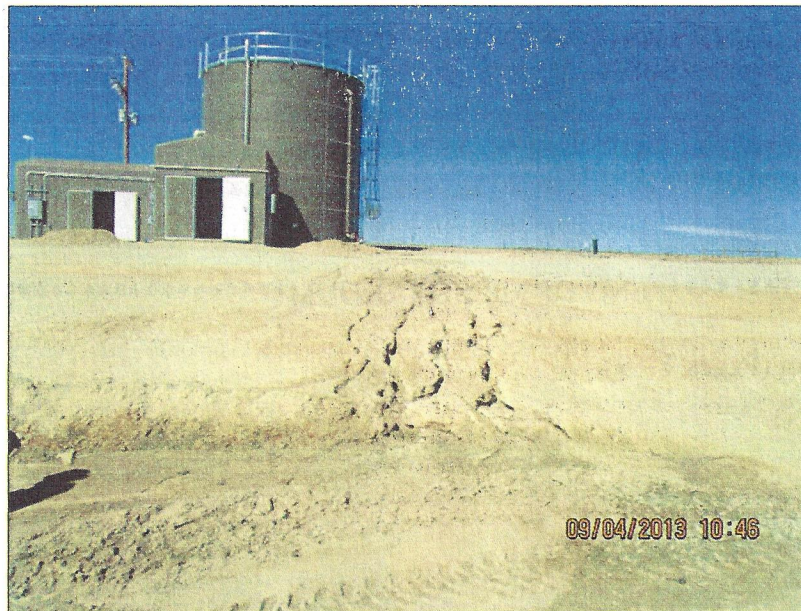
Photo Number 2: This is another depiction of the water storage tank in the Plant Site. The rills in the foreground were created by the overflowing of several hundred gallons of fresh groundwater while the tank was being filled earlier this day (or the previous night).

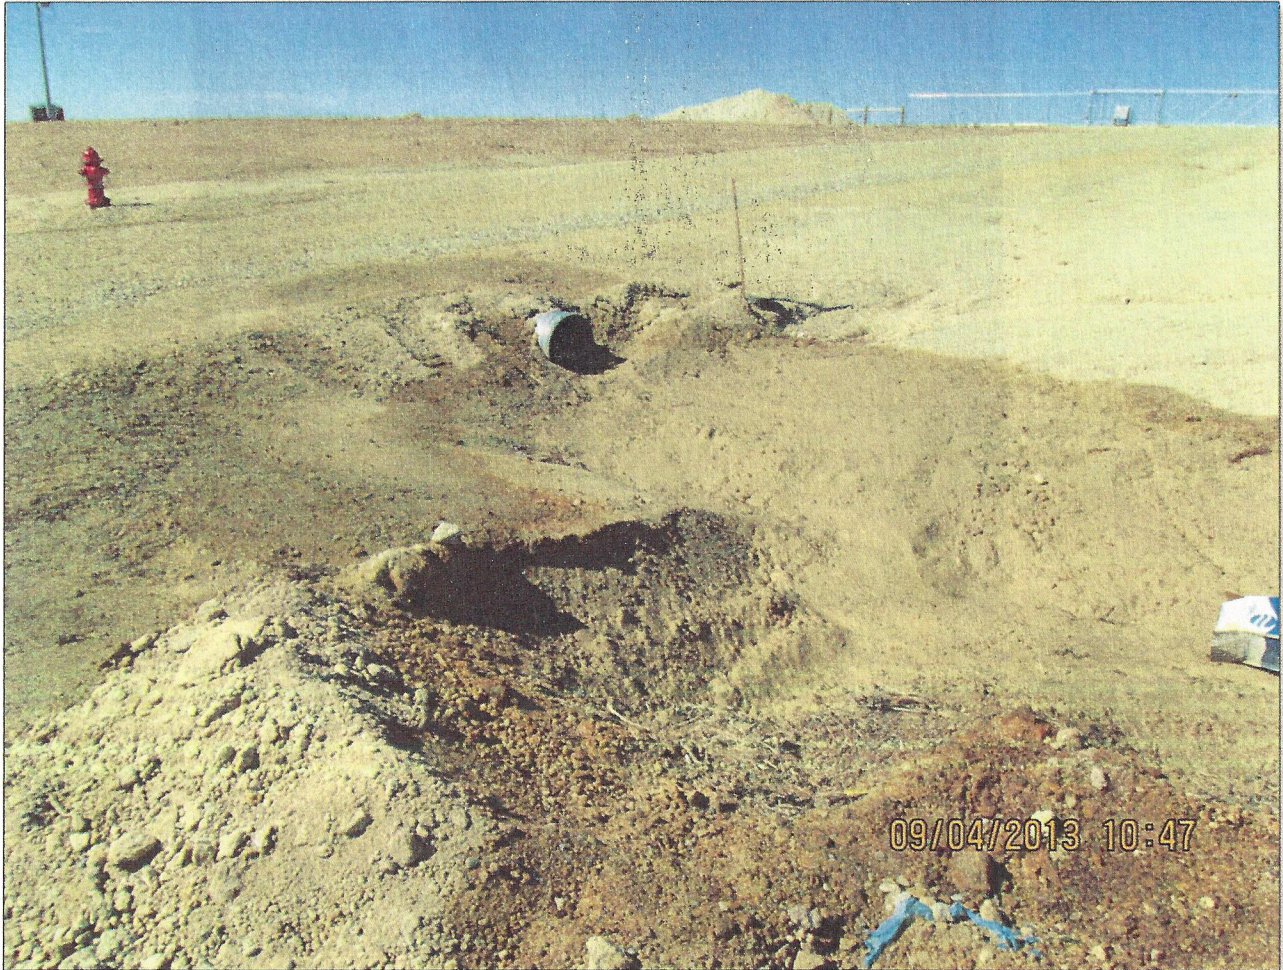
Photo Number 3: This depicts the upgradient side of the culvert that runs under the northwest access route into the Plant Site. The ground is saturated in the ditch to the right of this culvert due to the flowing of several 100 gallons of fresh groundwater that overflowed while the site's 80,000 gallon fire-suppression water storage tank was being filled. The culvert appeared to function properly during this event. However, as revealed by the wet soil above the culvert, water must have pooled here for some period of time. This culvert was sized for the drainage area upgradient from here (which is probably ~0.2 acres); not for a slug of several hundred gallons of water coming at it in a 20-30 minute time period. Therefore, it is not surprising to see that water pooled upgradient from this culvert. To prevent any problems in the event of future overfilling accidents, LCI personnel may consider installing a sump somewhere between the water storage tank and this culvert.

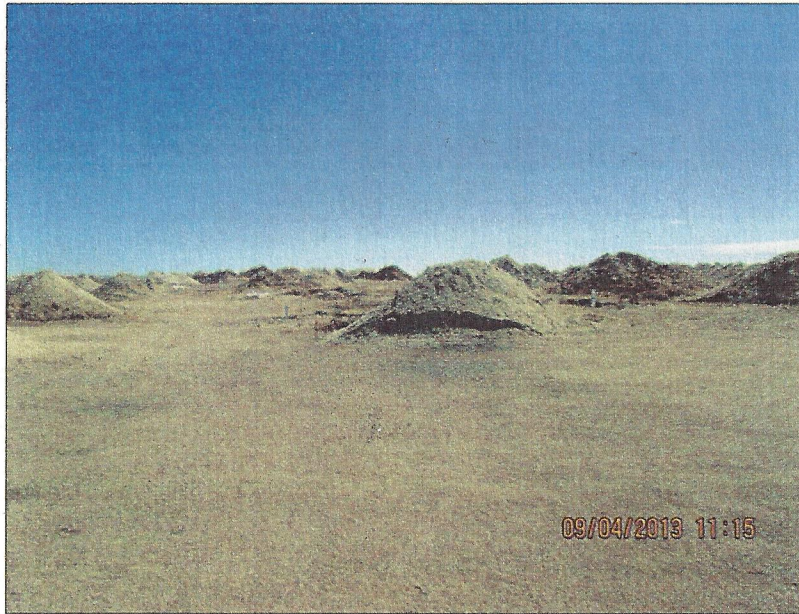
The eastern portion of MU1 was inspected today (see photo addendum). The eastern portion of MU1 is currently a "sea" of drill sites, mud pits, and stockpiles (topsoil and subsoil). There were no concerns with the eastern portion of MU1. Mr. Stonaker indicated that plans continue for the establishment of travel routes within HH1-1 through HH1-3 in MU1 as well as fall seeding in the same areas. A brief discussion with LCI's Steve Loose at the end of today's Inspection indicated that Header House 4 in Mine Unit 1 (HH1-4) is not ready for authorization yet.

Photo Number 4: This depicts the eastern portion of MU1. No drill rigs were operating in MU1 today, which is unusual. LCI just recently reduced the number of onsite drill rigs from six (6) to 12. All six (6) drill rigs were in MU2 or MU3 during today's Inspection.

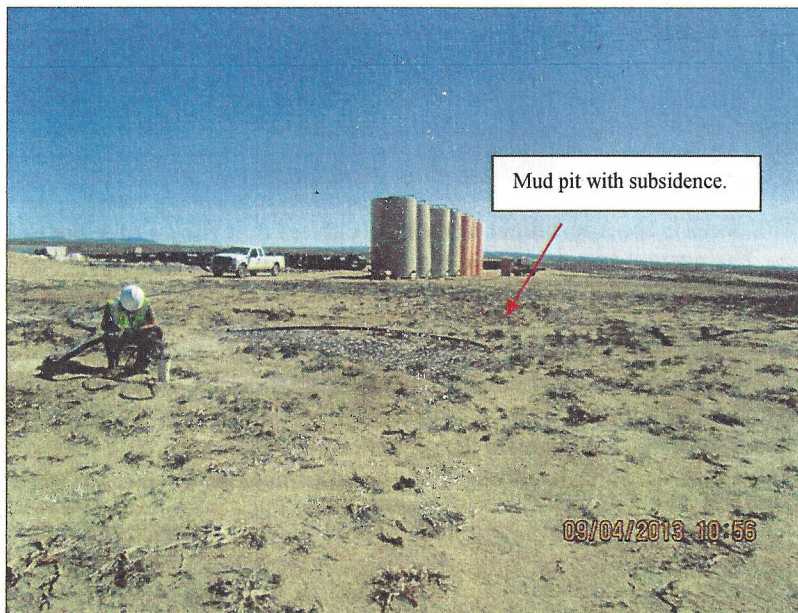
The last item on the list above (i.e. heavily used travel routes) is a new addition to the list since the last Inspection Report. It was added as a result of an observation made during this Inspection. Specifically, the water supply well at the southwest corner of DDW-4 is one that is heavily used and has significant trampling of native ground. Additionally, this well's

(backfilled) mud pit is showing signs of subsidence. The subsidence will need to be repaired prior to the application of seed this fall.

Photo Number 5: This depicts the southwest corner of the DDW-4 site. In the foreground can be seen LCI's Eric Stonaker taking a reading from the water supply well at this location. The red arrow indicates the location of the backfilled mud pit for this well. It has subsided since it was backfilled and will need to be graded before being seeded.

Also, during fall seeding, when LCI plans to seed areas in and around this water supply well (and other wells), LCI should also plan to establish (via the installation of metal t-posts or some other type of deterrent to vehicular access) one travel route directly to the well head. The travel route itself need not be stripped of topsoil; rather, it can be left as a two-track road. All of the affected areas outside the travel route (once it is established) should be seeded this fall. This method of travel route is referred to as a “tertiary road” (or two-track) in Section 2.6 of the Operations Plan of the Permit.

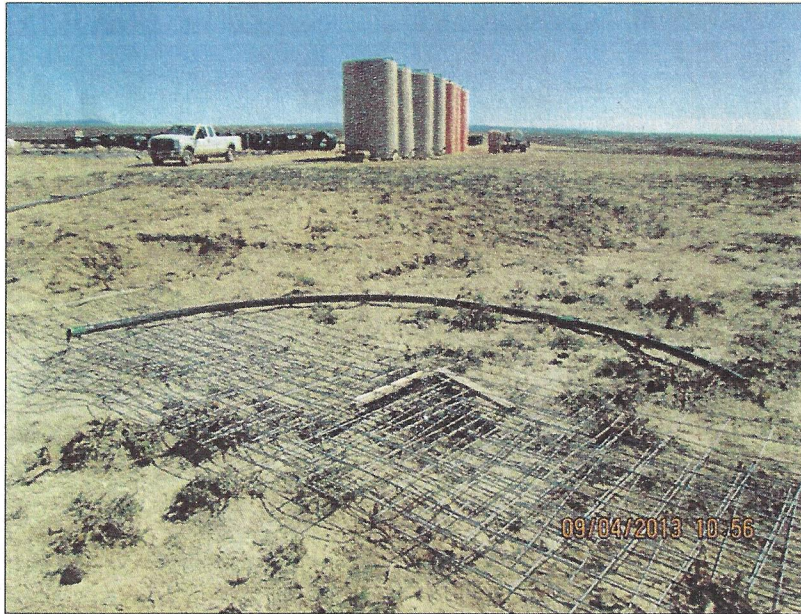
Photo Number 6: This is a closer view of the backfilled mud pit (with subsidence) for the water supply well at the southwest corner of the DDW-4 site.

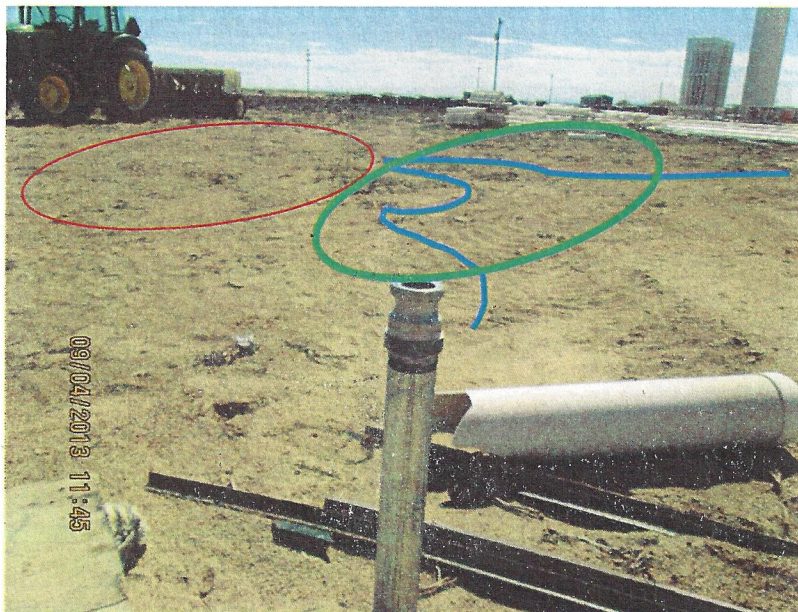
Photo Number 7: This depicts the well head for M118. It is at the west edge of the "field laydown area" just north of MU1, which is being cleared for fall reclamation. The area indicated by the circles are places where sage brush was trampled. The blue line indicates the approximate flow path of purge water from biweekly well sampling events. The area encircled in red does not receive any of the purge water (see Photo Number 9 on the following page). However, the area encircled in green does receive purge water. The sage in this area is showing signs of life (as depicted in Photos 9 and 10 on the following pages).

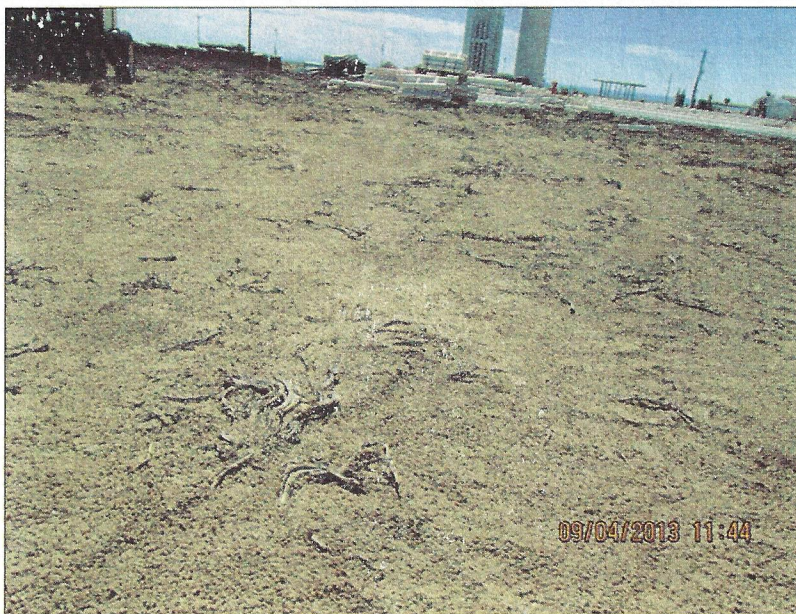
Photo Number 8: This is a close up view of the trampled sage that occurs within the area encircled in red in Photo Number 7 above. It appears to be dead. There are no leaves on these sage brush plants. This area does not receive purge water from the biweekly sampling of well M-118.

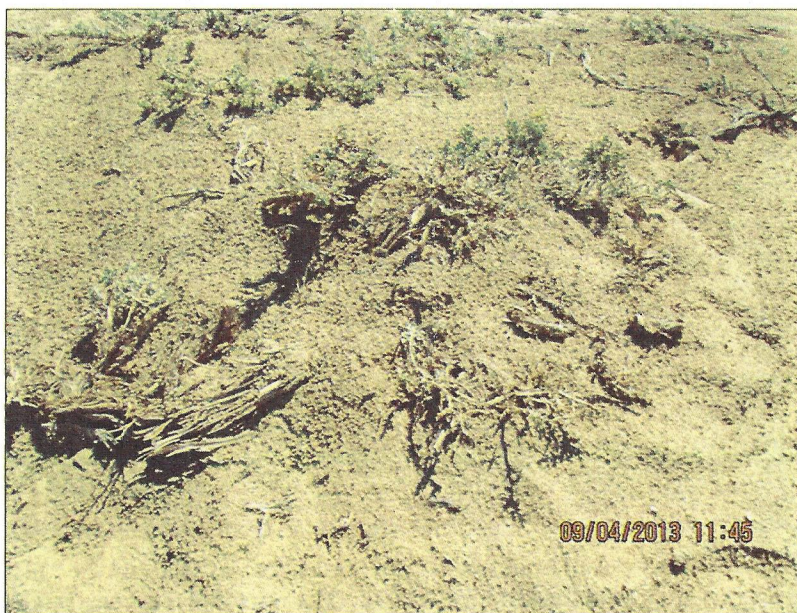
Photo Number 9: This depicts some of the trampled sage brush from the area encircled in green in Photo Number 7. This sage brush does receive purge water from the sampling of well M-118. It has a lot of new leaf growth on it.

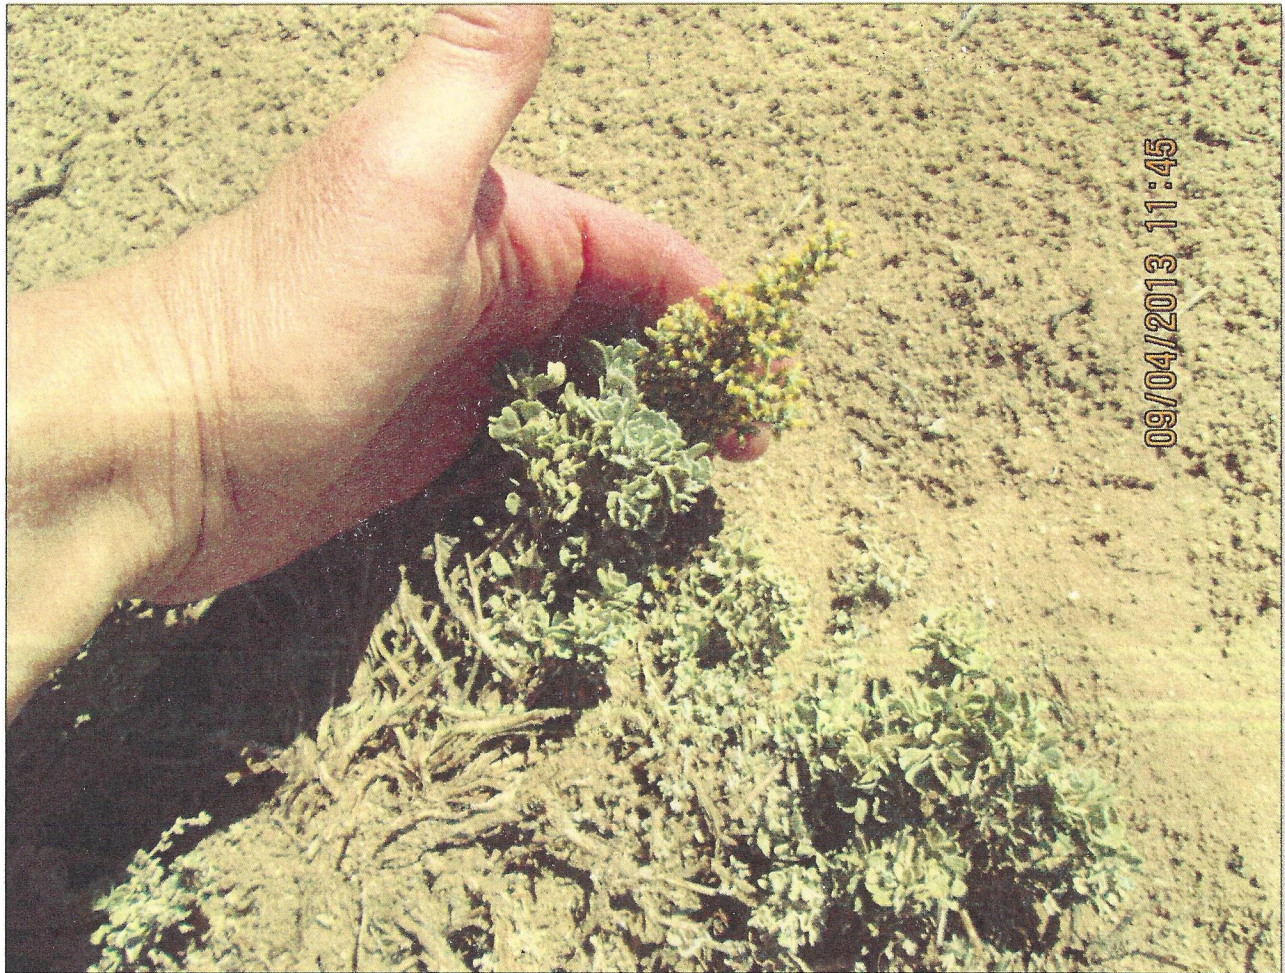
Photo Number 10: This depicts a sage brush plant that has gone to seed as a result of receiving purge water from the biweekly sampling of well M-118.
