**FOIA/PA NO: \_\_\_\_\_2013-0250\_\_\_\_\_**

## EVENT TIMELINE

## Timeline of Events - Catawba Loss of Offsite Power

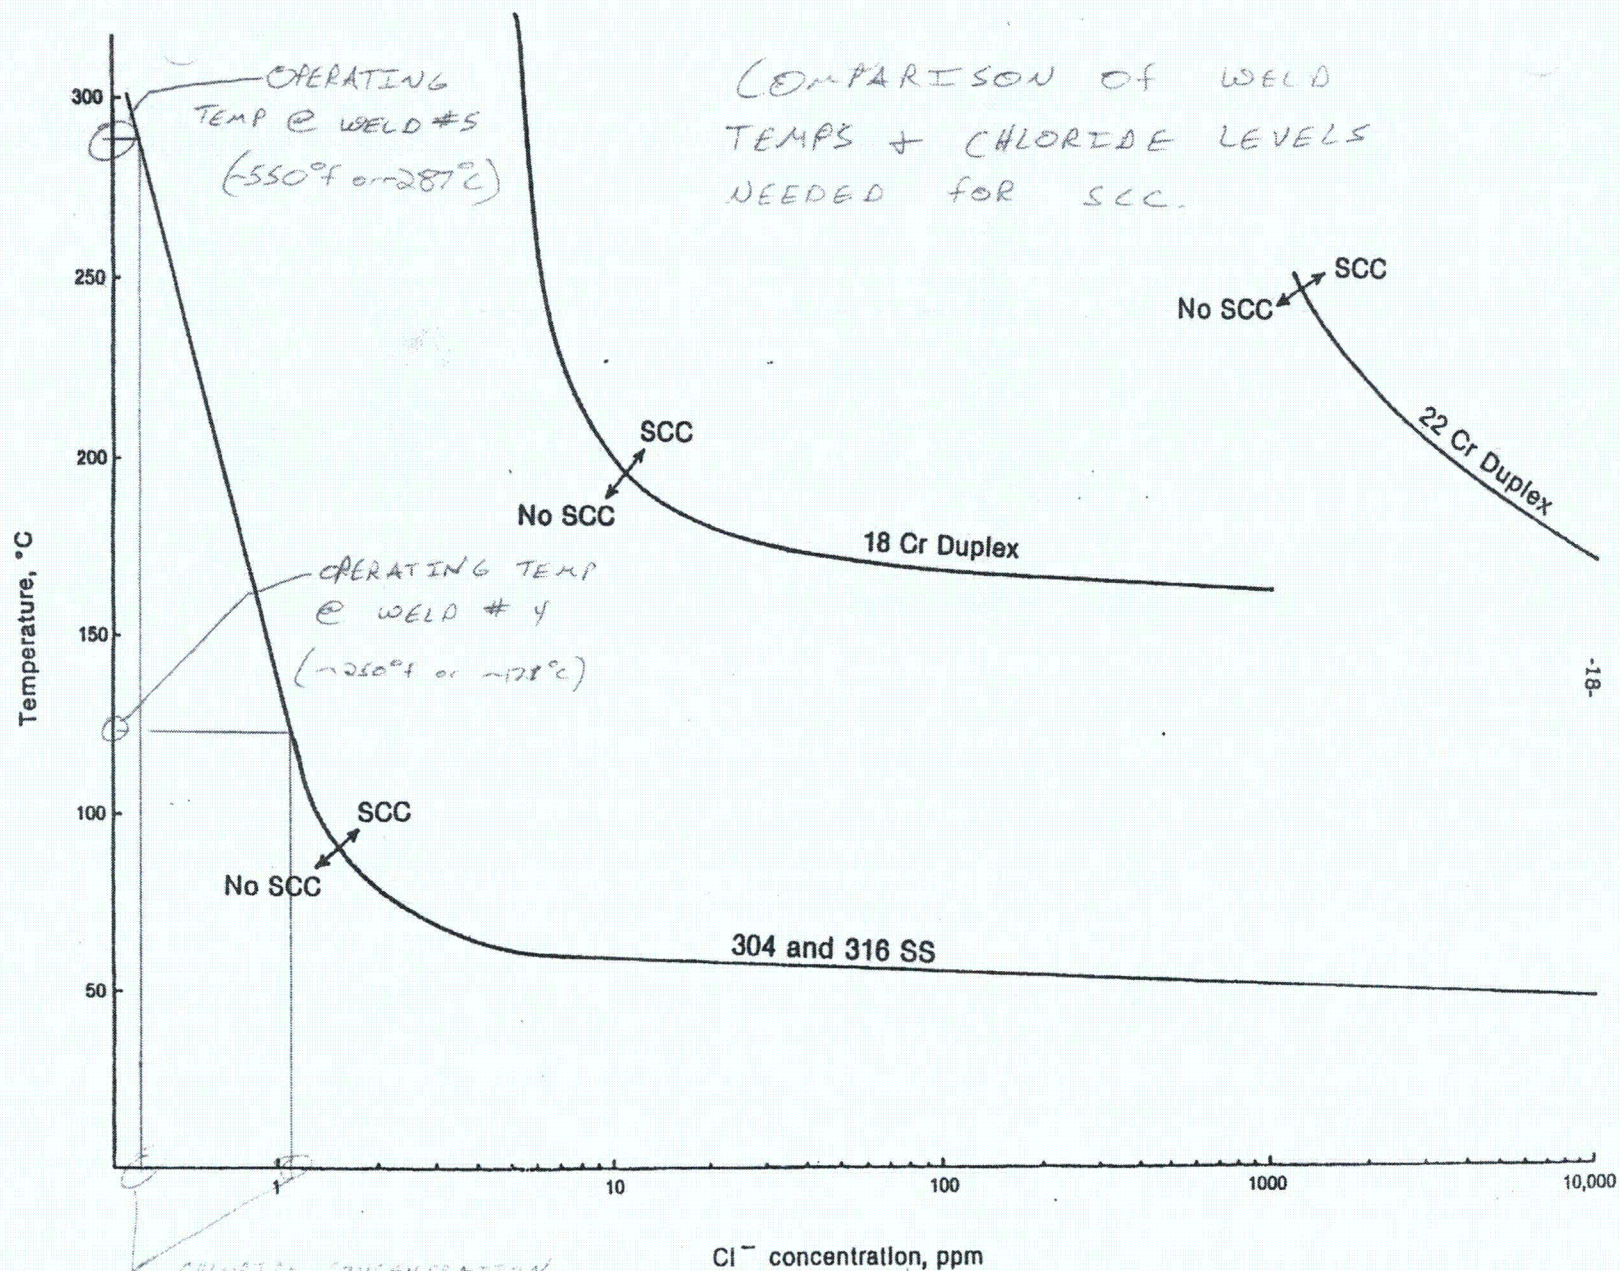
**Figure 9**  
Relative chloride SCC resistance of solution-annealed 304 or 316 stainless steel compared to Duplex stainless steels [24].

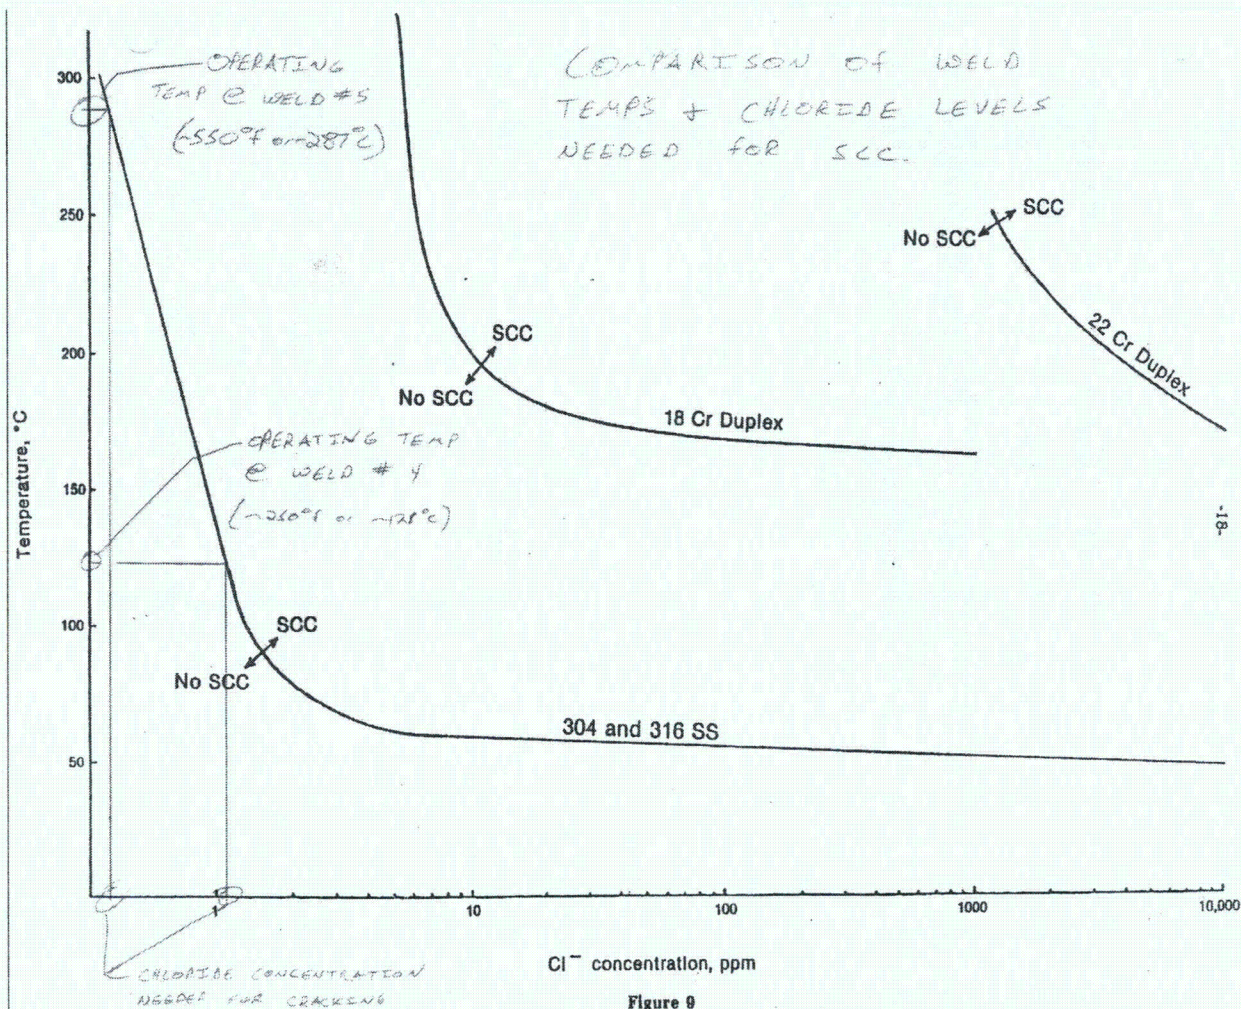
Figure 9  
Relative chloride SCC resistance of solution-annealed 304 or 316 stainless steel compared to Duplex stainless steels [24].
