June 27, 1980

Docket Nos. 50-361, 50-362

IE Bulletin No. 80-16

POTENTIAL MISAPPLICATION OF ROSEMOUNT INC. MODELS 1151 AND 1152 PRESSURE TRANSMITTERS WITH EITHER "A" OR "D" OUTPUT CODES

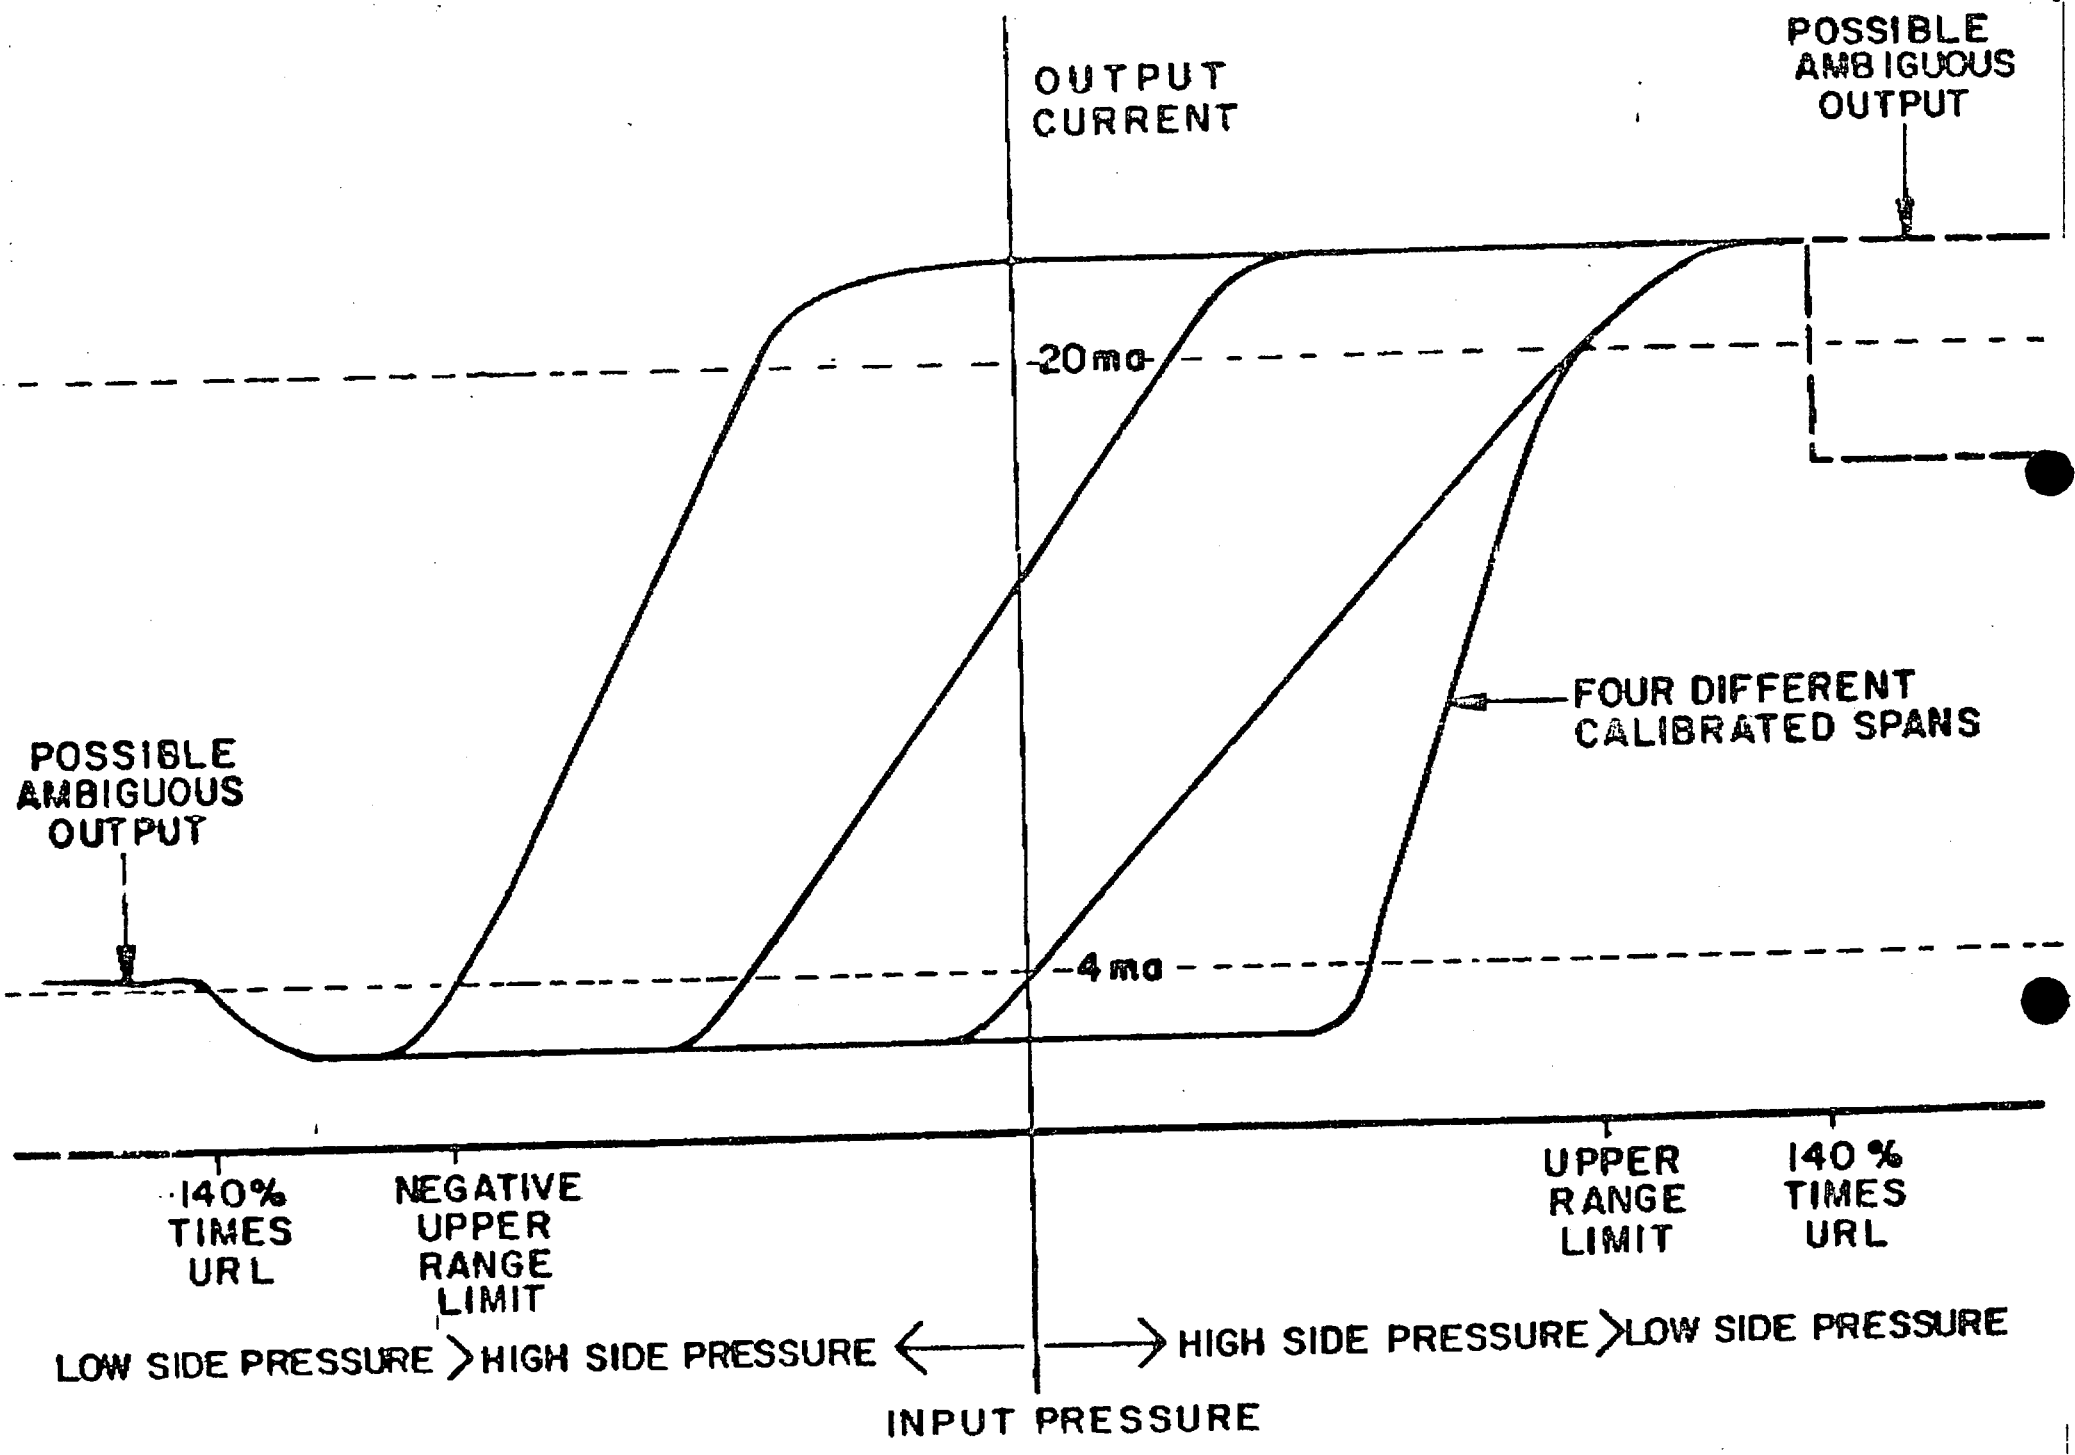
Rosemount's Model 1152 pressure transmitter provides a specified linear output of 4 to 20 mA throughout the calibrated range of operation. The transmitter output is not specified by Rosemount for pressures outside of the calibrated range of operation. It has been observed in a limited number of transmitters that an output between 4 and 20 mA can occur with certain input pressures outside of the calibrated range. These ambiguous outputs can occur in both an over pressure condition and a reverse pressure condition. Both conditions arise when the center diaphragm of the pressure sensor bottoms out against either of the fixed capacitor plates. In each case the normal capacitance signal becomes a very high capacitance signal which affects the operation of the electronic circuit.

For the over pressure condition, the effect of the high capacitance from the sensor is a modulated output on the oscillator circuit which may cause the output current of the transmitter to drop below 20 mA. In a limited sample size, the ambiguous output during this over pressure condition occurred in 5% of the transmitters at ambient conditions. Referring to the attached graph, this does not occur until the over pressure condition is 140% of the upper range limit regardless of span. At that point a discontinuity can occur with the output current instantaneously decreasing to less than 20 mA. As an example of this potential applications problem, the upper range limit of a range 5 1152 differential pressure transmitter (Model 1152DP5A22) is 750"H<sub>2</sub>O. The range of this pressure transmitter can be set from 0 to 150"H<sub>2</sub>O. If the ambiguous output in the over pressure condition is to occur, it will occur at 140% or more of the upper range limit or, in this case, at pressures 1050"H<sub>2</sub>O (750"H<sub>2</sub>O x 1.4). The transmitter then could give an output less than 20 mA at a pressure that is, in this example, seven

times (1050"H<sub>2</sub>O ' 150"H<sub>2</sub>O) the upper range value. Note that the significant figure for use in determining the pressure above which an ambiguous output can occur is the specified upper range limit (750" H<sub>2</sub>O in this example) not the customer selected upper range value (150"H<sub>2</sub>O in this example).

For the reverse pressure condition, the effect of the high capacitance from the sensor is the oscillator circuit drawing more current which may cause the output current of the transmitter to exceed 4 mA. In a limited sample size, the ambiguous output during this reverse pressure condition occurred in 55% of the transmitters at ambient conditions. Referring to the attached graph, this does not occur until the reverse pressure condition exceeds 140% of the upper range limit regardless of the span. At this point the output may exceed 4 mA. As an example of this potential applications problem consider the range 5 differential transmitter in the previous paragraph. If the ambiguous output in the reverse pressure condition is to occur, it will occur at 140% or more of the upper range limit, or in this case at reversed pressures J 1050" H<sub>2</sub>O (750"H<sub>2</sub>O x 1.4). The transmitter then could give an output greater than 4 mA at a pressure that is, in this example, seven times (1050" H<sub>2</sub>O ' 150" H<sub>2</sub>O) the upper range value, but reversed. Also note that with absolute pressure units a reverse pressure is not possible since the low pressure side of the cell is evacuated. With gage units a reverse pressure is possible only if a vacuum is present on the connected part since the low pressure side of the cell is vented to ambient atmosphere. Since the maximum reverse pressure would be one atmosphere, only range 3 and 4 gage units could obtain a reverse pressure exceeding 140% of the upper range limit.

The safety system should be analyzed in view of this supplementary report to determine if a potential application problem exists and appropriate corrections to the safety system should be implemented.
