UNITED STATES
NUCLEAR REGULATORY COMMISSION
OFFICE OF INSPECTION AND ENFORCEMENT
WASHINGTON, D.C. 20555

July 31, 1980

IE Bulletin No. 80-20

FAILURES OF WESTINGHOUSE TYPE W-2 SPRING RETURN TO NEUTRAL CONTROL SWITCHES

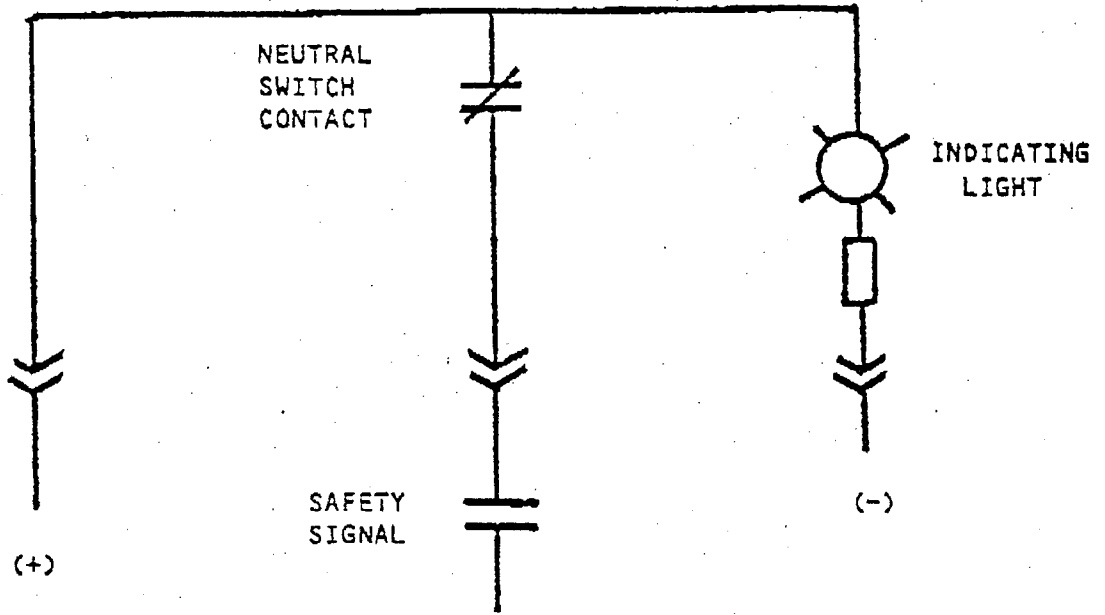
EXISTING INDICATING LIGHT CIRCUIT (TYPICAL)

Depending on how the indicating light circuit is wired, loss of continuity thru the neutral position contact of a W-2 switch could remain undetected until the equipment associated with the switch were called upon to operate. Since such a failure would be equivalent to by-passing the system associated with the switch, consideration should be given to rewiring the switches used in safety-related applications as shown in Figure 1. Such rewiring would provide an acceptable means for detecting contact failure, provided the indicating light is in the control room and readily visible by the operator. If the indicating light is not so located, consideration should be given to annunciating the neutral position contact failures at the control room to alert the operator of the inoperable status of a safety-related system. In addition, consideration should be given to adding redundant contacts to the W-2 switches or to replacing the W-2 switches with others having a more positive contact wiping action.

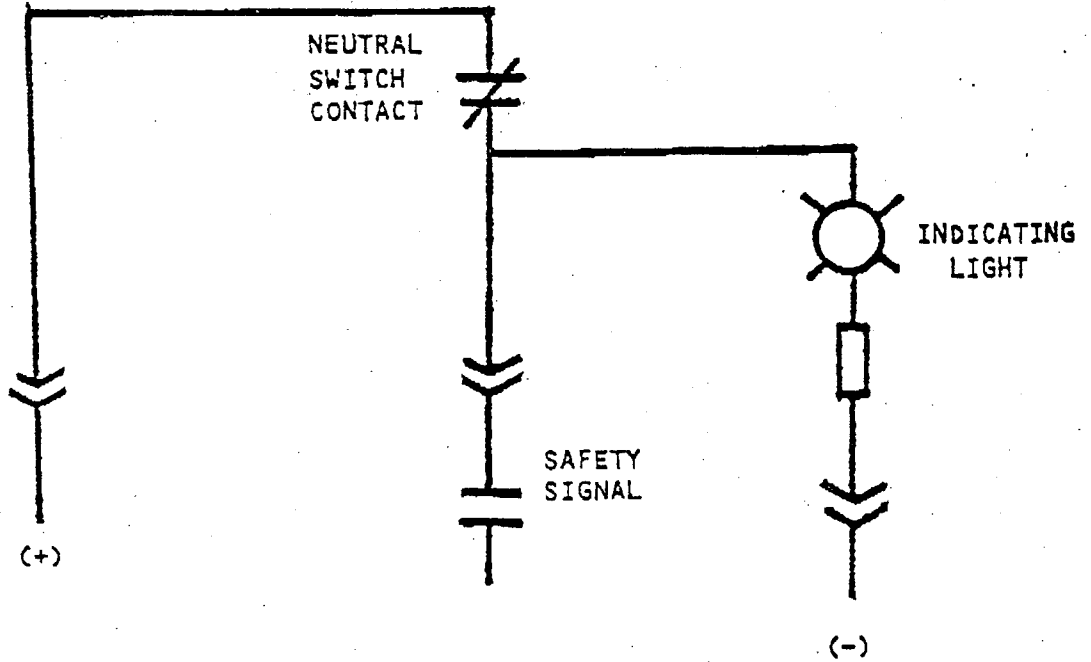
PROPOSED REWIRING OF INDICATING LIGHT CIRCUIT (TYPICAL)

REWIRING OF INDICATING LIGHT CIRCUIT OF W-2 SWITCHES
AS RECOMMENDED BY WESTINGHOUSE TECHNICAL BULLETIN NSD-TB-80-9

A review of this matter by Westinghouse led to the issuance of NSD Technical Bulletin No. NSD-TB-80-9 to the utility owners of all Westinghouse operating plants. The recommendations contained in the Westinghouse technical bulletin include: (i) testing the neutral position contacts of the subject W-2 switches for continuity, and (ii) rewiring of the indicating light circuit to permit the early detection of a neutral contact failure as shown in Figure 1.

3. Licensees of operating plants and holders of construction permits shall describe the longer term corrective measures planned and the date by which such measures will be implemented by actual installation or by design change, as appropriate. As a minimum, the longer term corrective measures should include rewiring the indicating light as shown in Figure 1 provided the light is readily visible to the control room operator. If not, failures of the neutral position contacts should be annunciated in the control room.
