AEOD/C204

SAN ONOFRE UNIT 1
LOSS OF SALT WATER COOLING EVENT
ON MARCH 10, 1980

Office for Analysis and Evaluation
of Operational Data

July 1982

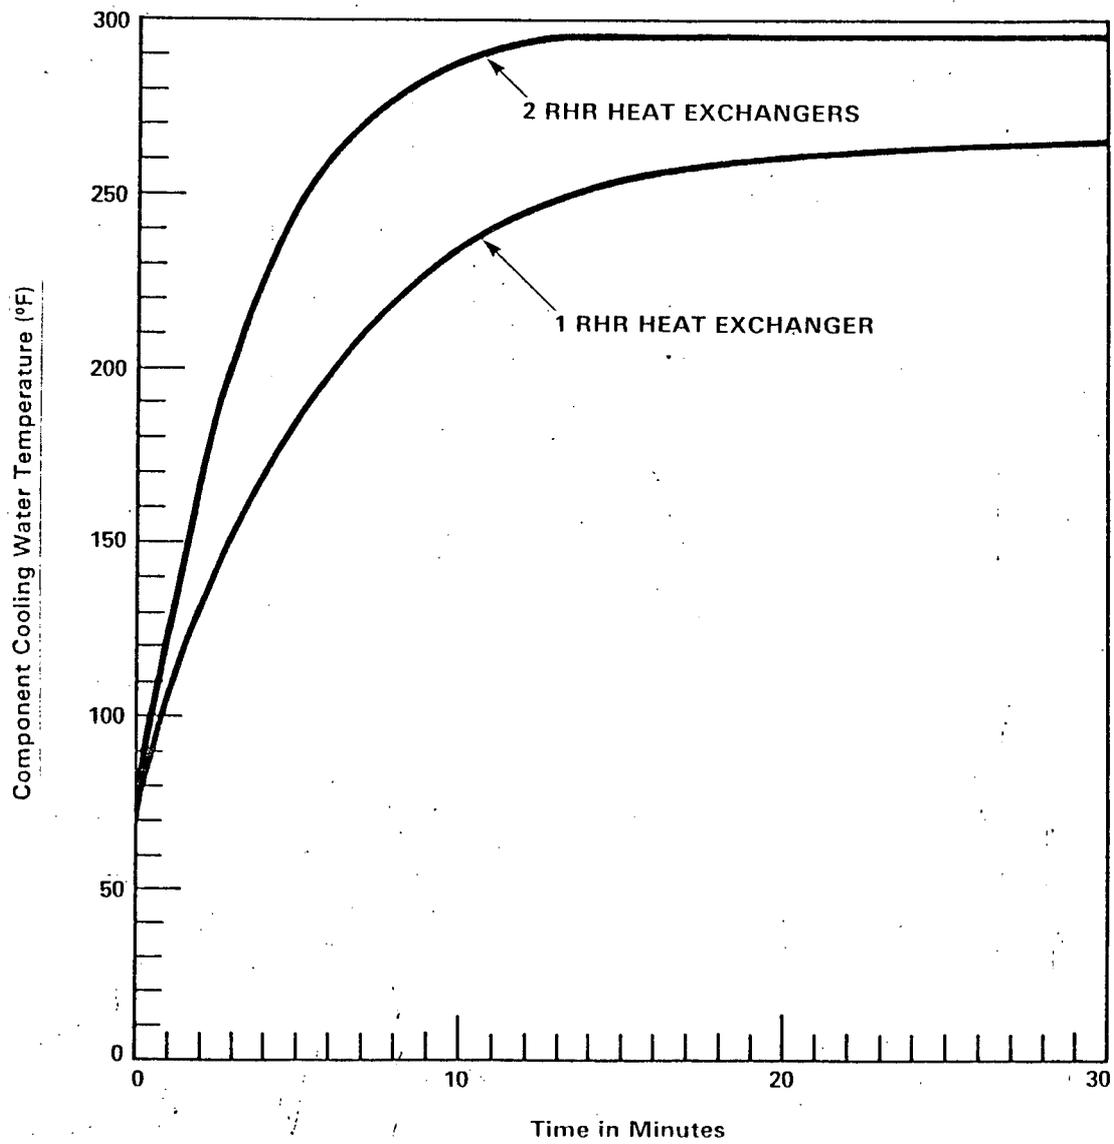
Based on this information, the modes of operation of greatest concern for loss of the SWC system are when the RHR system is in operation during normal shutdown and during main steamline break accident conditions. In accordance with NRC's request (Ref. A-4) the licensee performed scoping analyses of plant performance with degraded salt water cooling under accident conditions (Ref. A-5). The bottom line of the analyses was that if there is a total loss of salt

water cooling shortly after the plant's RHR system is actuated (for the case of normal shutdown or a main steamline break), the CCW system would reach its limiting temperature of 200°F within three to six minutes. Temperature plots for the two cases of total loss of salt water cooling appear in Figure A-1.* As seen on this figure for the case of cooldown with two RHR heat exchangers, the CCW would approach 290°F in ten minutes; for the case of cooldown with one RHR heat exchanger, the component cooling water temperature would exceed 230°F in ten minutes. It should be noted that at some point the water in the component cooling water system will begin to boil and release steam through the head tank. An analysis to determine when this would occur was not done; however, CCW temperatures in excess of 230°F are considered physically unlikely.

Figure A-1 Component cooling water temperature during a loss of all salt water cooling at the start of RHR cooling.

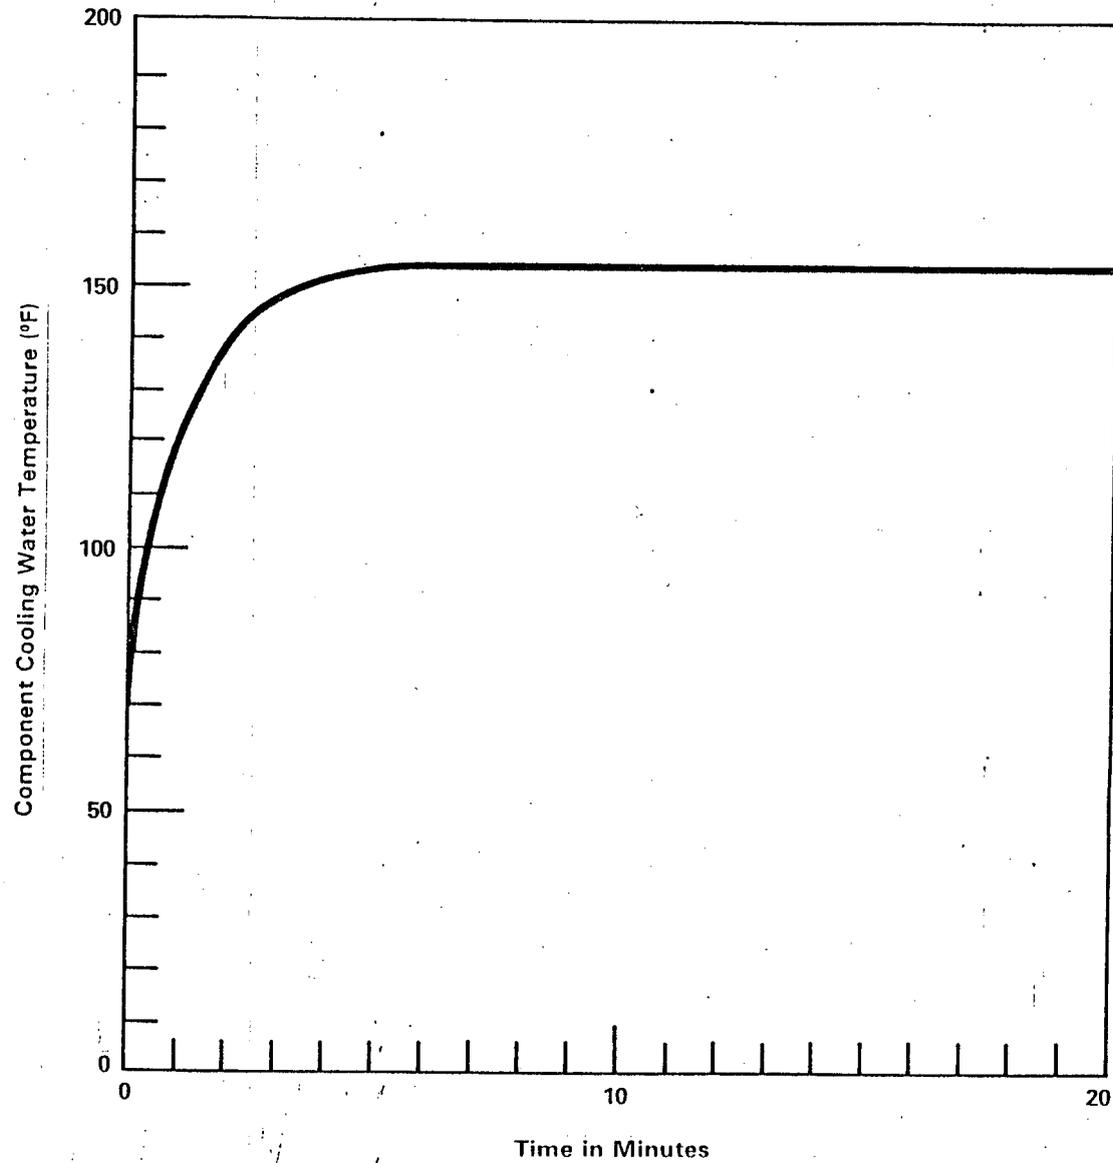
Figure A-2 Component cooling water temperature during a loss of one salt water cooling pump at the start of RHR cooling (2 RHR heat exchangers).

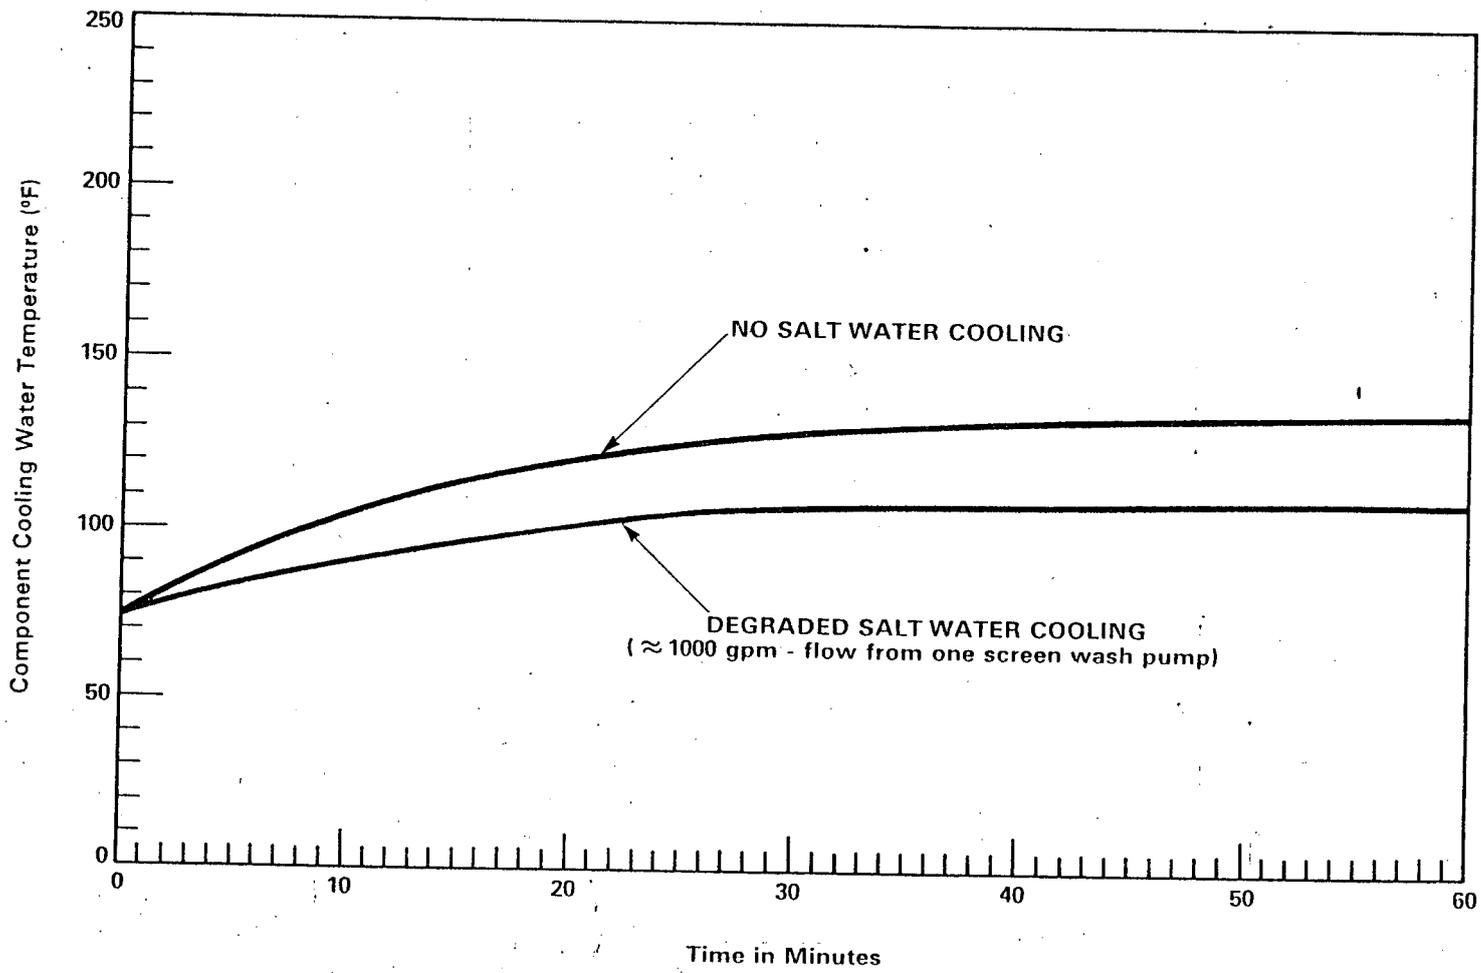
Two additional cases of interest that were calculated included a large LOCA with no salt water cooling and a large LOCA with 1000 gpm salt water cooling (corresponding to the flow of one screen wash pump). The results of these analyses (Figure A-3) showed that for a LOCA the loss of salt water cooling does not result in significant consequences; i.e., for a large LOCA with no salt water cooling, the CCW temperature reaches 120°F in 20 minutes and levels off at 130°F in about one hour. For the LOCA with one screen wash pump operational, the maximum CCW temperature levels off at about 95°F in about 25 minutes.

Figure A-3 Component cooling water temperature during a LOCA with degraded salt water cooling.

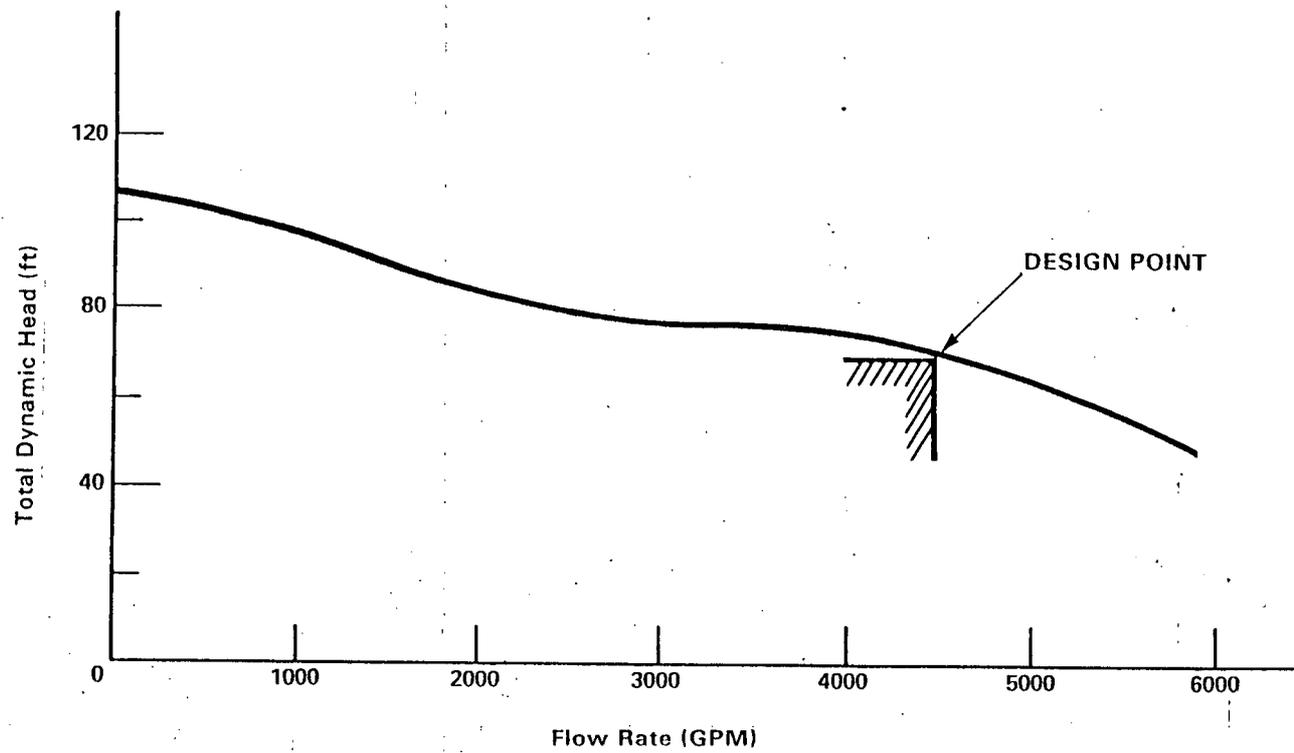
As noted in Appendix C, the IST data for flow and ΔP for the SWC pumps can be subject to large errors because ΔP is obtained from tide height (for many tests reference elevation was included incorrectly), and because the SWC pump performance curve is very flat in the range where the inservice testing is performed (250 gpm/ft of head).

Figure C-1 Salt water cooling pump performance curve.

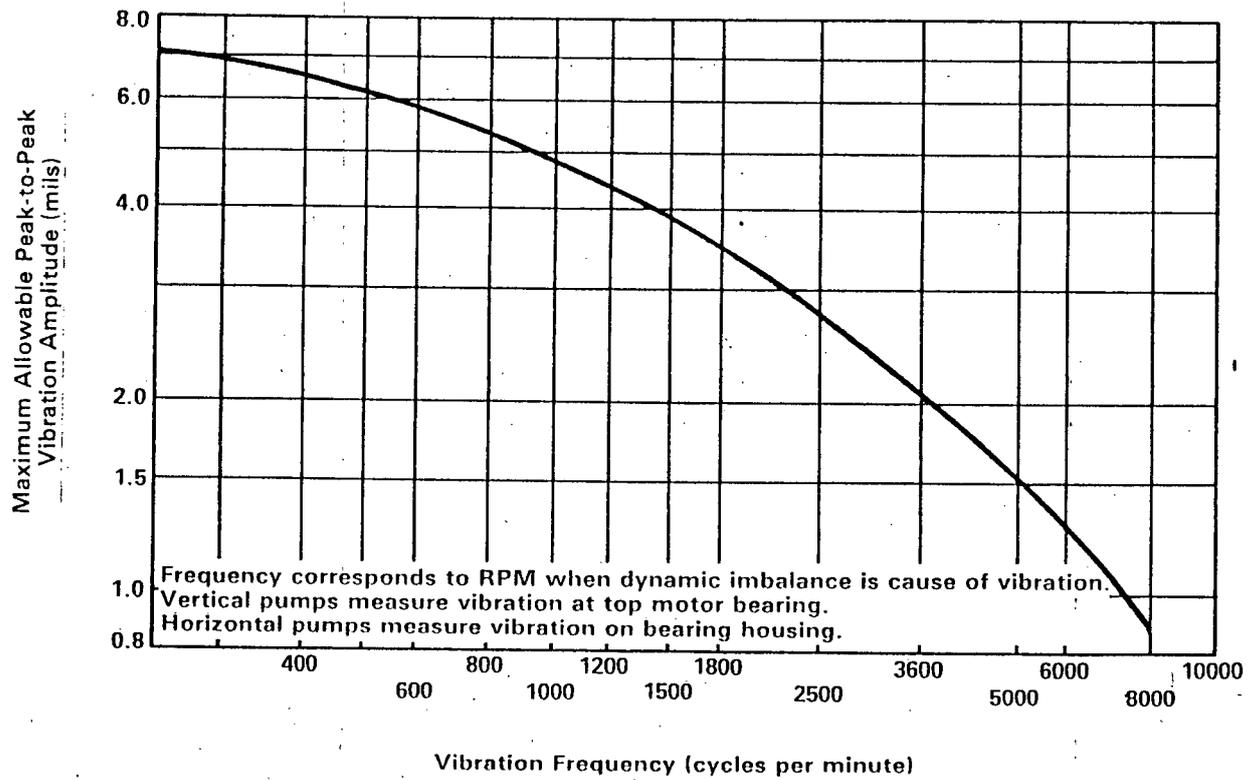
As part of the IST Program, the licensee measures vibration of the thrust bearing at the top of the drive motor. This data is used in accordance with ASME section XI IST requirements to determine when the pump shaft requires investigation and/or corrective action. The Hydraulic Institute's Standard Curve (see figure C-2), the "General Machinery Vibration Severity Chart" (Ref C-13), and other similar references are used as guides to determine acceptable vibration levels.

Figure C-2 Hydraulic Institute curve for pump shaft vibration testing.

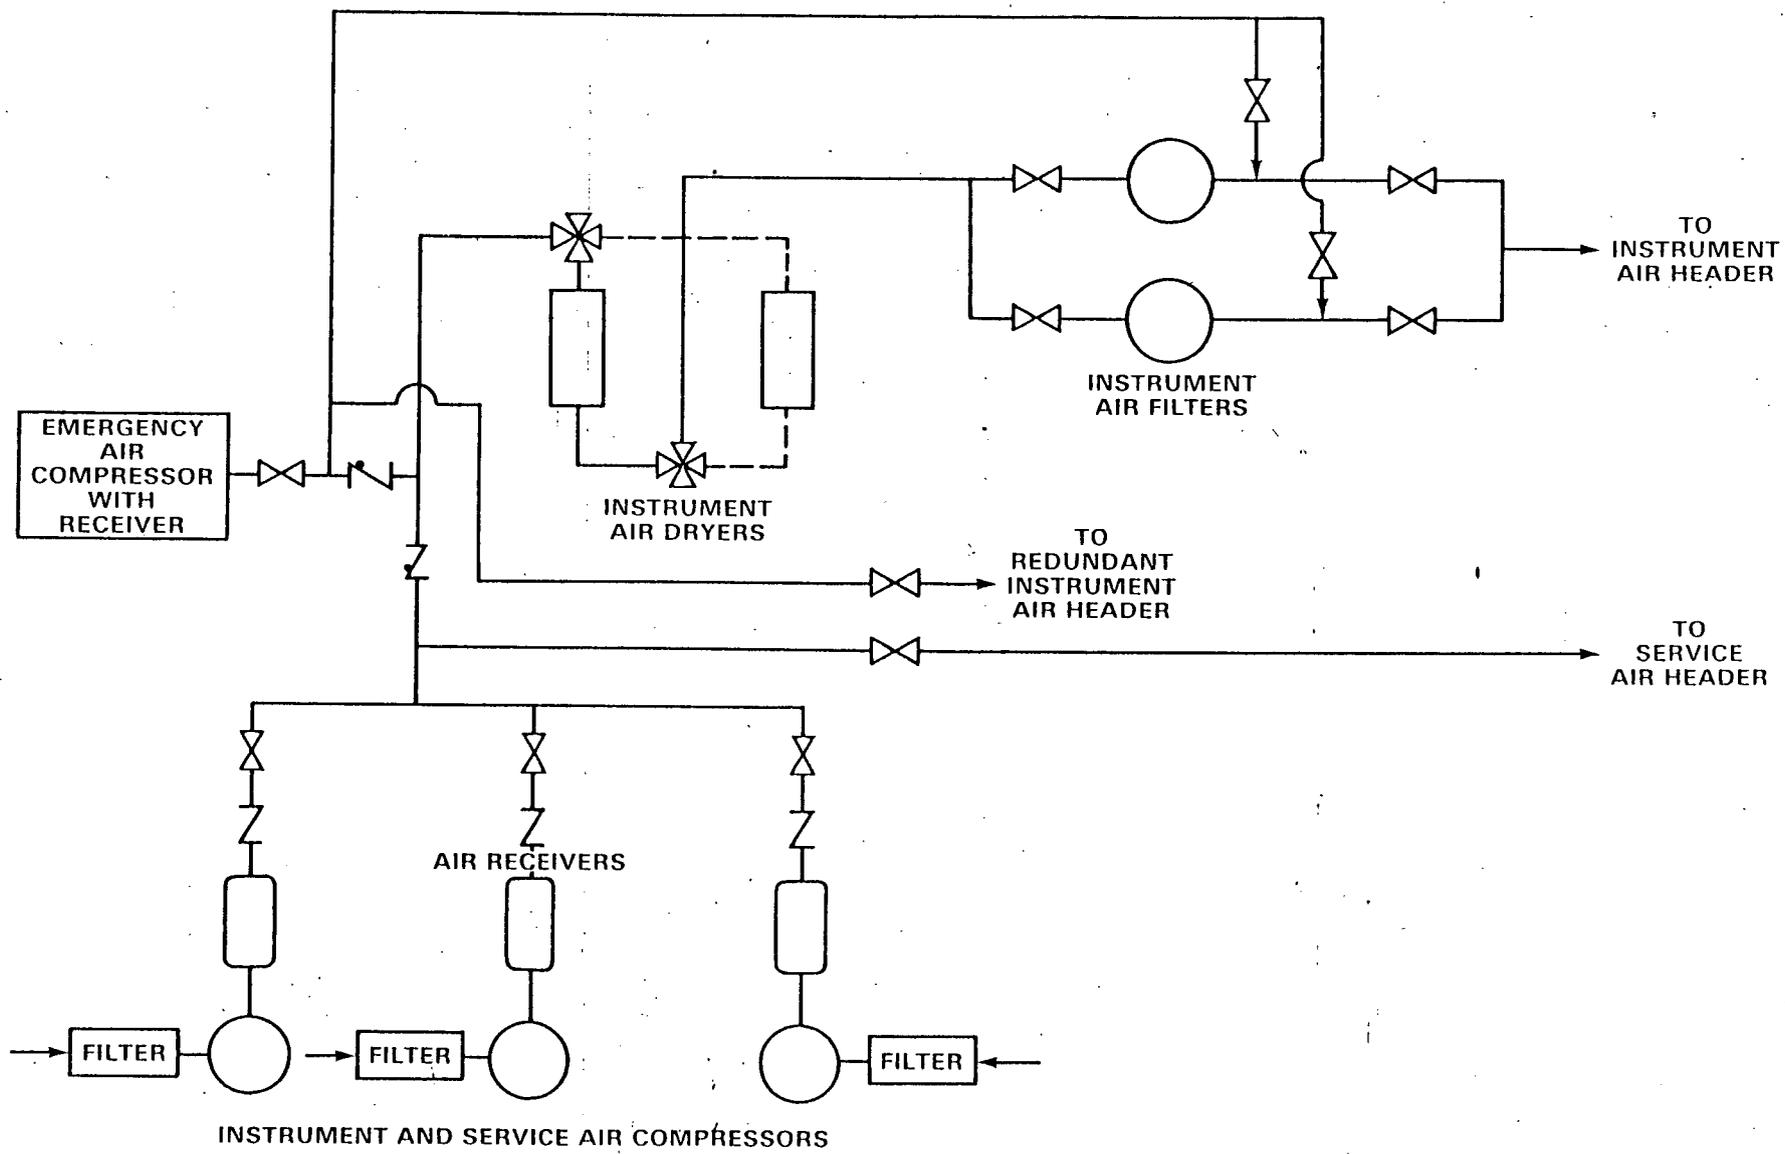
As noted in Appendix D, instrument air which is provided by the emergency air compressor is not necessarily filtered. Such operation may pose a common cause failure potential for much safety-related equipment. The issue of contamination of both trains of safety-related equipment caused by the emergency air supply has been discussed with the licensee. We are presently unaware of any plans for corrective action.

The air dryers, through which instrument air is routed, are vertical tanks containing silica gel desiccant material in bulk form. It is believed that, due to the prolonged use between replacement of the air dryers at San Onofre, the desiccant broke down into small fragments (Ref. D-1). Some of the fragments

Figure D-1 Schematic diagram of the compressed air system.

migrated from the tanks to the filters downstream. These filters, which also contained desiccant in bags, were initially effective in removing the small desiccant fragments from the air. However, the desiccant fragments gradually coated the filters, thereby increasing the pressure drop across the filters. This increased pressure drop caused increased bypass flow around the filters, and the small desiccant fragments eventually appeared downstream. Desiccant fragments then migrated throughout the instrument air system to areas inside containment, the auxiliary building, and the intake structure.
