ACRS MEETING MINUTES ON THE MEETING OF THE  
WESTINGHOUSE WATER REACTORS SUBCOMMITTEE  
FEBRUARY 12, 1986  
WASHINGTON, DC

SUBJECT: STAFF ACTIONS RESULTING FROM THE INVESTIGATION  
OF THE NOVEMBER 21 SAN ONOFRE NUCLEAR GENERATING  
STATION, UNIT 1 EVENT (NUREG-1190)

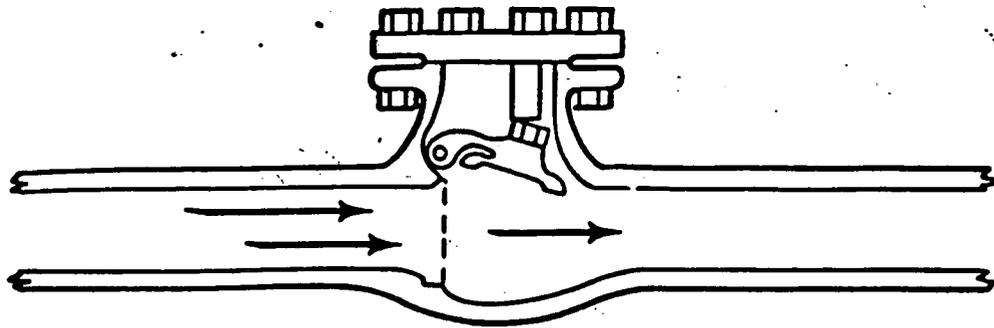
PACIFIC VALVE DESIGN

design, and inadequate consideration of the effects of reduced power operation on check-valve operation. It was noted that the failed check valves and check valves of similar design have had a history of failures. The failed check valves were "oversized" for the application and this contributed to their susceptibility to failure at reduced flow. (The lift forces at reduced flow were not large enough to lift the valve disk out of the flow stream. The valve disks were subjected to an increased level of flow-induced vibration when in the flow stream.) The IIT was not able to reconstruct the history of past check valve failures at SONGS-1 from the information in the maintenance records. The inservice testing procedures for this check valves were judged to be inadequate in detecting check valve degradation.

4. SCE intends to replace the check valves of the type involved in the check valve failures with a different design. The old (Pacific Valve) valve design and the replacement (Atwood-Morrill) valves are shown on Figure 1. The configuration of the feedwater lines will be modified as to reduce the potential for water hammer. A number of other modifications are being proposed by SCE. These modifications are summarized on Attachment D.
