UNITED STATES
NUCLEAR REGULATORY COMMISSION
WASHINGTON, D. C. 20555

May 10, 1989

I am responding to your letter of May 4, 1989, in which you expressed concern regarding the operation of Southern California Edison's (Edison) San Onofre Unit 1 facility with cracked bolts in the reactor vessel thermal shield. The Nuclear Regulatory Commission (NRC) staff has been aware of the cracked bolts since January 1989.

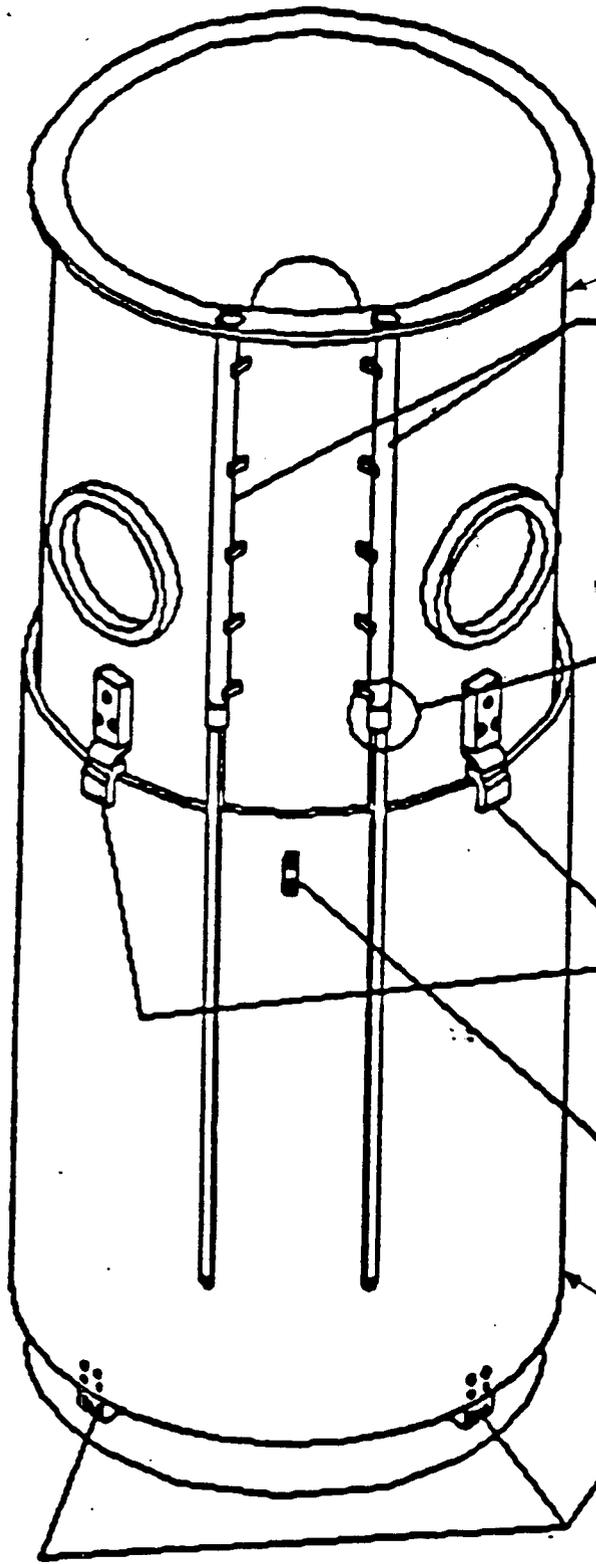
On January 3, 1989, Southern California Edison conducted a visual inspection of the thermal shield with a remote camera; 24 of 30 bolts could be visually inspected. Three bolts out of the 24 inspected were found to be broken. In addition, the locking devices for two bolts and the locking device for one dowel pin had cracks. Five out of six flexures at the top of the thermal shield have been broken since 1978. The flexures were originally added to provide radial and tangential restraint to the top of the thermal shield. When these were discovered to be broken, an evaluation was made which concluded that the flexures were unnecessary. As a result of the January inspection, the licensee found no evidence of damage to or motion of the thermal shield.

NO DAMAGE NOTED

FLEXURE FIXTURE 5 OF 6 BROKEN OR CRACKED SINCE 197
 (TYP 6 PLACES) NO CHANGE NOTED

5 BOLTS PER SUPPORT BLOC:
 3 BOLTS (TOTAL) BROKEN
 AFFECTING 2 OF 6 SUPPORT:

affected. Based on the analysis, the licensee has proposed to return San Onofre Unit 1 to power and monitor the condition of the thermal shield during operation by using neutron noise analysis and acoustical techniques. Although the sixth flexure is no longer necessary, the licensee's monitoring program will include monitoring of this flexure, since failure of the sixth flexure could be an indication of motion of the thermal shield beyond what is predicted. The neutron noise analysis would detect a change in vibration should the sixth flexure fail and this would require the licensee to shut down for repairs. A mid-cycle inspection would also be conducted not later than June 30, 1990, to visually confirm the expected behavior of the thermal shield. If the inspection proves satisfactory, the licensee would operate until about January 1991, at which time repairs would be conducted.

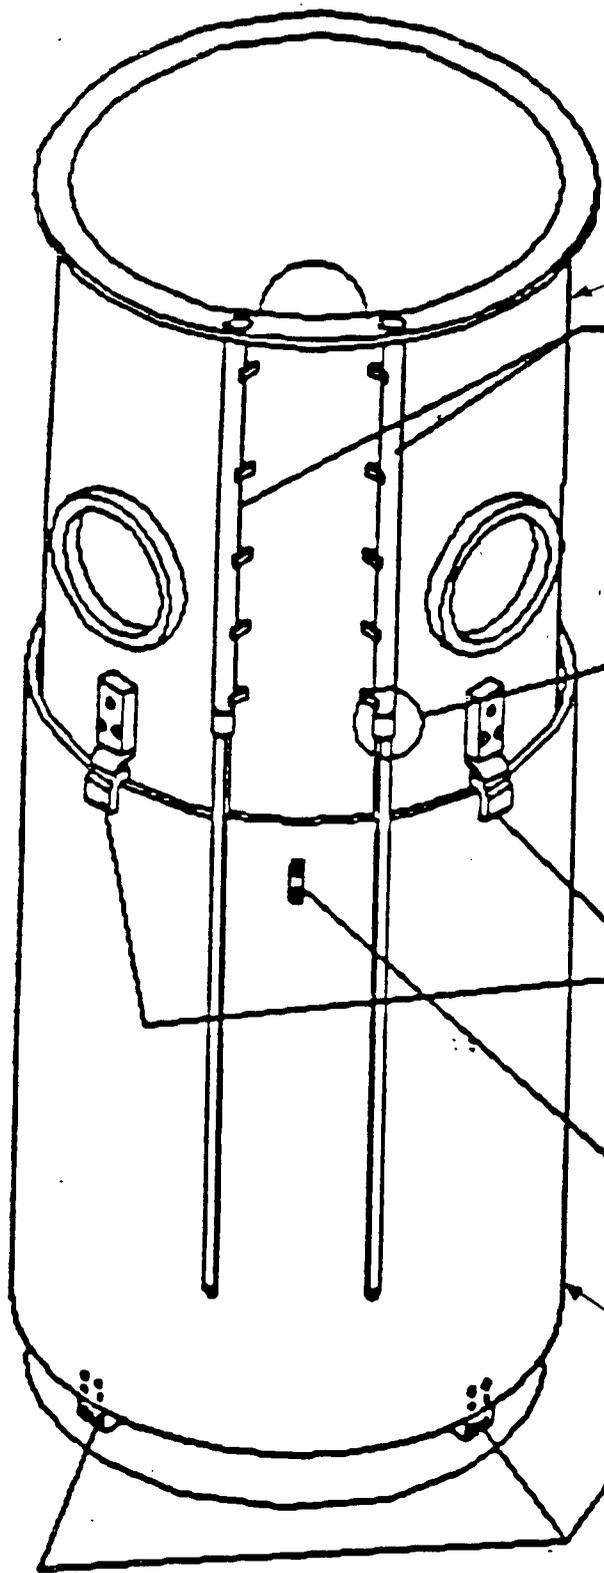
On January 3, 1989, Southern California Edison conducted a visual inspection of the thermal shield with a remote camera; 24 of 30 bolts could be visually inspected. Three bolts out of the 24 inspected were found to be broken. In addition, the locking devices for two bolts and the locking device for one dowel pin had cracks. Five out of six flexures at the top of the thermal shield have been broken since 1978. The flexures were originally added to provide radial and tangential restraint to the top of the thermal shield. When these were discovered to be broken, an evaluation was made which concluded that the flexures were unnecessary. As a result of the January inspection, the licensee found no evidence of damage to or motion of the thermal shield.

NO DAMAGE NOTED

FLEXURE FIXTURE (TYP 6 PLACES) 5 OF 6 BROKEN OR CRACKED SINCE 19
NO CHANGE NOTED

5 BOLTS PER SUPPORT BLOC
3 BOLTS (TOTAL) BROKEN
AFFECTING 2 OF 6 SUPPOR

affected. Based on the analysis, the licensee has proposed to return San Onofre Unit 1 to power and monitor the condition of the thermal shield during operation by using neutron noise analysis and acoustical techniques. Although the sixth flexure is no longer necessary, the licensee's monitoring program will include monitoring of this flexure, since failure of the sixth flexure could be an indication of motion of the thermal shield beyond what is predicted. The neutron noise analysis would detect a change in vibration should the sixth flexure fail and this would require the licensee to shut down for repairs. A mid-cycle inspection would also be conducted not later than June 30, 1990, to visually confirm the expected behavior of the thermal shield. If the inspection proves satisfactory, the licensee would operate until about January 1991, at which time repairs would be conducted.

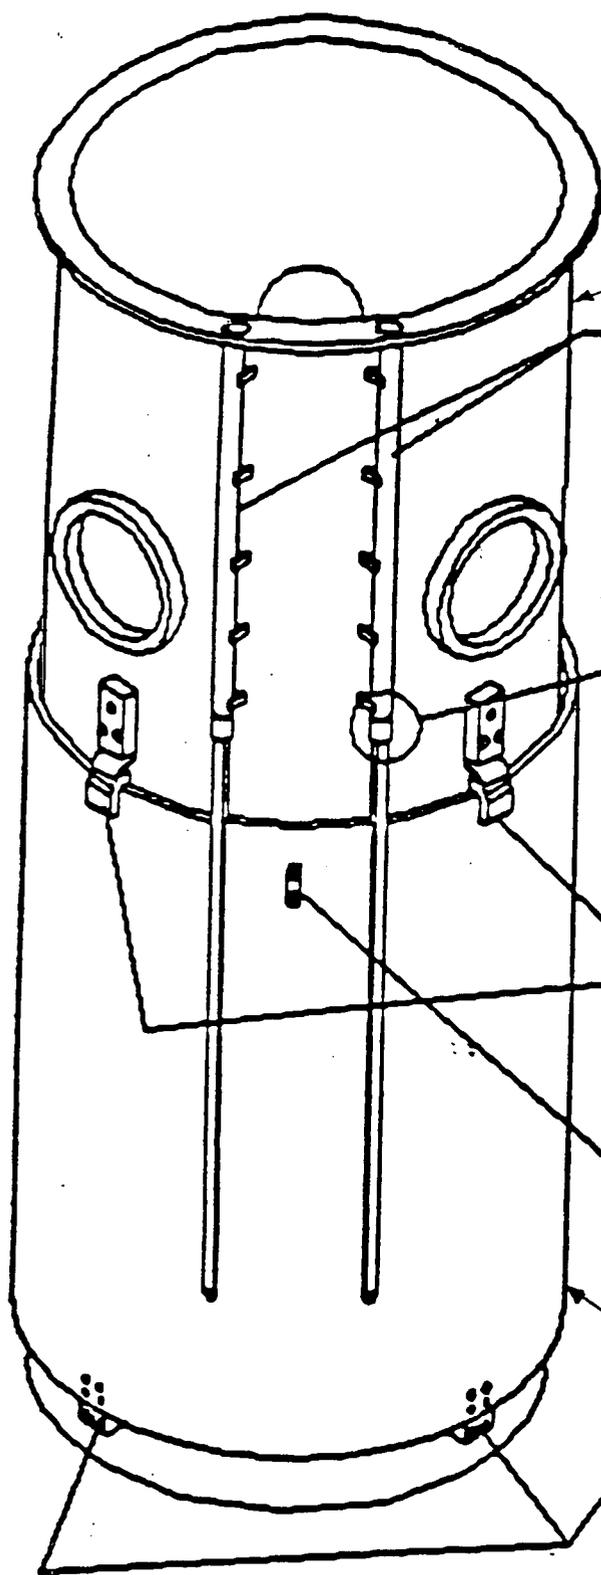
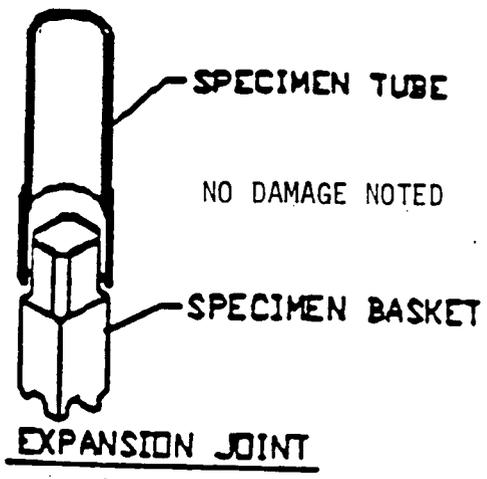
On January 3, 1989, Southern California Edison conducted a visual inspection of the thermal shield with a remote camera; 24 of 30 bolts could be visually inspected. Three bolts out of the 24 inspected were found to be broken. In addition, the locking devices for two bolts and the locking device for one dowel pin had cracks. Five out of six flexures at the top of the thermal shield have been broken since 1978. The flexures were originally added to provide radial and tangential restraint to the top of the thermal shield. When these were discovered to be broken, an evaluation was made which concluded that the flexures were unnecessary. As a result of the January inspection, the licensee found no evidence of damage to or motion of the thermal shield.

FLEXURE FIXTURE 5 OF 6 BROKEN OR CRACKED SINCE 19
 (TYP 6 PLACES) NO CHANGE NOTED

NO DAMAGE NOTED

5 BOLTS PER SUPPORT BLC
 3 BOLTS (TOTAL) BROKEN
 AFFECTING 2 OF 6 SUPPOR

affected. Based on the analysis, the licensee has proposed to return San Onofre Unit 1 to power and monitor the condition of the thermal shield during operation by using neutron noise analysis and acoustical techniques. Although the sixth flexure is no longer necessary, the licensee's monitoring program will include monitoring of this flexure, since failure of the sixth flexure could be an indication of motion of the thermal shield beyond what is predicted. The neutron noise analysis would detect a change in vibration should the sixth flexure fail and this would require the licensee to shut down for repairs. A mid-cycle inspection would also be conducted not later than June 30, 1990, to visually confirm the expected behavior of the thermal shield. If the inspection proves satisfactory, the licensee would operate until about January 1991, at which time repairs would be conducted.
