Monticello Nuclear Generating Plant

**MNGP Evaluation
EC-22537**

2013 H8-H9 Shroud Support Structure Indications Update

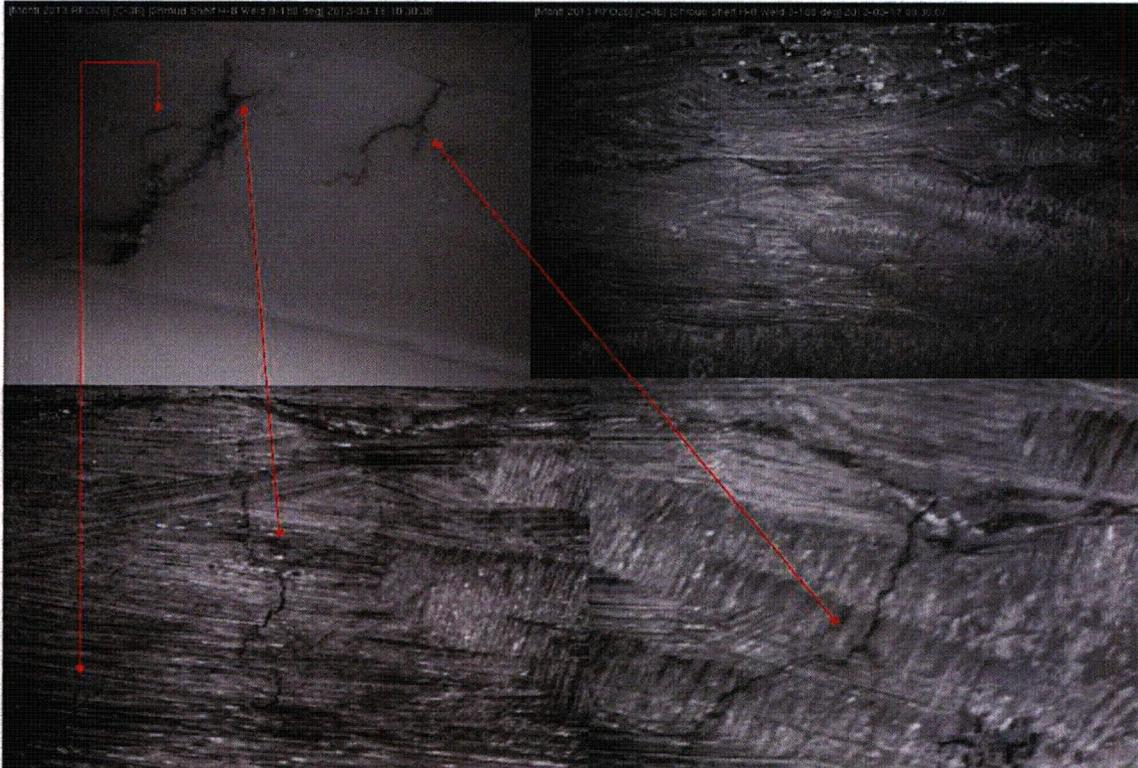
Four locations were selected for cleaning and visual inspection on the underside of the shroud support plate on the H8 and H9 welds. Two locations on the underside of the H8 weld at the 68° and 210° vessel azimuths and two locations on the underside of the H9 weld at the 142° and 292° vessel azimuths. Each of the four locations was cleaned using the hydrolasing tool deployed through the inlet nozzle of the jet pump for approximately 30 minutes at 17, 500 psi. Pre-cleaning visual inspections were performed at each of the locations. The pre-cleaning was completed and both the site and Westinghouse NDE personnel determined that the cleaning was acceptable for post cleaning final visual inspection. Below are photos of H8 weld, both pre- and post-cleaning. The top left photo is the weld before cleaning. The other 3 photos are the weld location post-cleaning and are representative of the other areas cleaned. It can be seen in the photos that the cleaning was highly effective in removing the scale on the locations. (e.g. grinding marks from original fabrication are visible) .

As shown above, the cleaning and visual inspection at the four locations confirmed the presence of flaws in both the H8 and H9 welds.

The indications were primarily transverse to the weld with some flaws oriented circumferentially. Most flaws had different variations of branching indicative of IGSCC. Alloy 182, the weld metal used for the H8, H9 and H10 welds, is susceptible to IGSCC. The residual stress from the welding and the clear evidence of grinding on the weld would be sufficient to provide the stress necessary for IGSCC flaw initiation and propagation.

Monticello has had hydrogen water chemistry (HWC) since 1987. Prior to the HWC installation, the environment would have had sufficient oxygen content to assist in IGSCC initiation. IGSCC flaws require 3 elements to continue to propagate: stress, poor environment and susceptible material. Given that the material was susceptible, that sufficient residual stress was present and that there was sufficient oxygen present and the morphology of the indications, the most likely cause was IGSCC.
