## Southern California Edison Company

Subject: Docket Nos. 50-361 and 50-362 San Onofre Nuclear Generating Station Units 2 and 3

## SAN ONOFRE UNITS 2 AND 3 CONTROL ROOM SURVEY OF NORMAL LIGHTING LEVELS

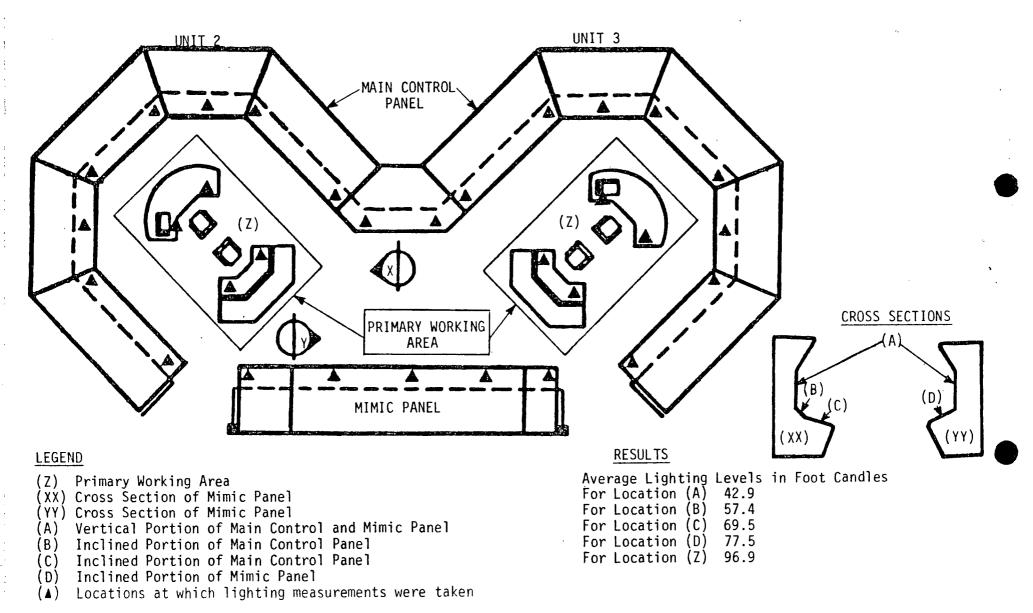
The results of the San Onofre Units 2 and 3 Control Room lighting survey for the normal lighting levels are summarized in Enclosure I. The results of the lighting survey for vertical section (A) of both the main control panel and mimic panel showed an average lighting level of 42.9 footcandles consistent with the guidelines of NUREG-0700 for panel areas. The results of the lighting survey for inclined sections (B) and (C) of the main control panel and inclined section (D) of the mimic panel showed average lighting levels of 57.4, 69.5 and 77.5 footcandles respectively. These higher lighting levels are a direct result of the increase in incident light on the panels due to the orientation of the inclined panels. The results for these inclined areas are also considered to be consistent with the guidelines of NUREG-0700 since the illumination levels fall between the recommended quidelines for vertical sections (panel area) and sit-stand sections (seated operator stations). The results for reading and writing areas (Z) showed an average lighting level of 96.9 footcandles consistent with the guidelines of NUREG-0700.

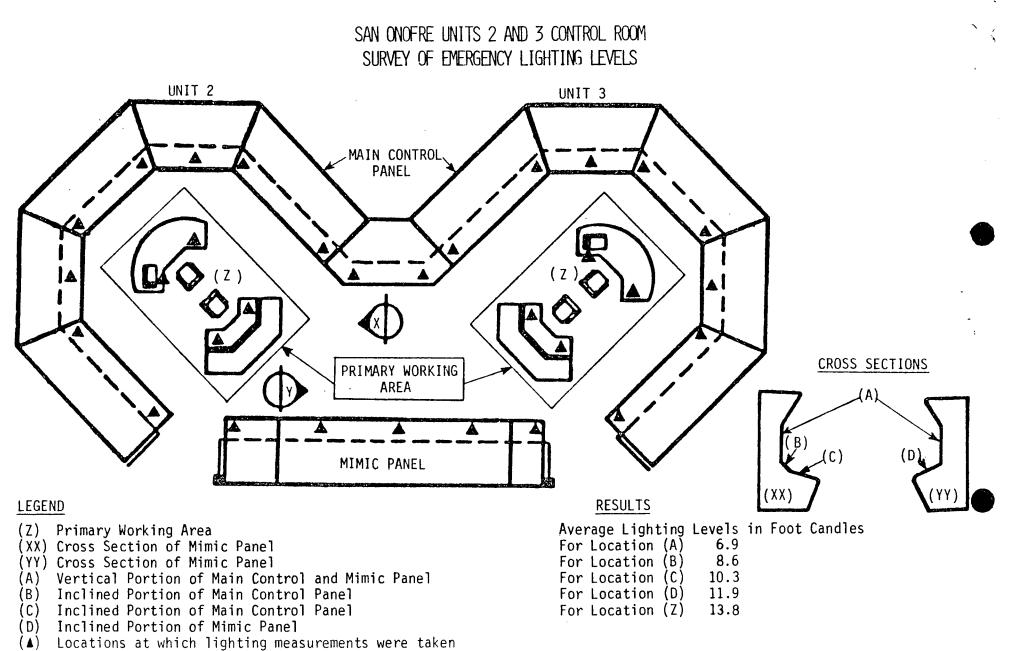
The results of the San Onofre Units 2 and 3 Control Room lighting survey for the emergency lighting level are summarized in Enclosure II. The results of the lighting survey for reading and writing areas (Z) (work stations in the primary working area) showed an average lighting level of 13.8 footcandles consistent with the guidelines of NUREG-0700 for emergency lighting. The average lighting levels for the panel areas are also identified in Enclosure II. The emergency lighting levels in the panel areas did not impair the capability of the operators to obtain clear and discernable readings.
