Subject: 2013 Annual Pond Inspection Report  
Source Materials License SUA-1534  
Docket Number 40-8943

**CROW BUTTE RESOURCES, INC.**

**CROW BUTTE MINE  
DAWES COUNTY, NEBRASKA**

**2013 POND INSPECTION REPORT**

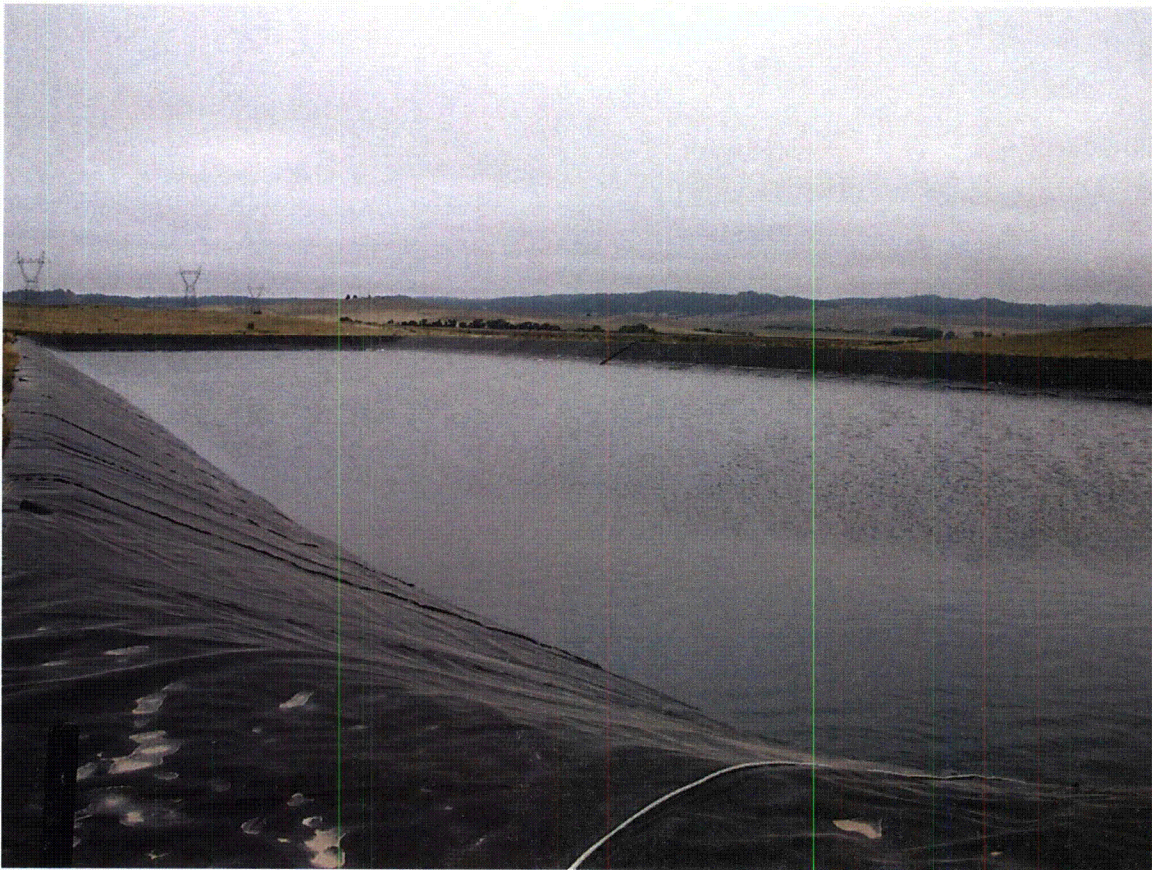
**#1 Southwest view of evaporation pond #1, date: 10/03/13**

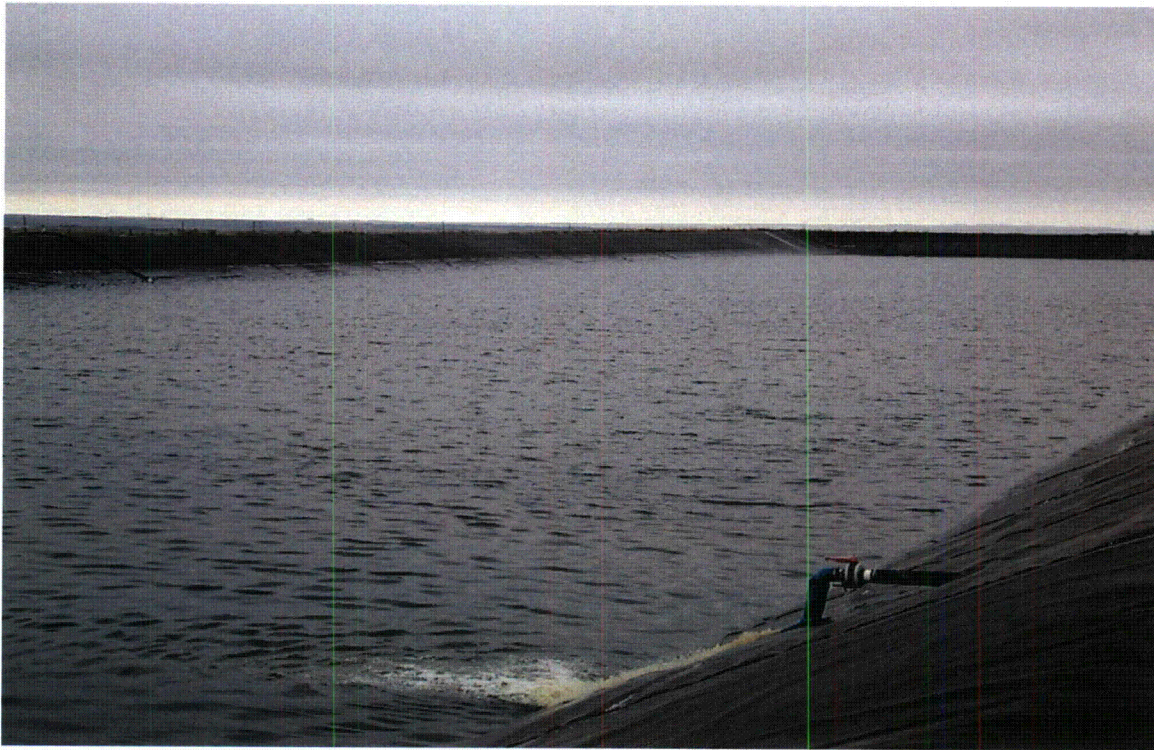
**#2 Northwest view of pond #1. Date: 10/03/13**

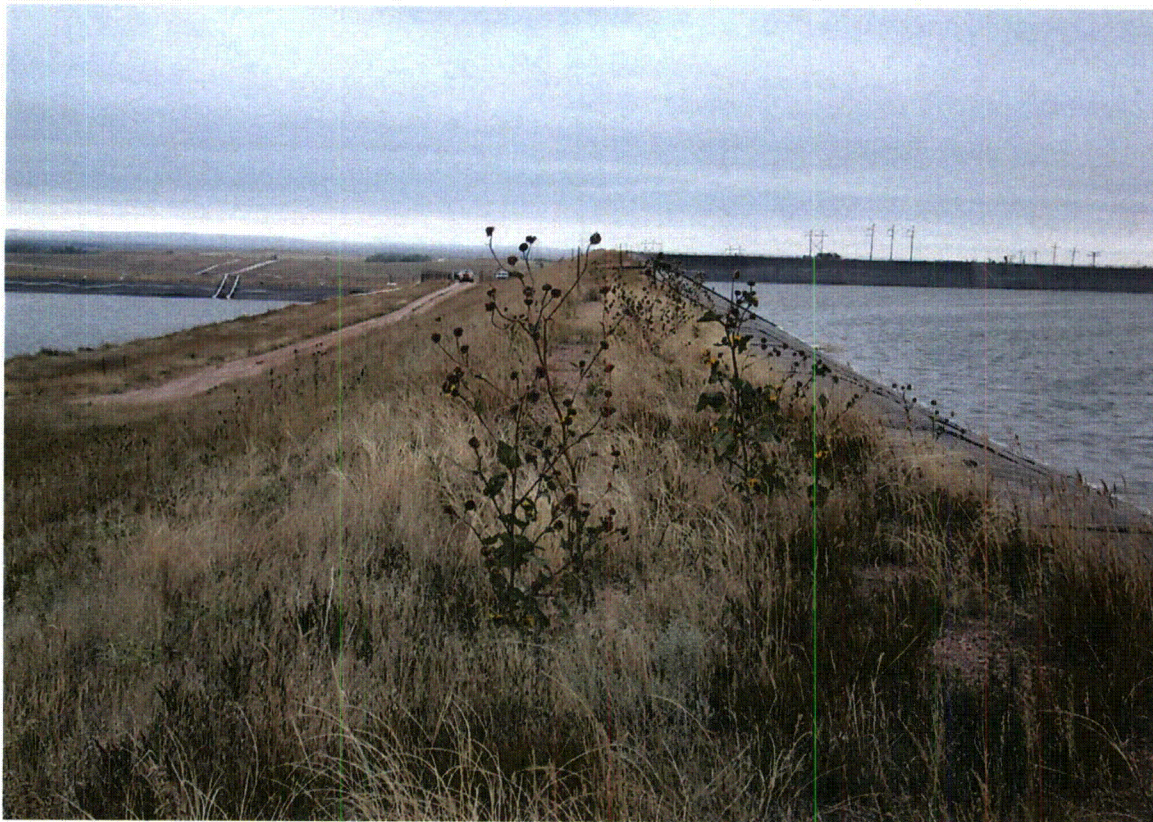
**North view of ponds #1, right & pond #3, left. Good vegetation. Date: 10/03/13**

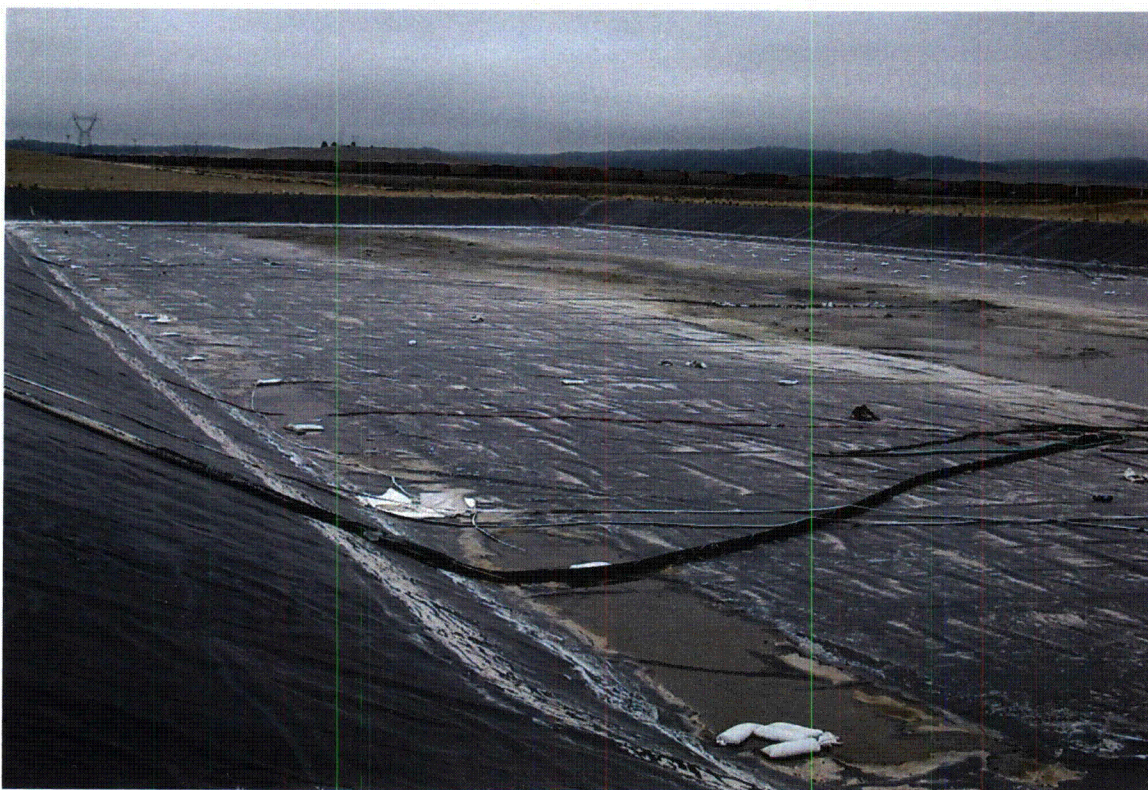
**Southwest view of Pond #4. Date: 10/03/13**

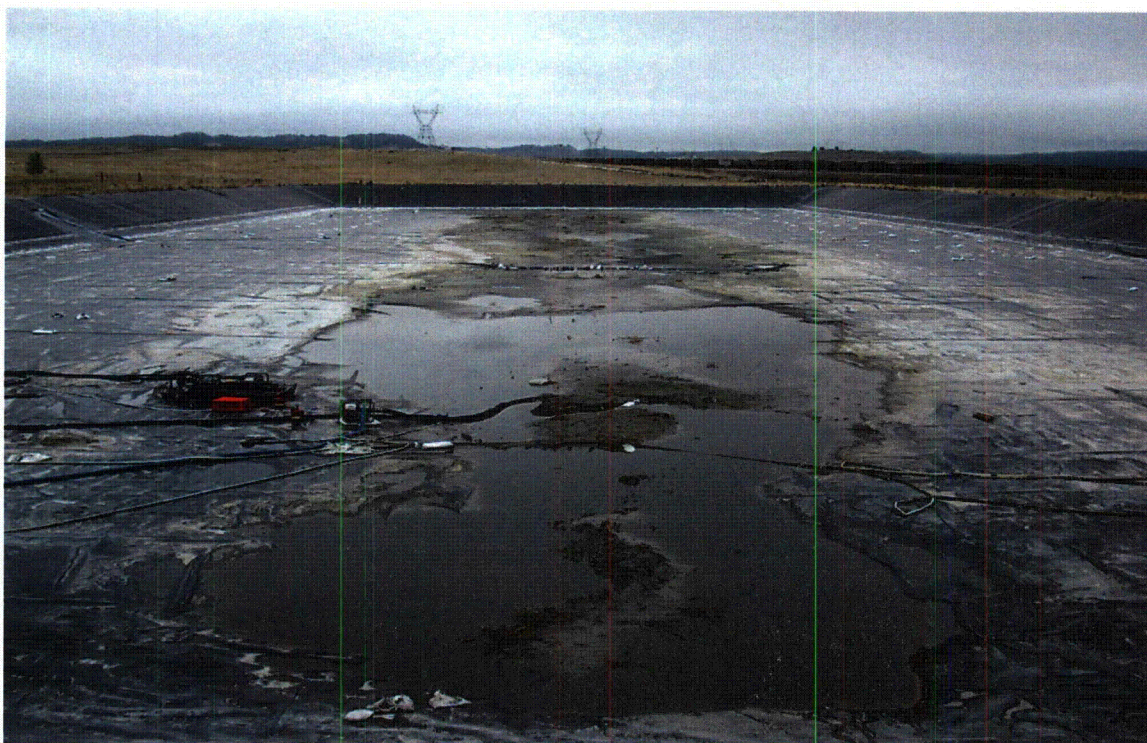
The pond depth of #4 was 0.0 feet leaving about 17.0 feet of additional storage. They were washing the residual pond sediments to the north end. Near the north end, there were mud pumps transferring Pond #4 sediments into Pond #3. I noticed a water truck in the area which was being used to furnish wash water into Pond #4. Larry Teahon indicated they were planning to have a liner specialist inspect Pond #4's liner to give them recommendation for future use of the liner.

**South view of Pond #4, zero storage depth. Date: 10/03/13**

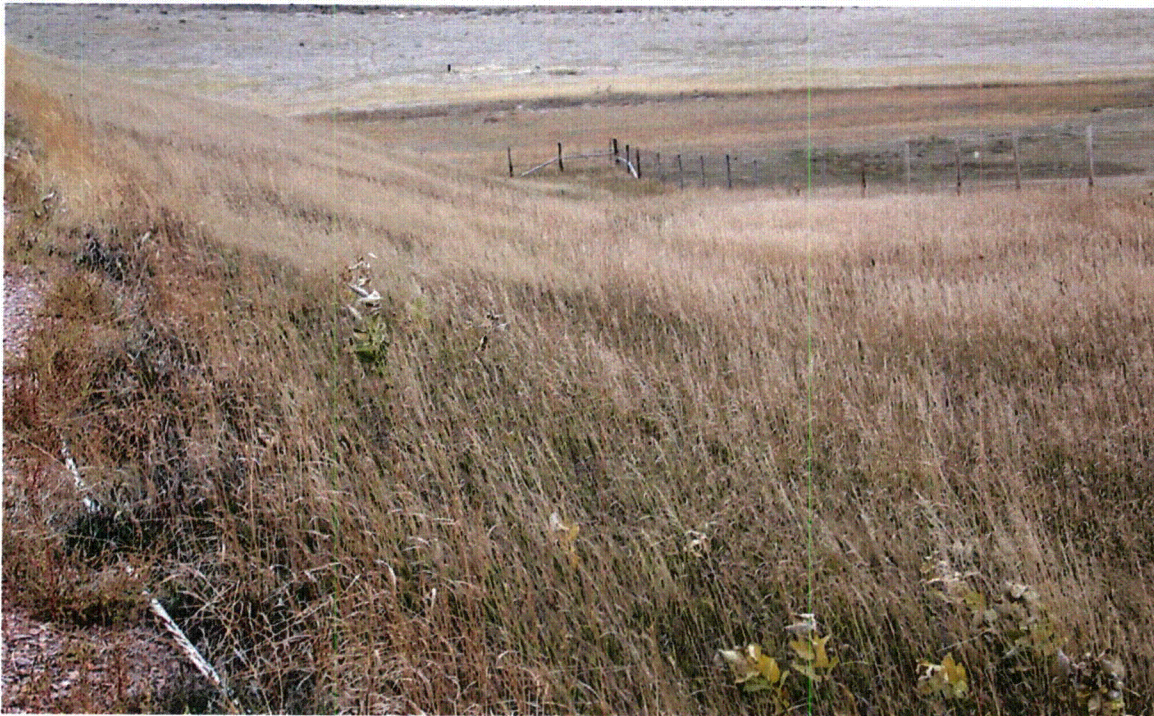
**North embankment of Pond #3 Date: 10/03/13**

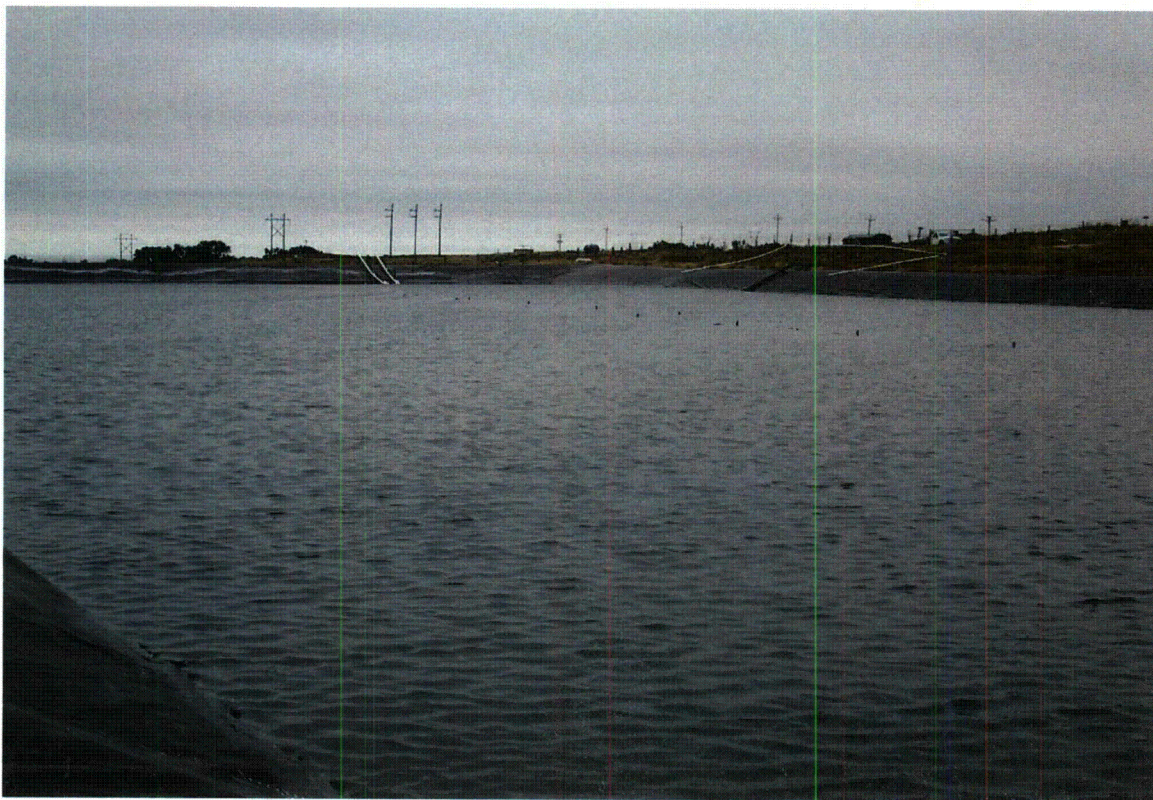
**Northeast view of Pond #3. 10/03/13**

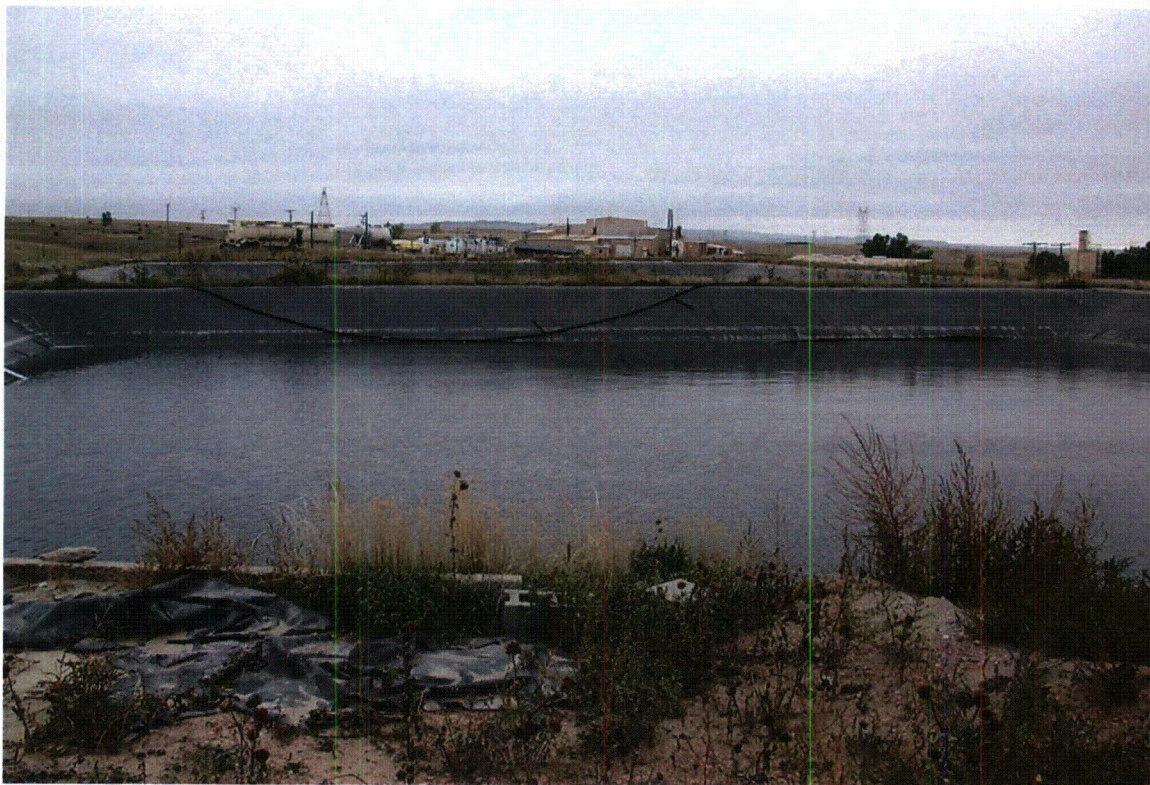
**West view of R&D ponds. Cell #2 (east pond) in foreground. Date: 10/03/13**

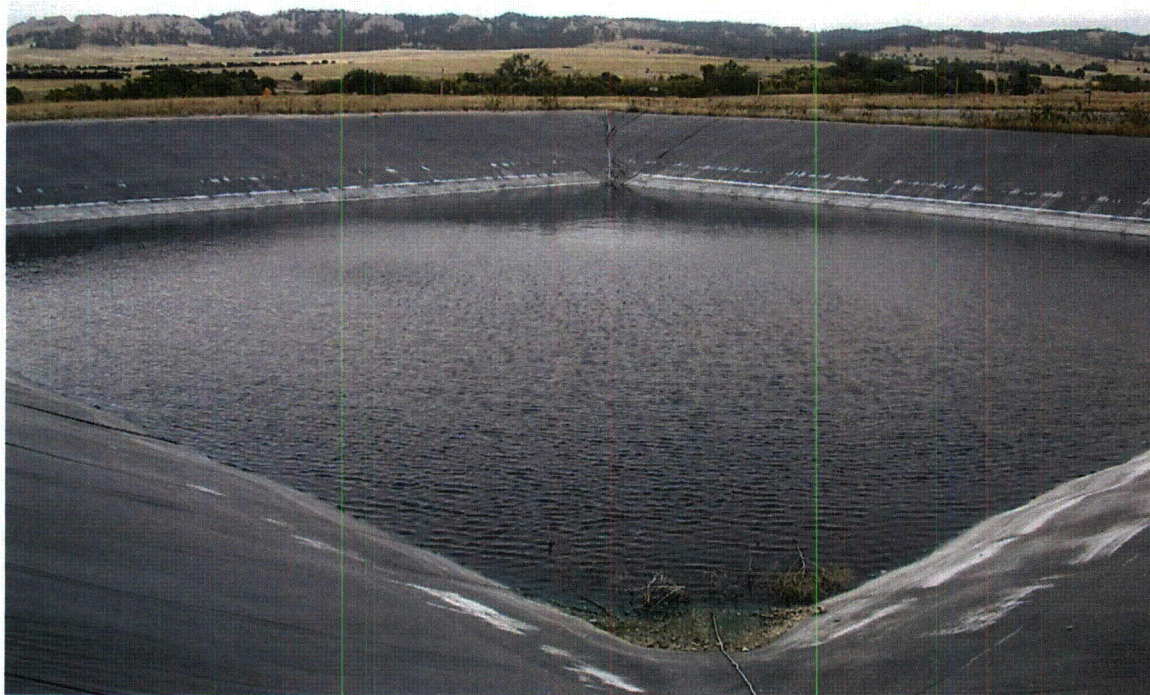
**Northeast view, R & D pond, west cell: Date: 10/03/13**

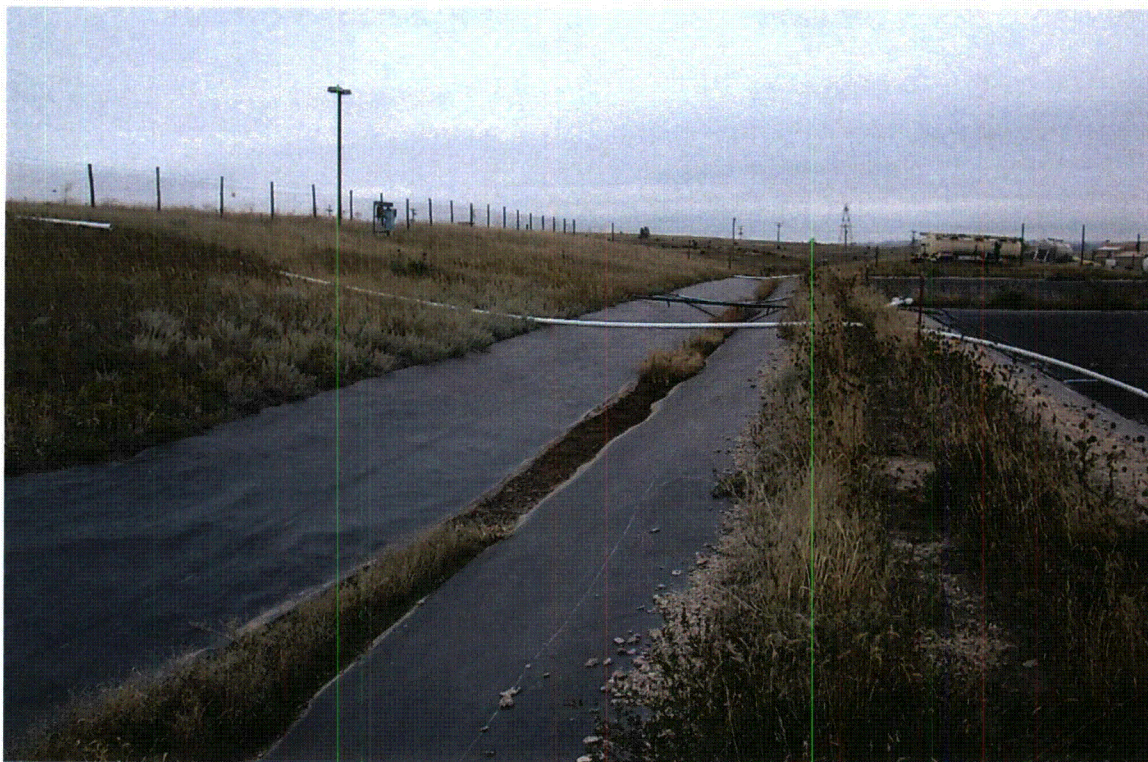
**View of diversion ditch on the south side of the R & D ponds. Photo taken 10/03/13**

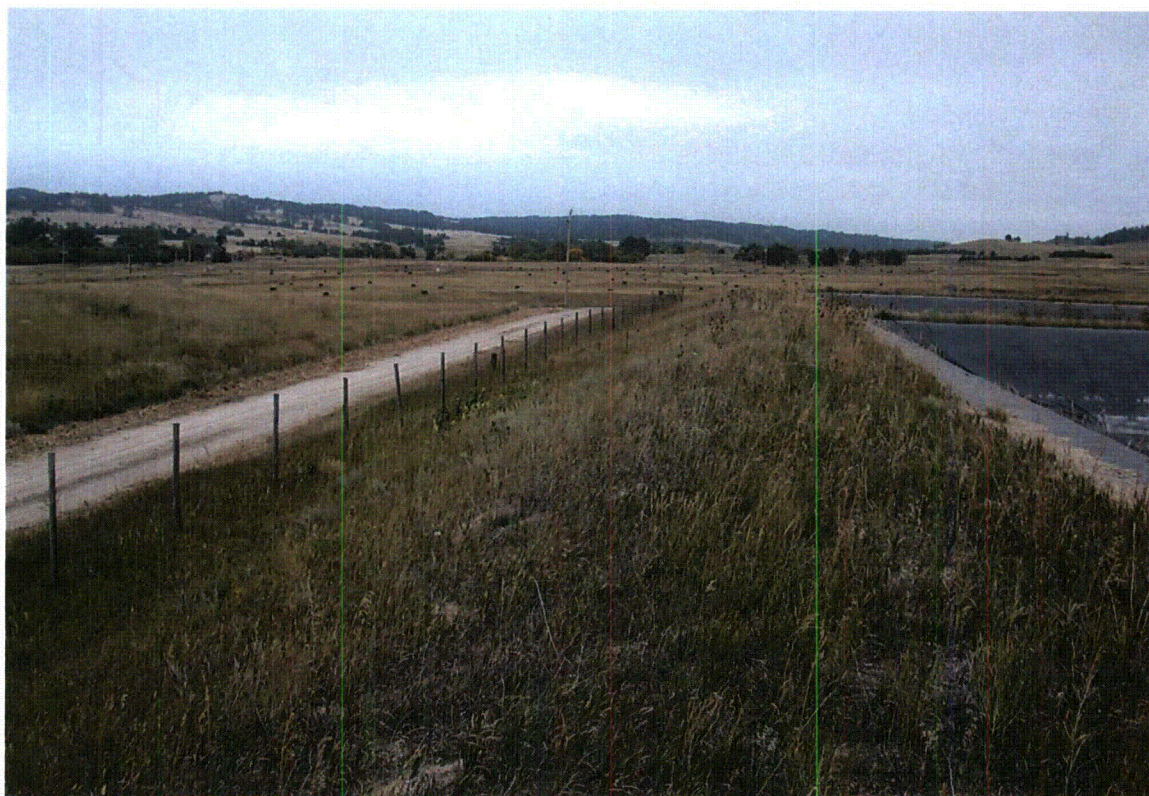
**North embankment slope of R & D ponds; Good vegetation. 10/03/13**
