SAN ONOFRE UNIT 1
LOSS OF SALT WATER COOLING EVENT
ON MARCH 10, 1980

Office for Analysis and Evaluation
of Operational Data

February 1982

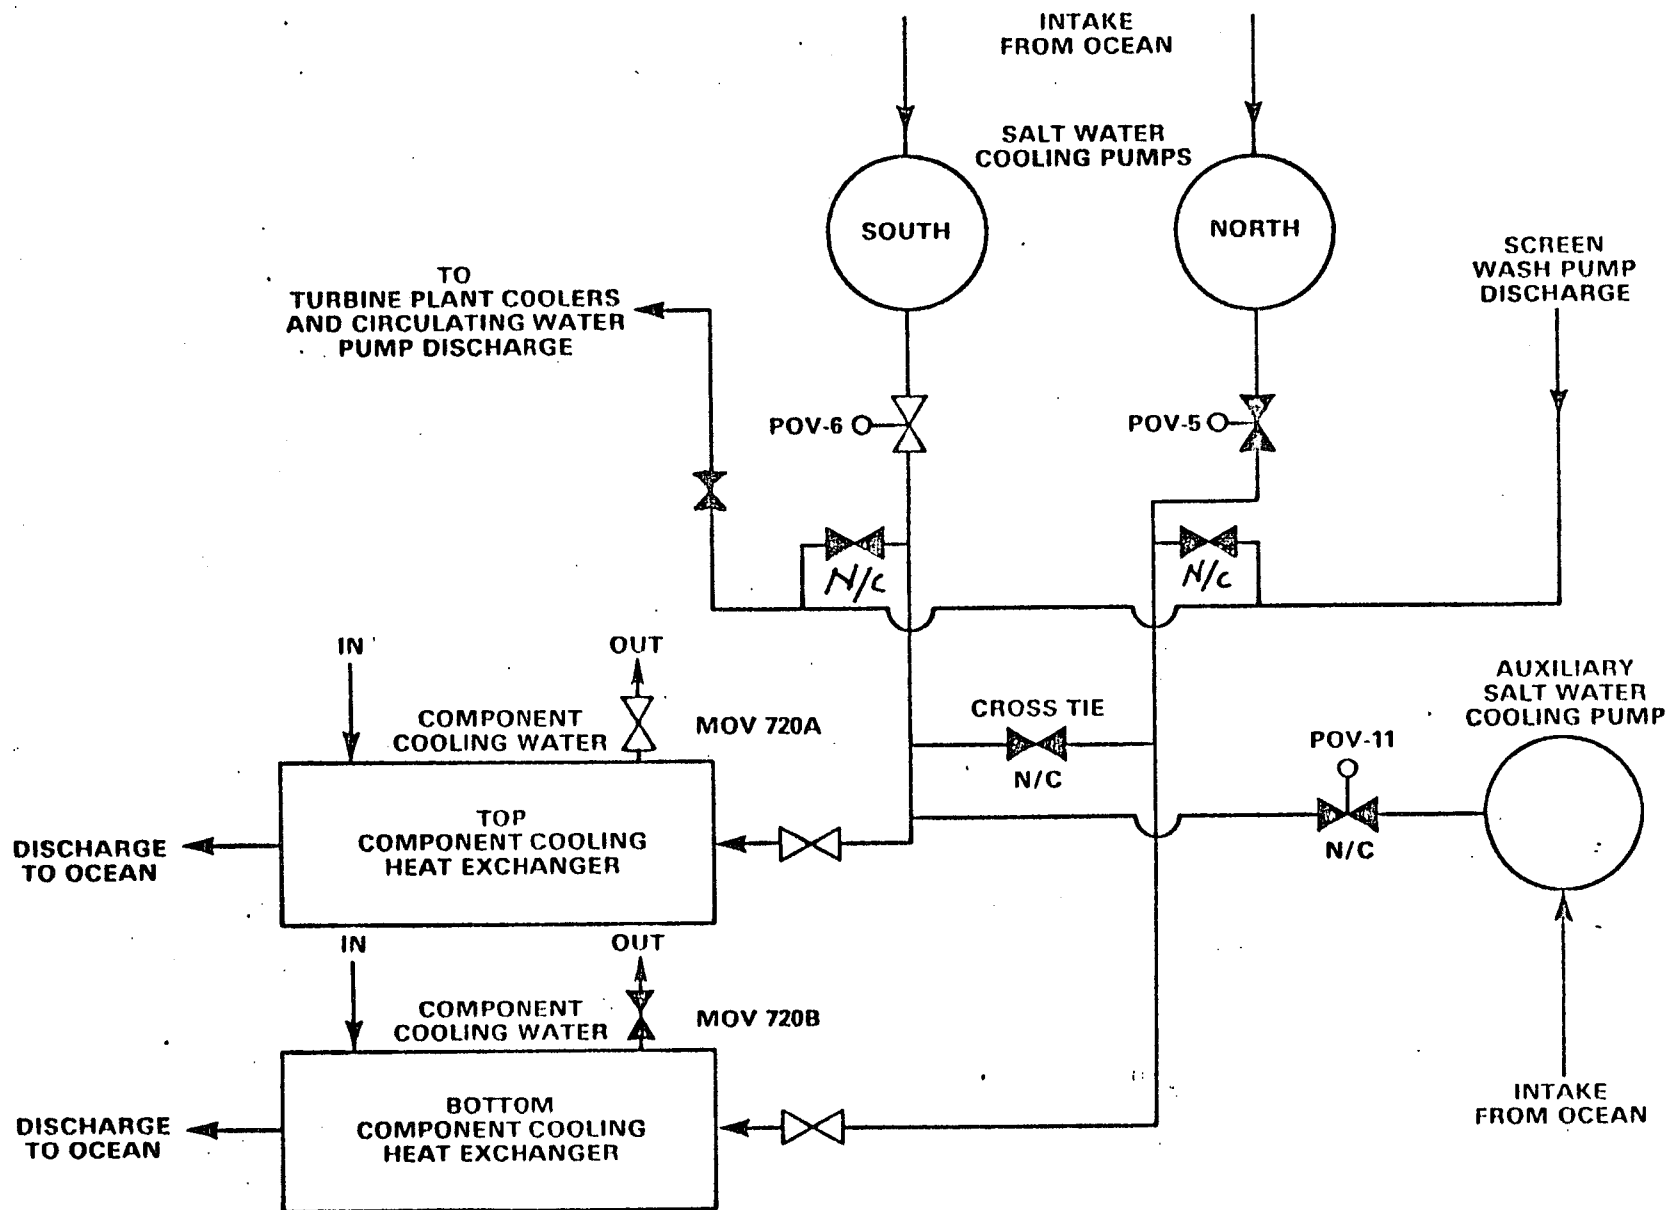
Figure 1 Salt water cooling system.

As shown in Figure 1, in addition to the two (north and south) SWC pumps, the SWC system has an auxiliary SWC pump which serves as a backup and has the same flow capacity (4620 gpm design) as the north and south SWC pumps. The auxiliary SWC pump can be aligned to either CCW heat exchanger. (The auxiliary SWC pump is normally aligned to the top CCW heat exchanger, but can be realigned to the

The SWC pump discharge valves (POV-5 and 6) are double-acting, air-driven, butterfly valves which are supplied instrument air by solenoid valves. There are no check valves in the SWC pump discharge lines; consequently, failure of the idle pump's discharge valve in the open position would allow a reverse flow if the cross-tie valve is open or if the auxiliary SWC pump is in operation.*

* During a visit to the plant on July 8-9, 1981, AEOD learned that the licensee was considering installation of check valves in these lines. The licensee's staff noted that an important feature of the present arrangement is that it minimizes the time during which the salt water cooling pumps experience high starting currents. To date, a final decision has not been made on this modification.

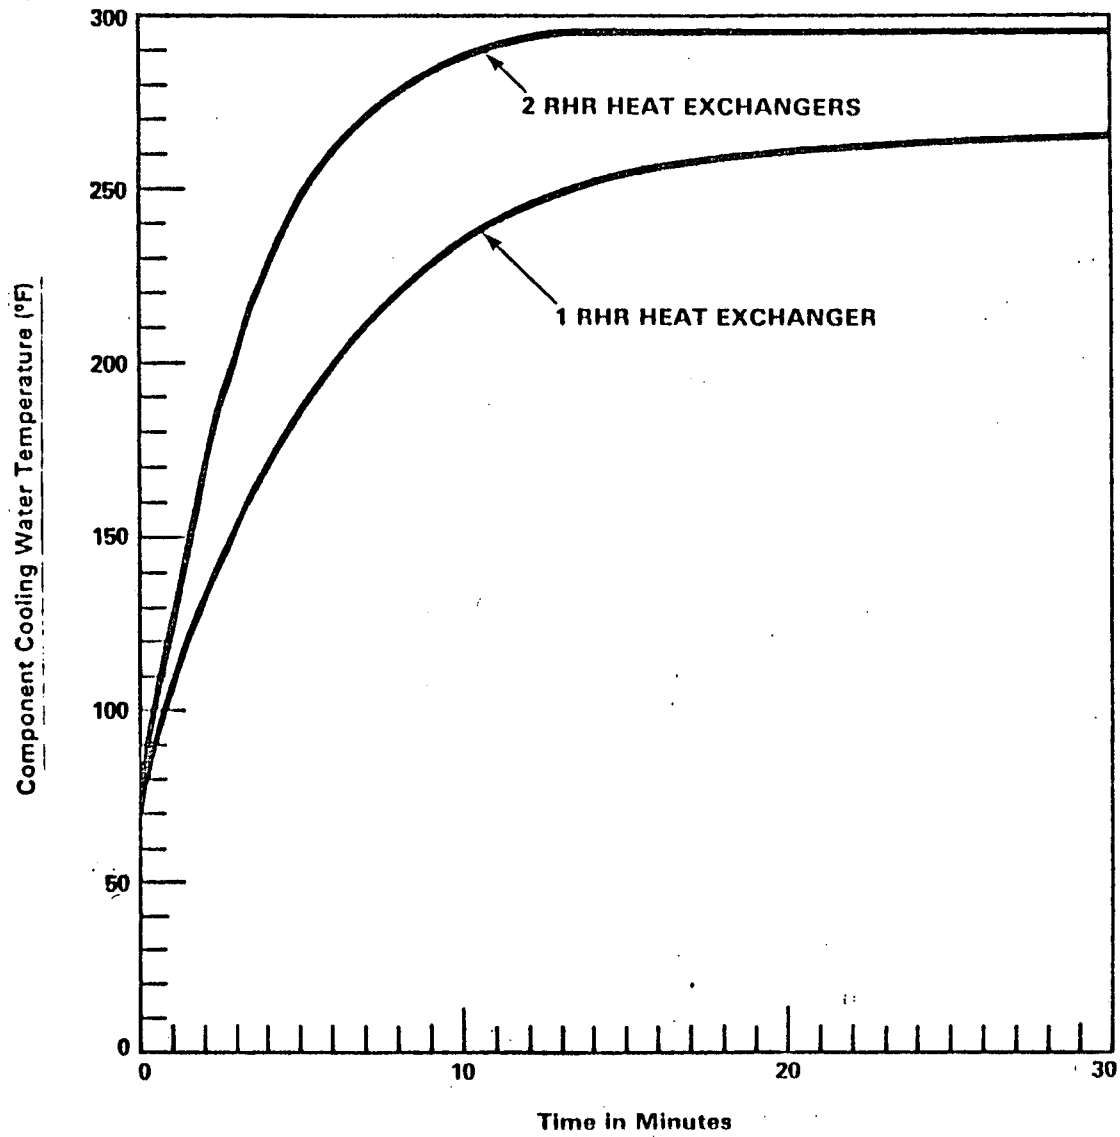
Figure A-1 Component cooling water temperature during a loss of all salt water cooling at the start of RHR cooling.

Based on this information, the modes of operation of greatest concern for loss of the SWC system are when the RHR system is in operation during normal shutdown and during main steamline break accident conditions. In accordance with NRC's request (Ref. A-4) the licensee performed scoping analyses of plant performance with degraded salt water cooling under accident conditions (Ref. A-5). The bottom line of the analyses was that if there is a total loss of salt

water cooling shortly after the plant's RHR system is actuated (for the case of normal shutdown or a main steamline break), the CCW system would reach its limiting temperature of 200°F within three to six minutes. Temperature plots for the two cases of total loss of salt water cooling appear in Figure A-1.* As seen on this figure for the case of cooldown with two RHR heat exchangers, the CCW would approach 290°F in ten minutes; for the case of cooldown with one RHR heat exchanger, the component cooling water temperature would exceed 230°F in ten minutes. It should be noted that at some point the water in the component cooling water system will begin to boil and release steam through the head tank. An analysis to determine when this would occur was not done; however, CCW temperatures in excess of 230°F are considered physically unlikely.

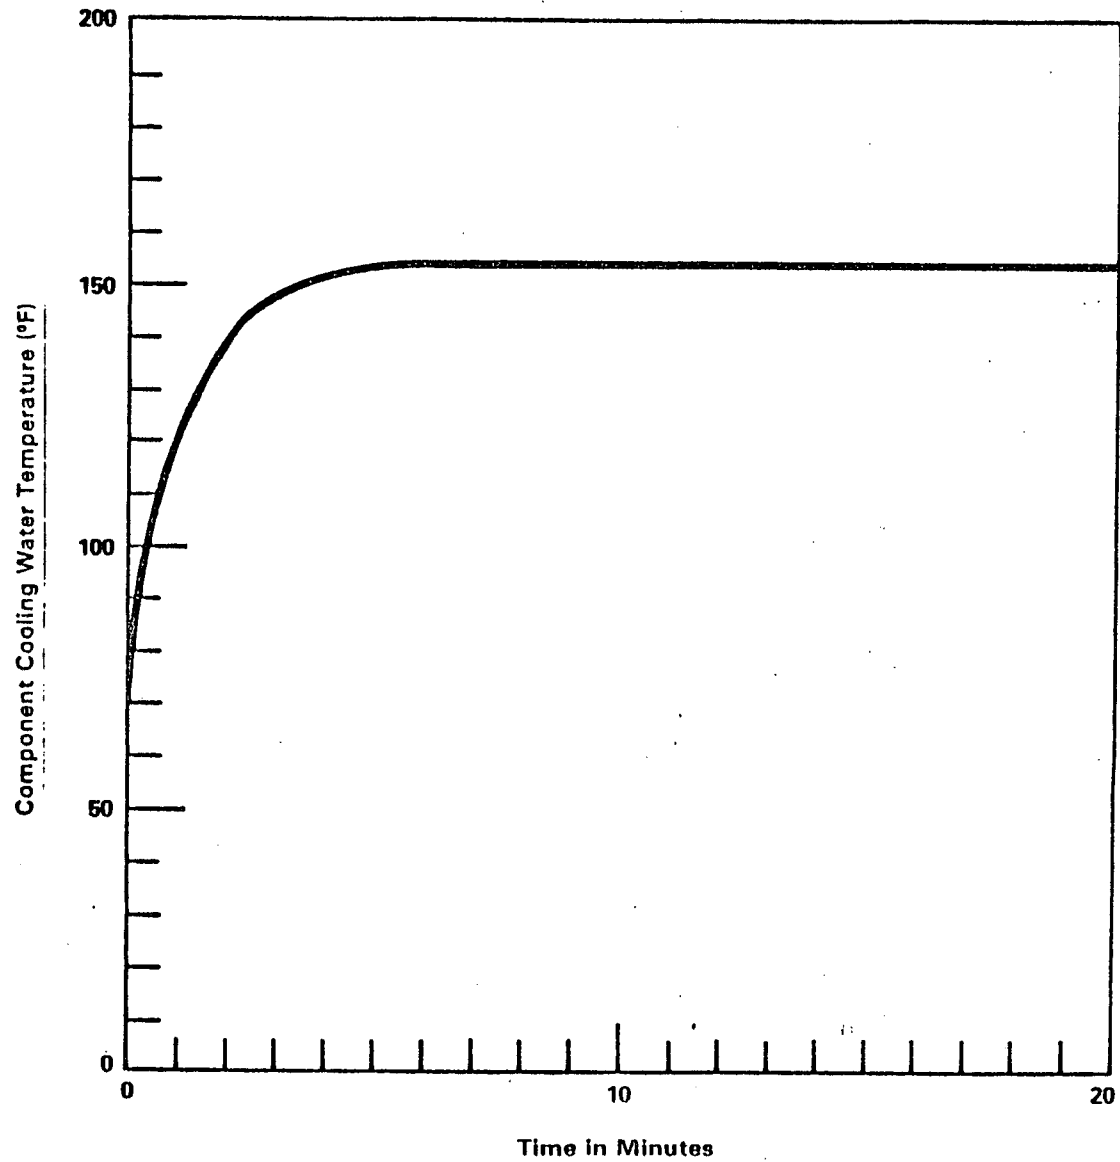
Figure A-2 Component cooling water temperature during a loss of one salt water cooling pump at the start of RHR cooling (2 RHR heat exchangers).

Another case of interest, but which is not as severe, is where one train of salt water cooling is lost shortly after the RHR system is actuated (with two RHR heat exchangers in operation). Results for this case appear in Figure A-2 and indicate that the CCW system reaches a maximum temperature of 150°F in about four minutes and stabilizes thereafter. It is not known how long the plant can sustain this temperature without equipment damage; nonetheless, operator action could be taken to decrease the heat load to the CCW system* and thus decrease its temperature to more acceptable levels.

* Decrease the plant shutdown rate, or initiate heat removal through the steam generator(s).

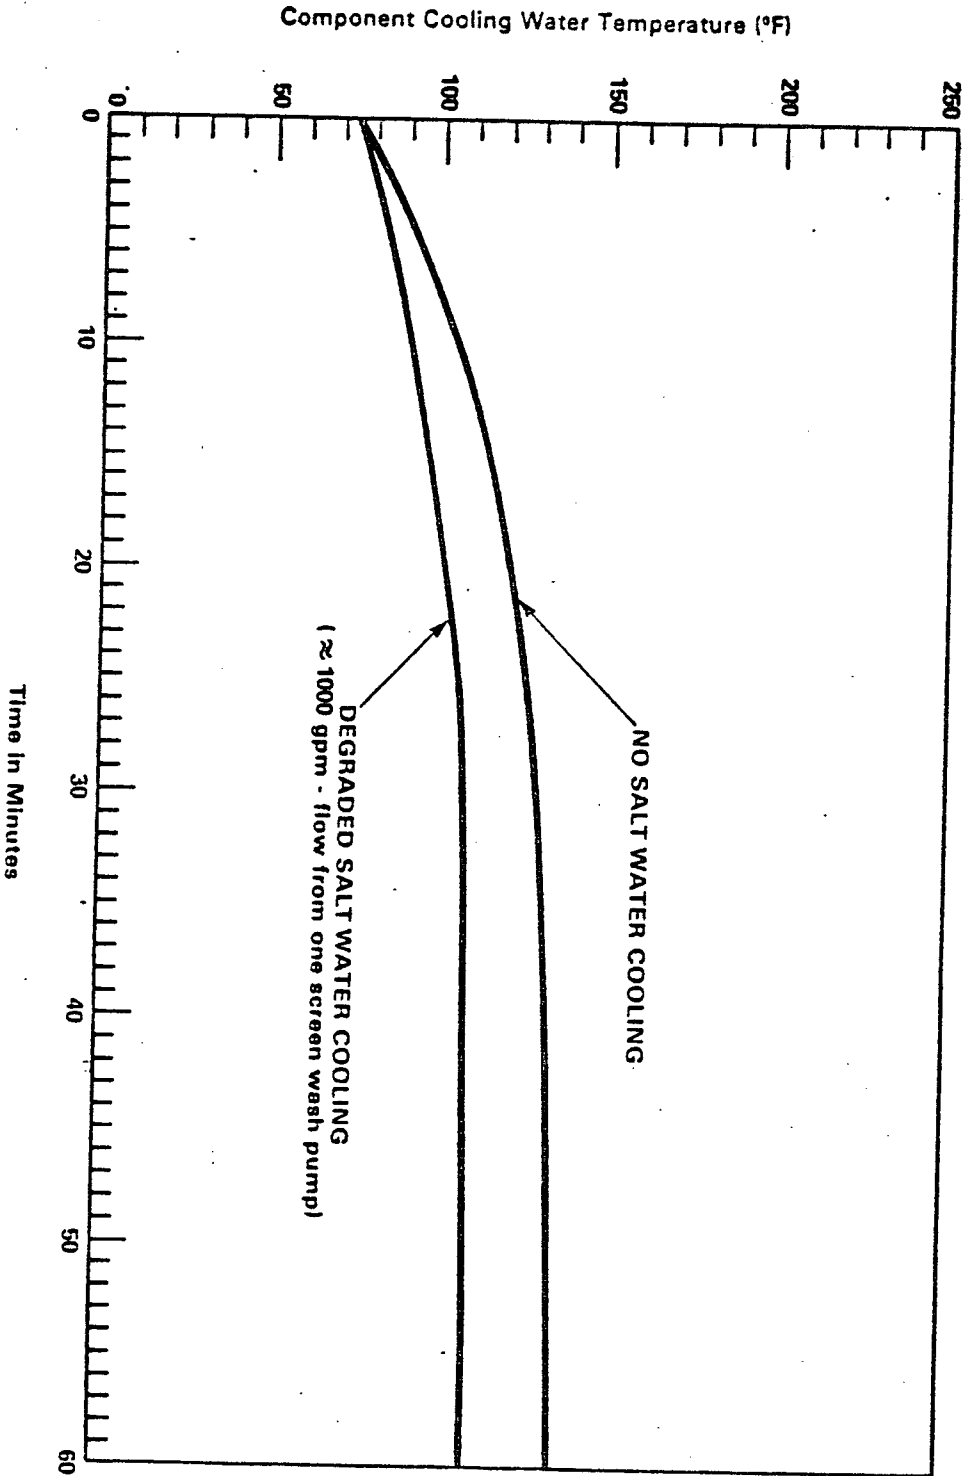
Figure A-3 Component cooling water temperature during a LOCA with degraded salt water cooling.

- Two additional cases of interest that were calculated included a large LOCA with no salt water cooling and a large LOCA with 1000 gpm salt water cooling (corresponding to the flow of one screen wash pump). The results of these analyses (Figure A-3) showed that for a LOCA the loss of salt water cooling does not result in significant consequences; i.e., for a large LOCA with no salt water cooling, the CCW temperature reaches 120°F in 20 minutes and levels off at 130°F in about one hour. For the LOCA with one screen wash pump operational, the maximum CCW temperature levels off at about 95°F in about 25 minutes.

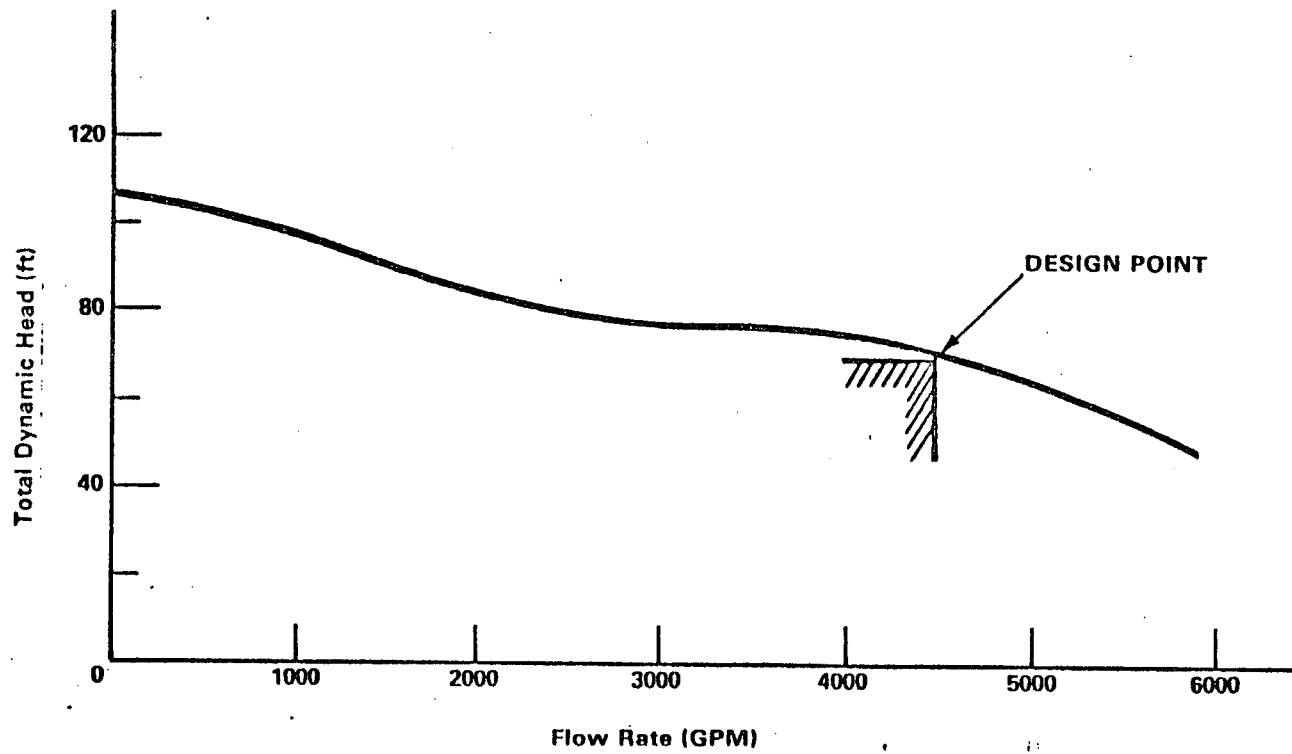
Figure C-1 Salt water cooling pump performance curve.

As noted in Appendix C, the IST data for flow and ΔP for the SWC pumps can be subject to large errors because ΔP is obtained from tide height (for many tests reference elevation was included incorrectly), and because the SWC pump performance curve is very flat in the range where the inservice testing is performed (250 gpm/ft of head).

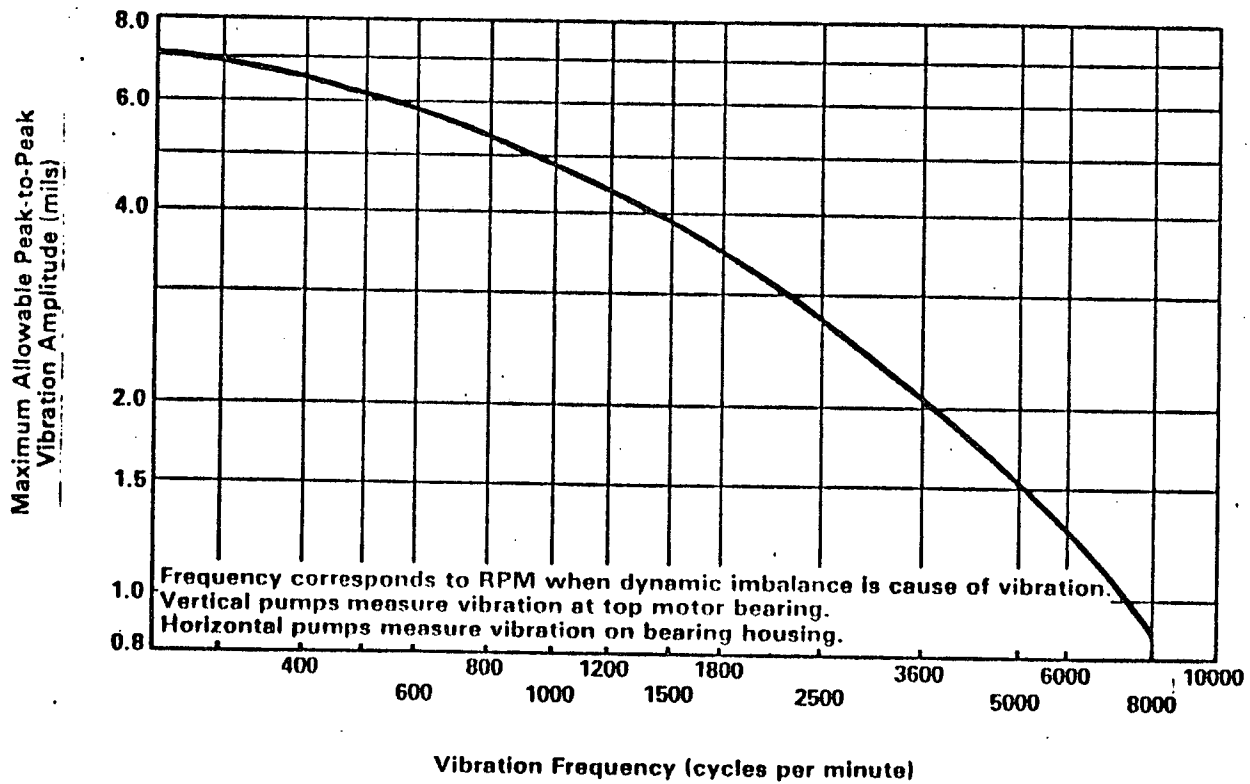
Figure C-2 Hydraulic Institute curve for pump shaft vibration testing.

While it is true that the bearings in the pump are water cooled and not directly accessible for measurement, it is also recognized that degrading bearing conditions frequently result in excessive shaft vibration which, in turn, is transmitted to the thrust bearing at the top of the drive motor.

As part of the IST Program, the licensee measures vibration of the thrust bearing at the top of the drive motor. This data is used in accordance with ASME section XI IST requirements to determine when the pump shaft requires investigation and/or corrective action. The Hydraulic Institute's Standard Curve (see figure C-2), the "General Machinery Vibration Severity Chart" (Ref C-13), and other similar references are used as guides to determine acceptable vibration levels.

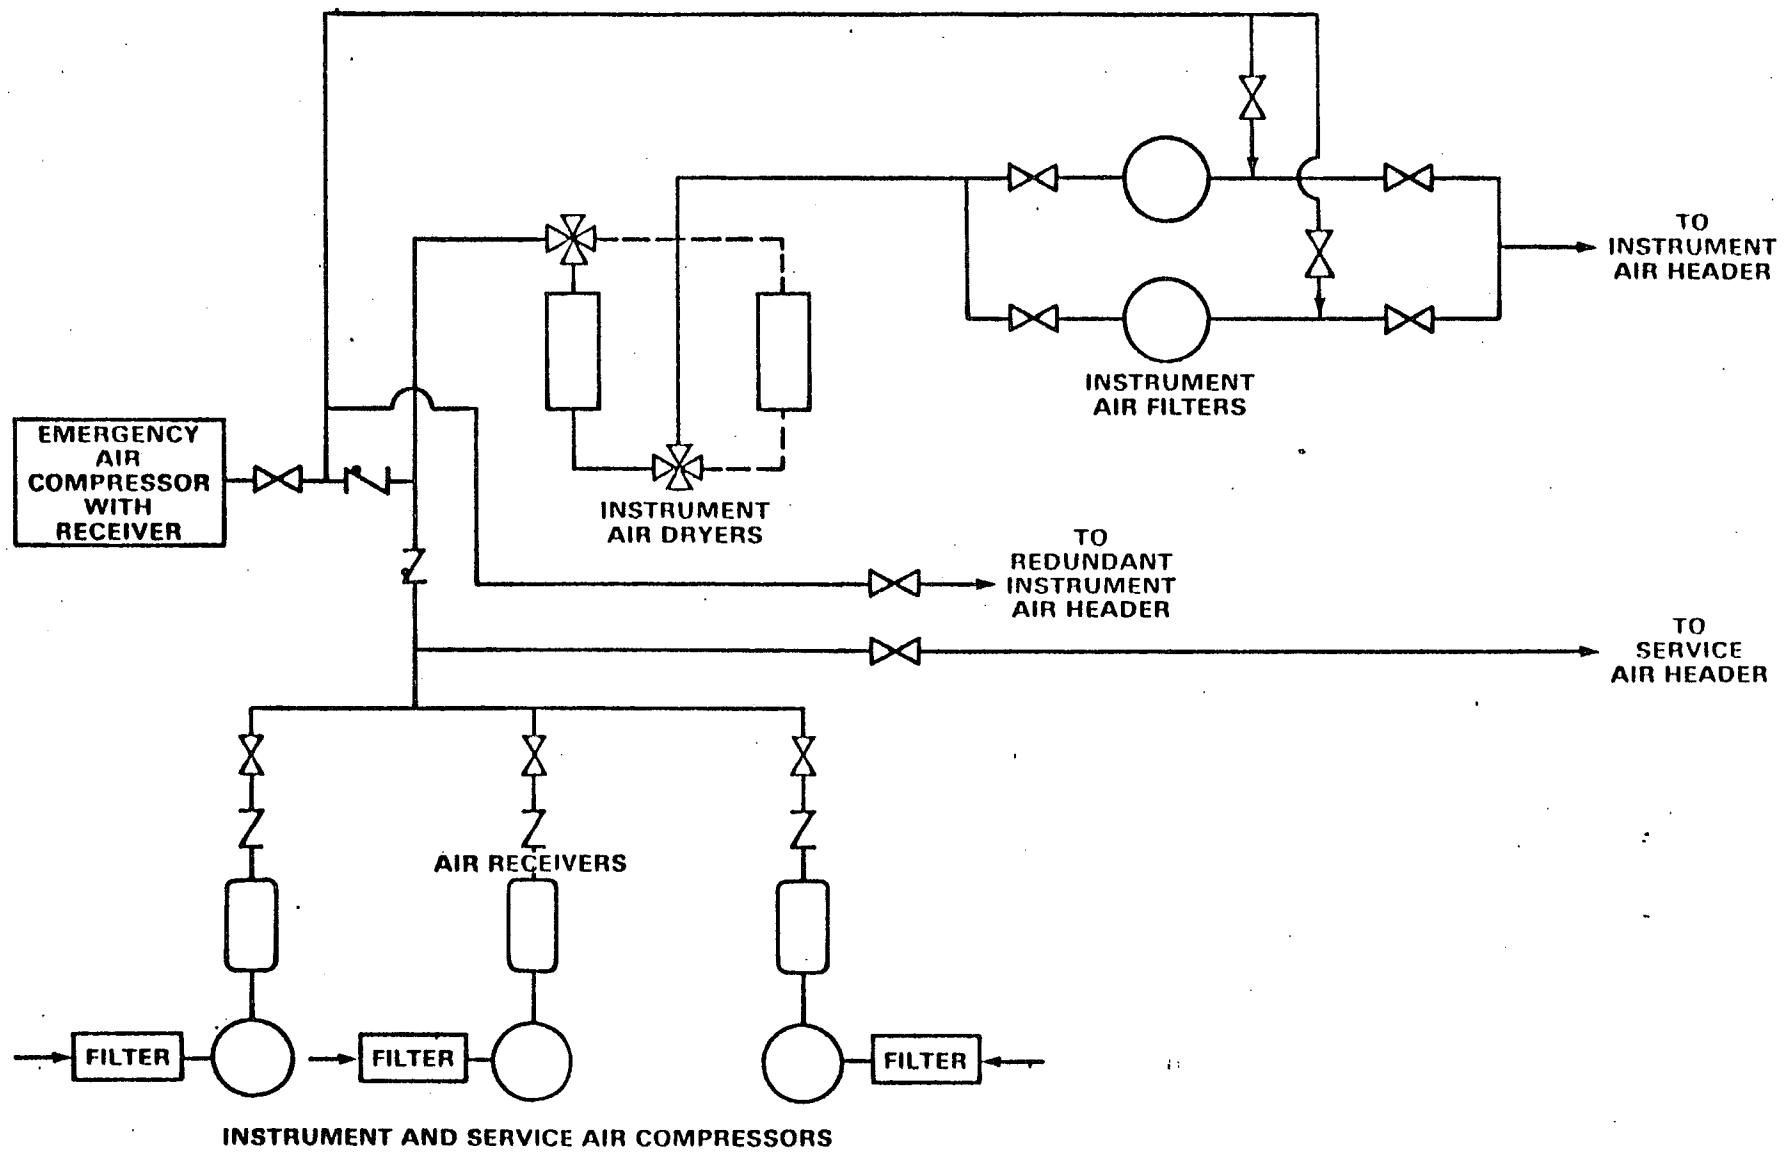
Figure D-1 Schematic diagram of the compressed air system.

As noted in Appendix D, instrument air which is provided by the emergency air compressor is not necessarily filtered. Such operation may pose a common cause failure potential for much safety-related equipment. The issue of contamination of both trains of safety-related equipment caused by the emergency air supply has been discussed with the licensee. We are presently unaware of any plans for corrective action.

The air dryers, through which instrument air is routed, are vertical tanks containing silica gel desiccant material in bulk form. It is believed that, due to the prolonged use between replacement of the air dryers at San Onofre, the desiccant broke down into small fragments (Ref. D-1). Some of the fragments

migrated from the tanks to the filters downstream. These filters, which also contained desiccant in bags, were initially effective in removing the small desiccant fragments from the air. However, the desiccant fragments gradually coated the filters, thereby increasing the pressure drop across the filters. This increased pressure drop caused increased bypass flow around the filters, and the small desiccant fragments eventually appeared downstream. Desiccant fragments then migrated throughout the instrument air system to areas inside containment, the auxiliary building, and the intake structure.

- (3) The plant's entire instrument air system has been blown down. New desiccant has been installed, as has a new air filtration system including instrumentation to measure the pressure drop across the filters. The licensee's preventive maintenance program will address the condition of the desiccant.
