NSIC-201

REVIEW OF THE OPERATING EXPERIENCE HISTORY
OF SAN ONOFRE 1 THROUGH 1980 FOR THE
NUCLEAR REGULATORY COMMISSION'S
SYSTEMATIC EVALUATION PROGRAM

M. L. Casada, JBF Associates, Inc.
A. B. Crawford, ORNL/NSIC
K. H. Harrington, JBF Associates, Inc.
G. T. Mays, ORNL/NSIC

May 1982

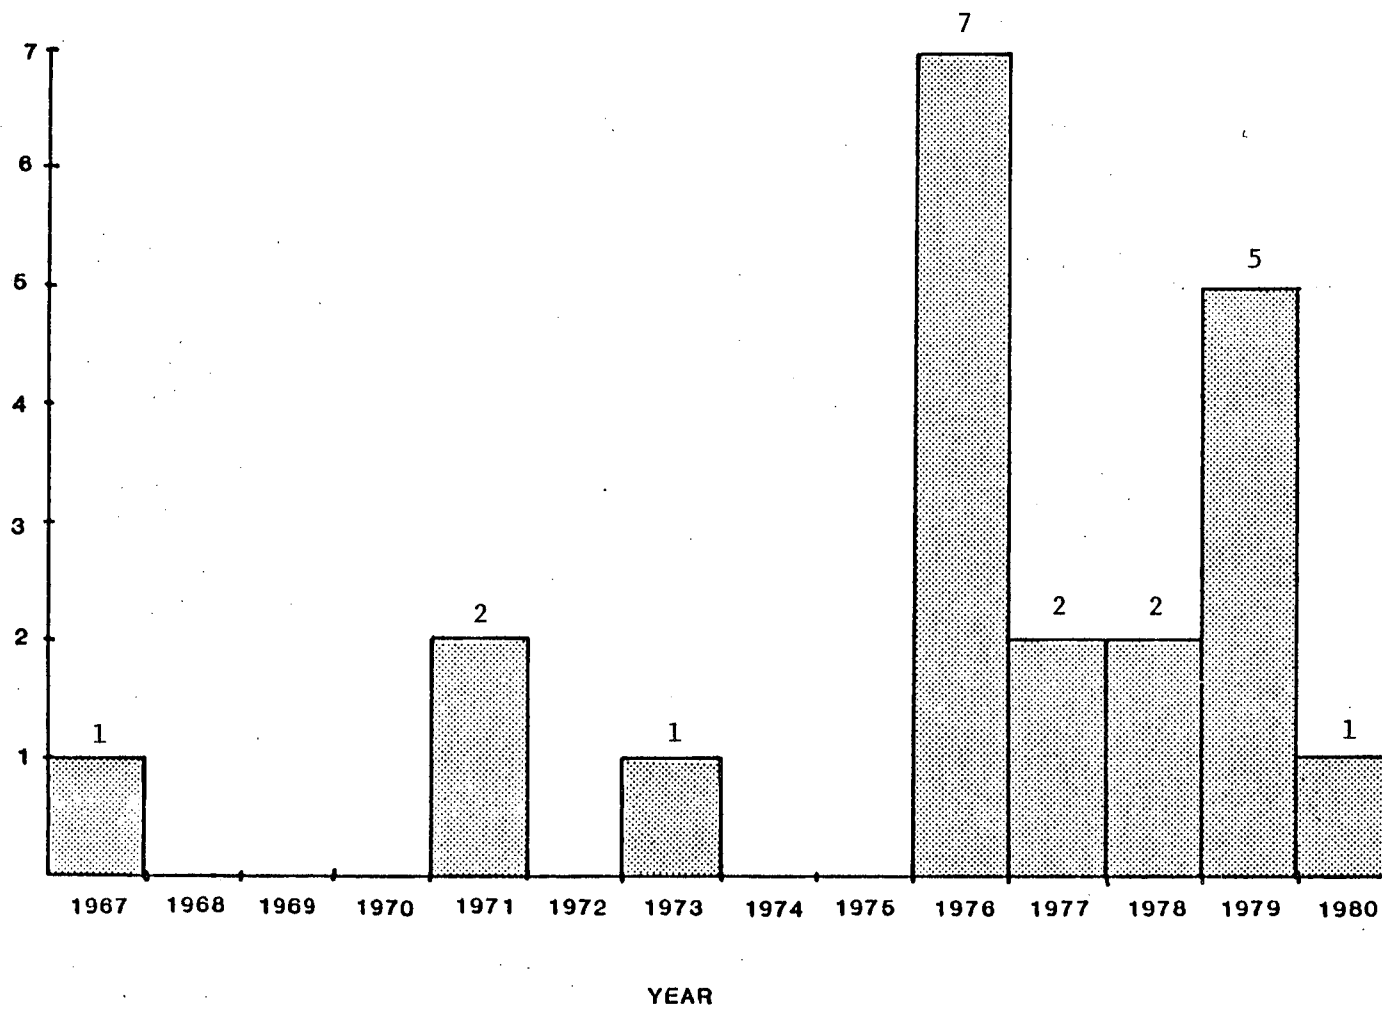
Figure 4.2 Number of Condenser Tube Leakage Events

The first power reduction because of condenser tube leaks did not occur until 1976. However, as Fig. 4.2 indicates, condenser leaks caused recurring power reductions through 1980. Power reductions to repair condenser tubes occurred on January 8, January 26, January 29, February 6,

March 23, March 29, and July 2, 1976; July 1 and July 2, 1977; March 2, and June 9, 1978; February 23, August 30, September 7, November 29, November 30, and December 2, 1979; and February 17, 1980.

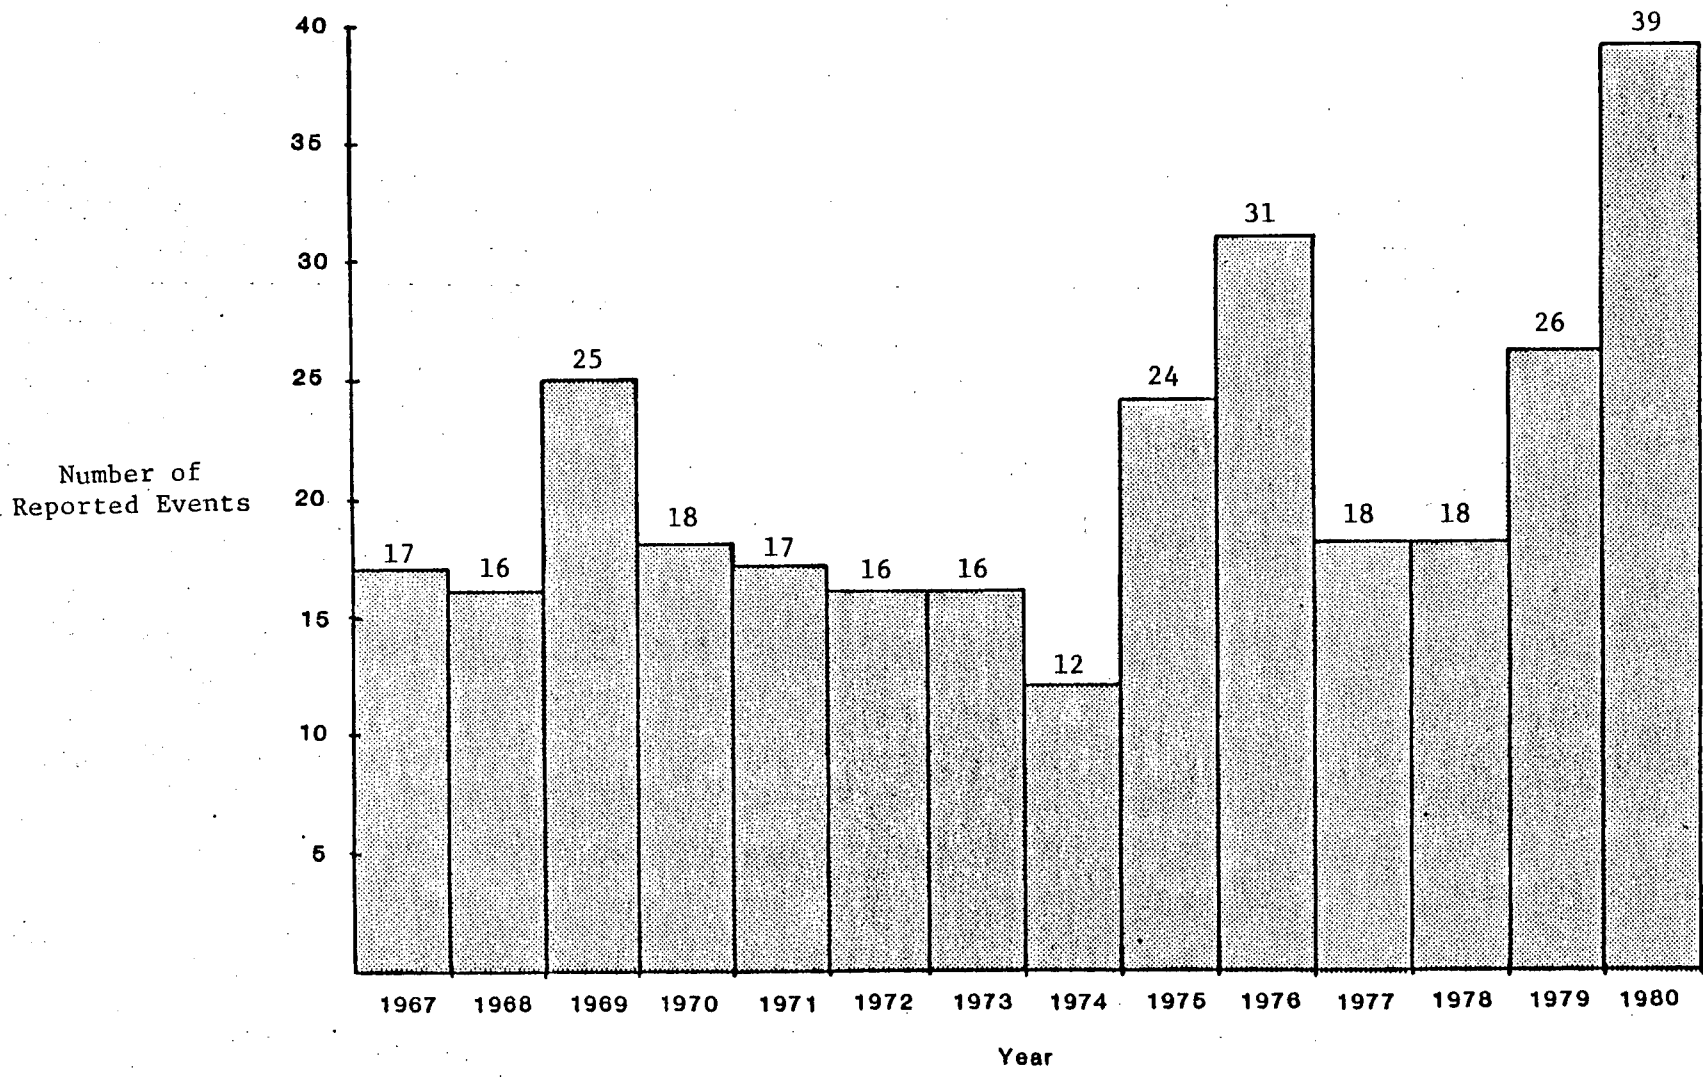
Figure 4.3 Number of Reported Events Per Year at San Onofre 1

San Onofre's initial criticality occurred in June 1967. This analysis examined 17 events that were reported during 1967. Two of those events are considered significant, one involving failure of both safety injection pumps and the second a spill of radioactive water from the rad-waste system. The first significant event occurred two weeks prior to initial criticality. Both safety injection pumps were declared inoperable

when they failed megger tests. This common cause failure is discussed in Sect. 4.5.2.1. The second event involved the overflow of a radwaste tank due to operator error and is described in Sect. 4.5.1.4.

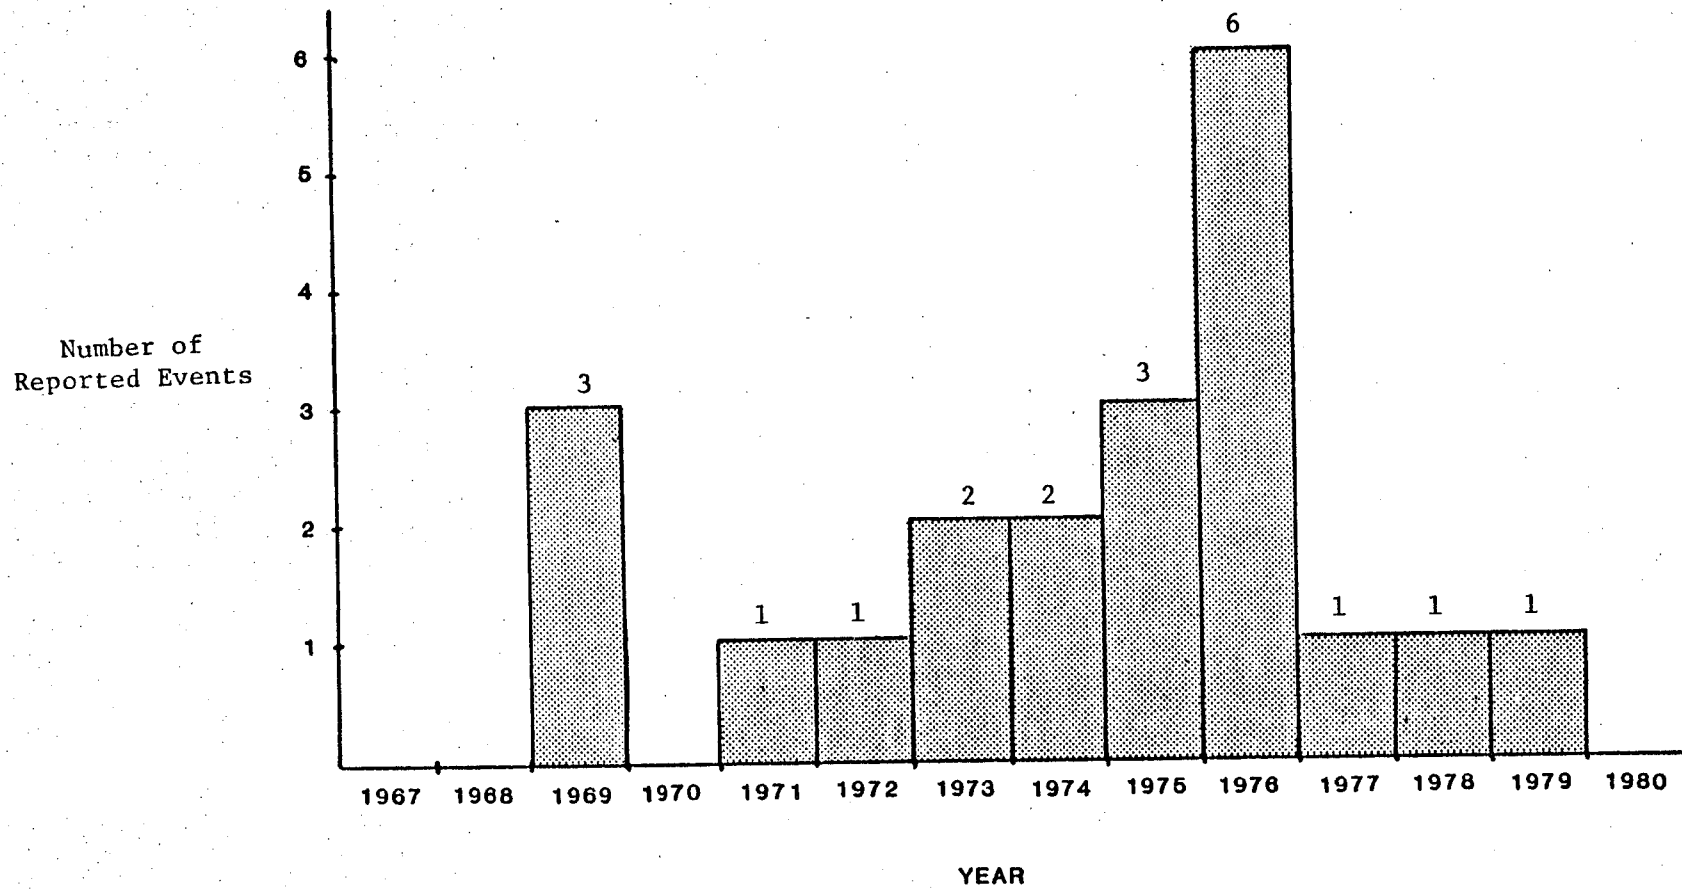
Figure 4.4 Number of Partial Vital Power Losses

On December 18, 1969, the failure of No. 2 vital bus inverter initiated a turbine runback. The inverter failure was triggered by a failed power switch in the control rod position recorder. The unit resumed 450 MW(e) operation the same day.

The No. 4 inverter failed on March 23, 1971, indicating a dropped rod. Investigation revealed a shorted capacitor in the transformer circuit. The capacitor was replaced and inverter No. 4 returned to operation.

The No. 3 vital bus transferred from the No. 3 inverter to its emergency power source on December 9, 1972. The transfer caused a momentary power loss to nuclear instrumentation channel 1207 leading to a nuclear dropped rod indication. Investigation revealed that the inverter low voltage power supply had failed.
