ADDENDUM 2 TO REPORT ON

SOIL BACKFILL CONDITIONS

SAN ONOFRE NUCLEAR GENERATING STATION

SEPTEMBER 14, 1983

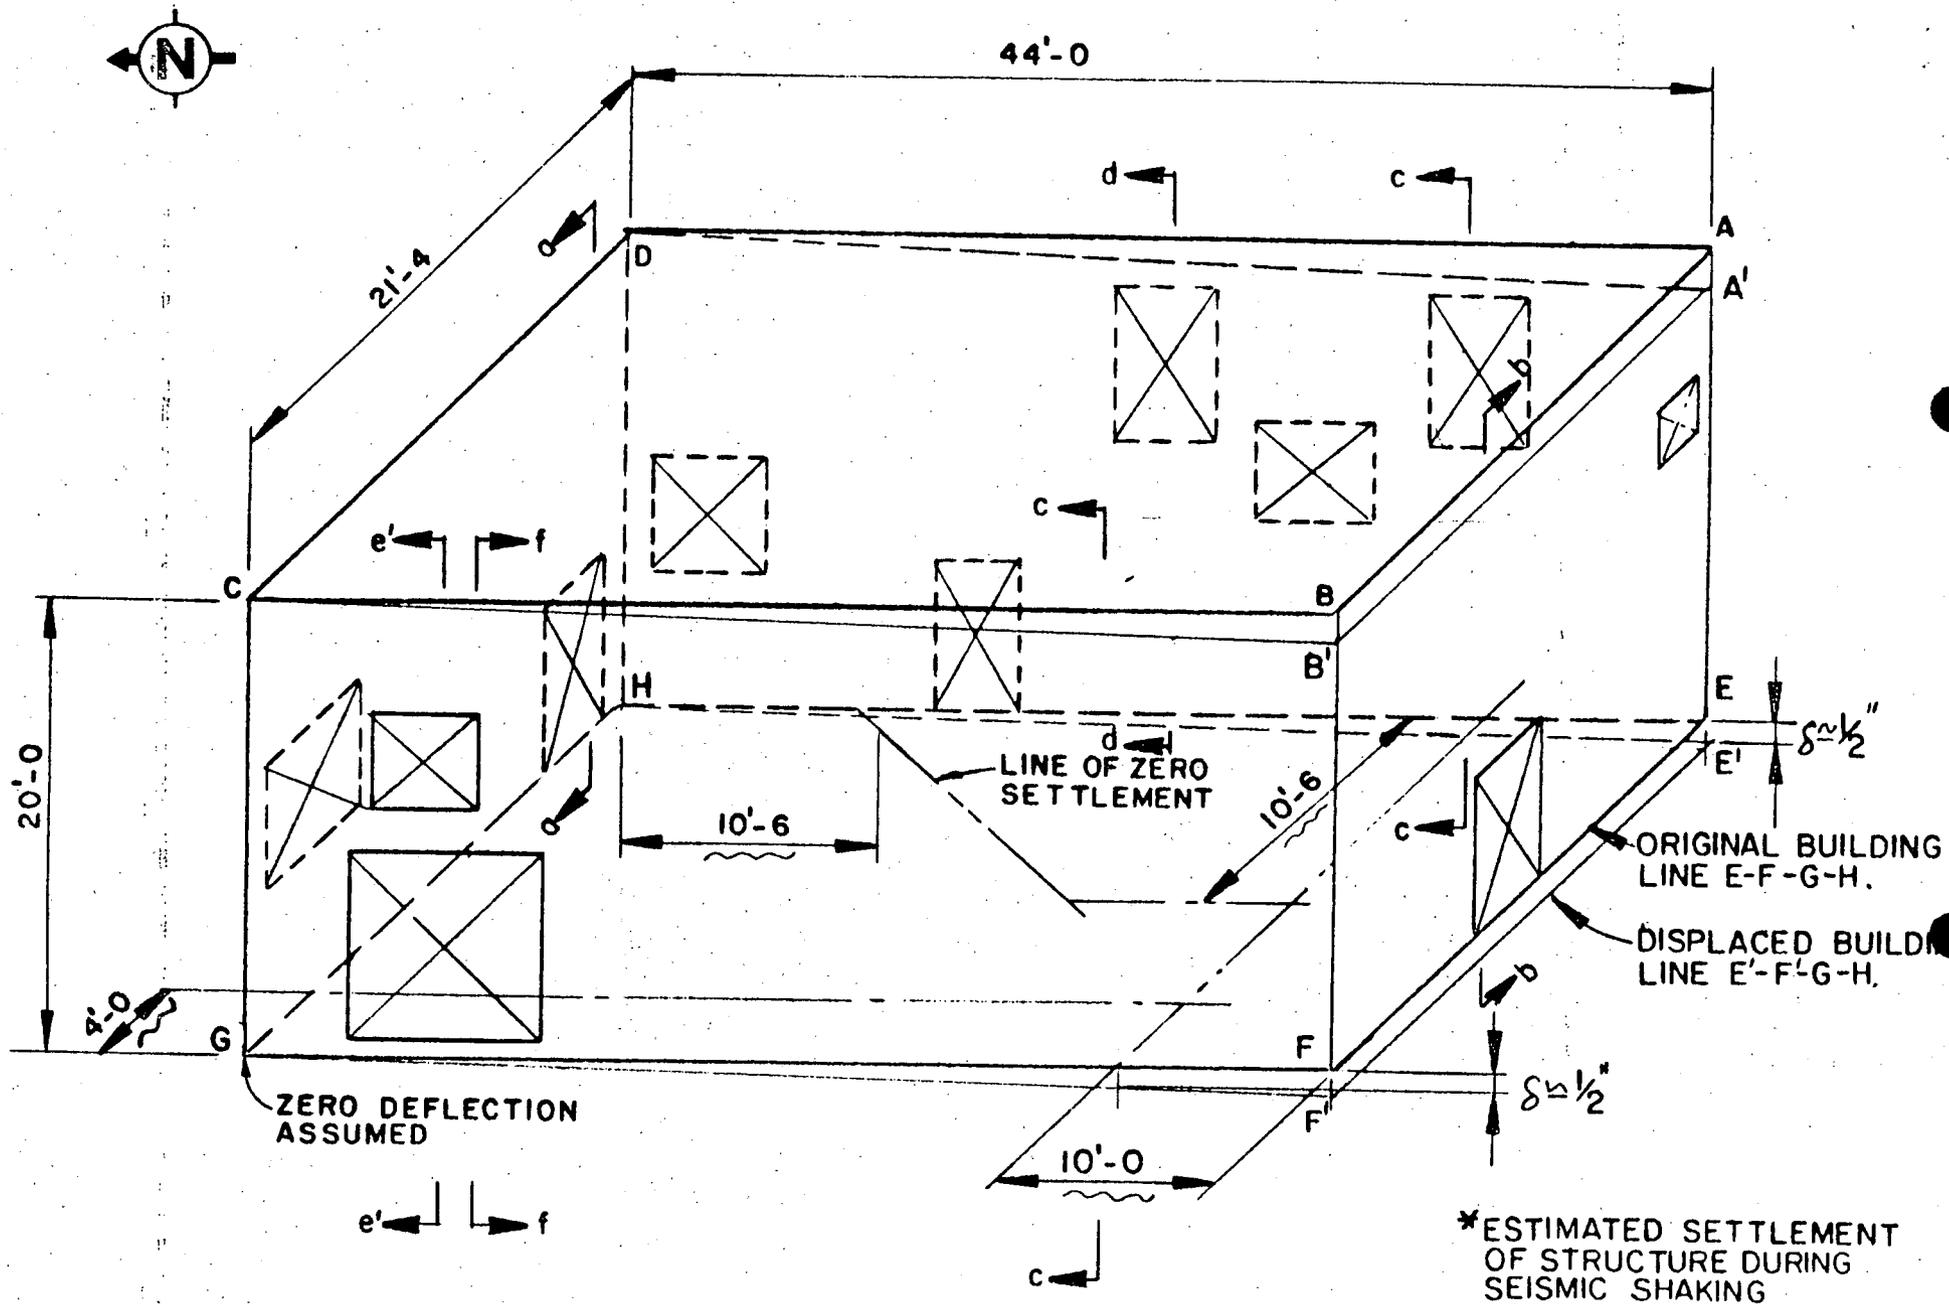
VENT BUILDING ISOMETRIC
 FIGURE I

The response of the structure to the inertial forces generated during a DBE seismic event was evaluated considering the induced settlements in soil backfill. The postulated soil settlement would result in the building tilting southward as a rigid box. For this condition, the analysis conservatively assumed a loss of soil support for the south wall and portions of the east and west walls (Figure 1). A comparison of building stresses during the DBE to allowable stresses and ultimate stresses is given in Table 1. This evaluation shows that for this condition flexural stresses in the floor slab and shear stresses in the walls exceed the allowable stresses given by the BOPSSR criteria (Reference 3). The table also shows that even though the values of calculated shear stresses in the walls exceed BOPSSR allowables, they are less than the ultimate capacity stresses.

The stresses induced by the postulated post-seismic soil settlement beneath portions of the east and west walls and the entire south wall of the structure have also been evaluated. The evaluation considered the building's east and west walls acting as cantilevered deep beams with the southern most 10 feet of the structure completely unsupported. Only the dead load of the structure was considered in this post-seismic settlement analysis. A summary of stresses for this evaluation is shown in Table 2. This post-seismic condition results in a less severe state of stress in the structure than the during-seismic condition previously described. The moments developed in the floor slab exceed the allowable while shear stresses in the walls do not.

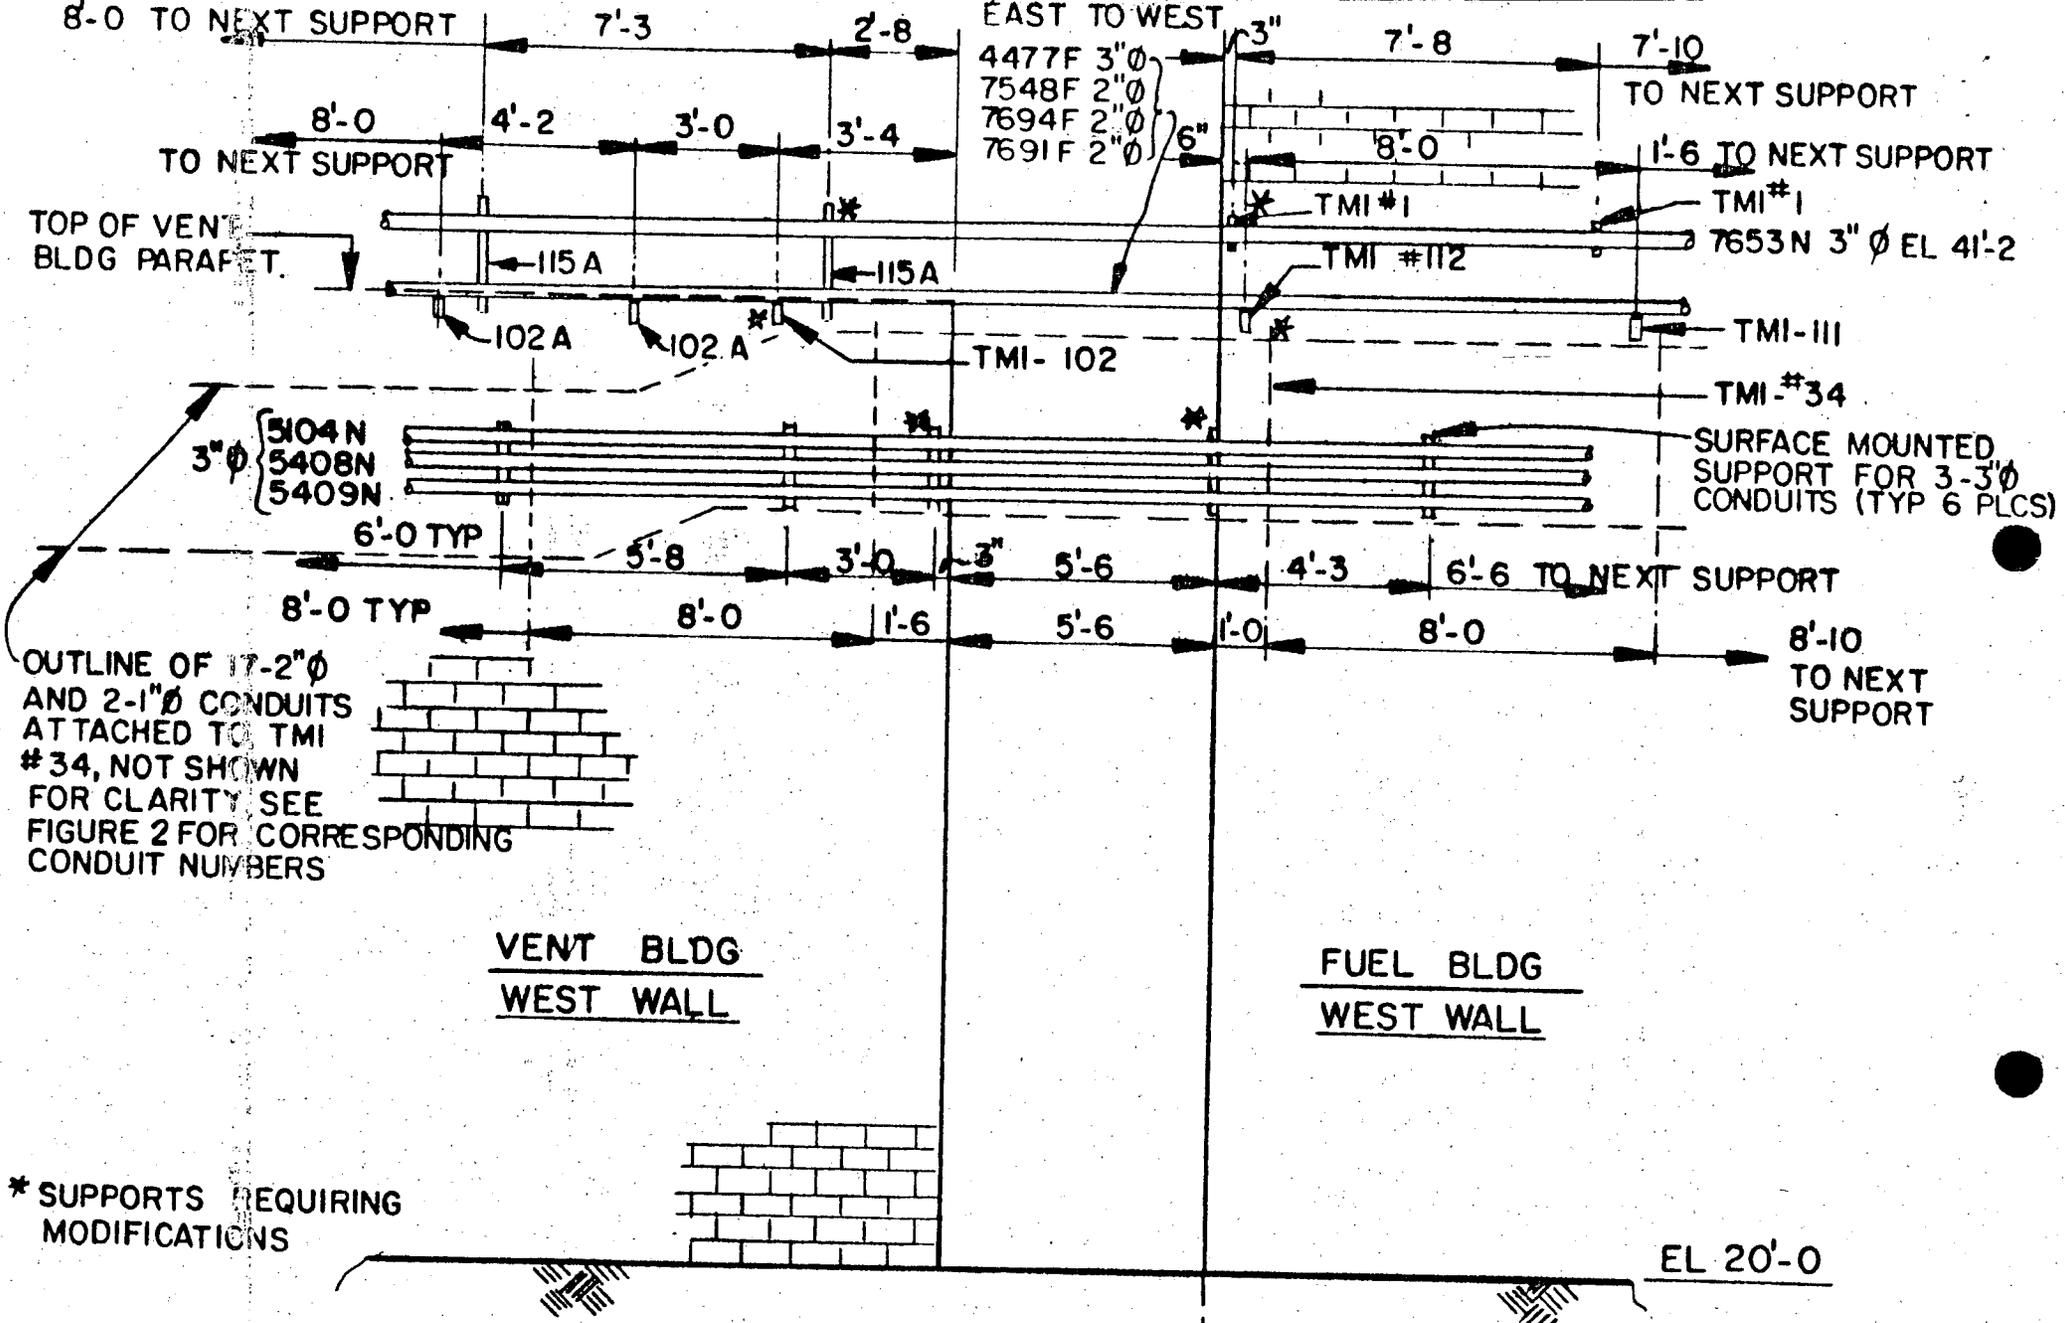
THE CONDUIT SUPPORTS REQUIRING MODIFICATIONS AT THE VENTILATION AND FUEL STORAGE BLDGS.
FIGURE 3

The most severe loading due to differential building settlement will occur in the support for the conduits spanning between the southwest corner of the Ventilation Equipment Building and the northwest corner of the Fuel Storage Building. A total of 27 conduits span between these two structures. Seventeen 2 inch and two 1 inch diameter conduits span 8 feet between adjacent supports at this location. These conduits are shown in Figure 2. During a DBE, under the worst case loading, the 1/2"φ, A307 through bolts anchoring the support for these conduits would experience loads of 755 lbs per bolt in tension and 535 lbs per bolt in shear. Since all bolts occur in separate blocks, the loads are within the respective allowables of 945 lbs per bolt in tension and 800 lbs per bolt in shear. Similarly, the 1/2"φ Hilti Kwik Bolts for these conduits on the northwest corner of the Fuel Storage Building would experience a tension of 1322 lbs per bolt and 944 lbs per bolt in shear. The allowable loads for tension and shear respectively are 1260 lbs per bolt and 1970 lbs per bolt. The circular interaction for both tension and shear gives a value of 1.33 which is below the allowable of 1.5. Consequently the anchorage is adequate. The maximum forces induced in the individual conduits, resulting from dead, seismic and settlement loads, are small and the associated stresses negligible. Therefore, the integrity of each of the nineteen conduits will be maintained.

Similar analyses were performed for the other 8 conduit raceways which span between the Ventilation Equipment buildings and the Fuel Storage building. These conduits are shown in Figure 3. Based on these analyses modifications are required for these conduit runs. Specifically, these modifications will involve the strengthening of the six support anchorages which are marked with an asterisk in Figure 3.

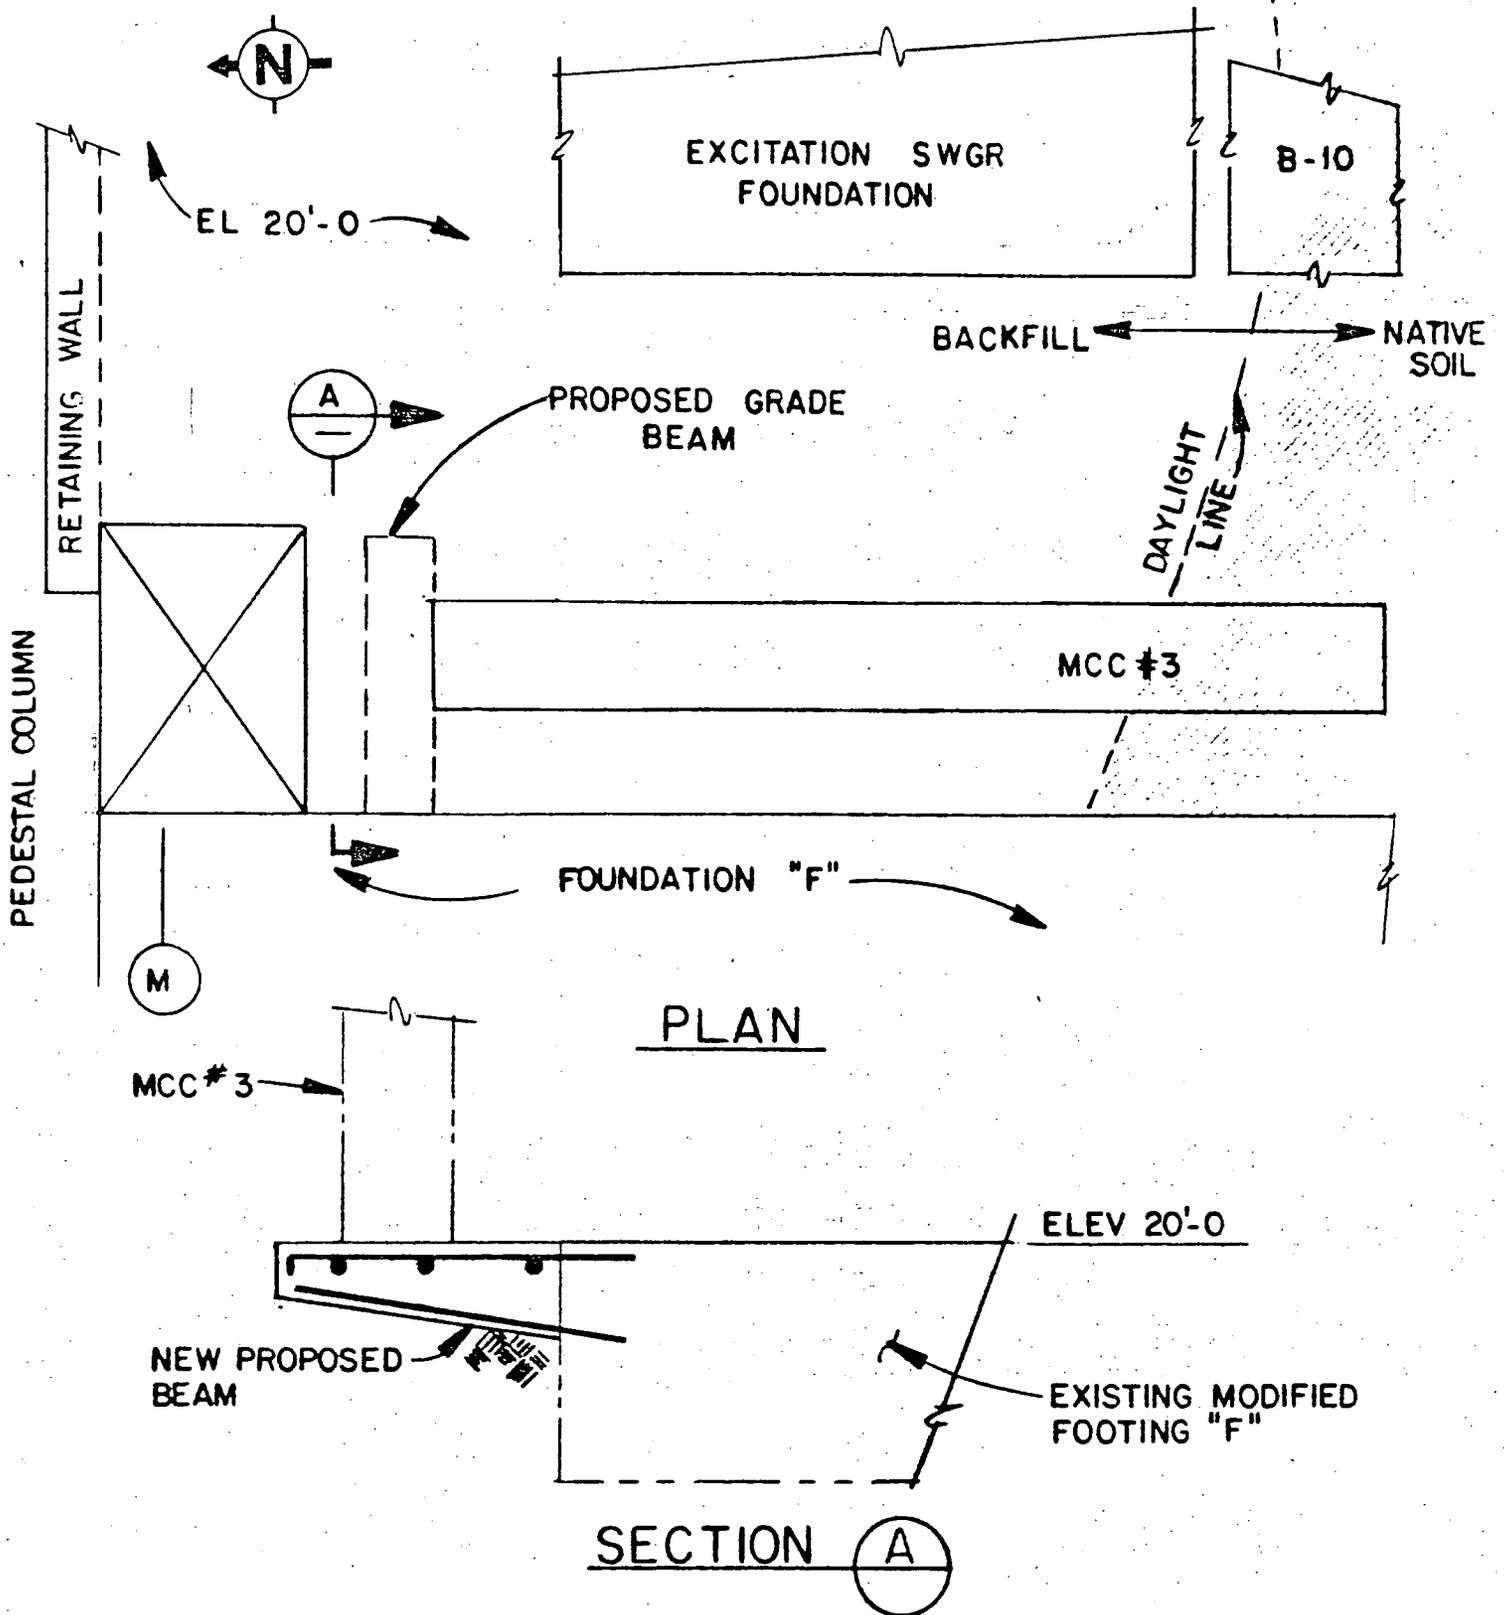
FIGURE 4

The analysis of this slab configuration indicates that a maximum slab moment of 7.5 K-ft/ft could develop during a DBE. The slab's moment capacity is 1.57 K-ft/ft and the corresponding ductility ratio is about 12; which is in excess of the criteria allowable of 3. The same analysis, which includes the affects of concrete cracking, indicates that the maximum slab deflection will be less than 1-1/2 inches which is the estimated settlement of the underlying soil. Consequently, no support from the settled soil can be expected. Therefore, the slab does not meet the seismic reevaluation criteria.

Modifications are required to restore the criteria margins. A conceptual modification scheme is shown in Figure 4 and would consist of an east-west running grade beam, anchored on foundation "F" and cantilevered out over the backfill. This beam would provide support at the north end of the MCC #3 foundation for the slab.

The slab would then act as a wide beam spanning between the grade beam at the north and native soil at the south. Alternatively, additional analyses may be performed which would demonstrate the integrity of the slab and the ability of MCC #3 to remain functional following a DBE or which would demonstrate that MCC #3 is not required to be operable following an earthquake.
