INSPECTION OF 480V ROOM AND VENTILATION
EQUIPMENT BUILDING FOR EFFECTS
FROM SOIL BACKFILL CONDITIONS AND
EVALUATION OF SETTLEMENT MARKERS

SAN ONOFRE NUCLEAR GENERATING STATION
UNIT 1

AUGUST 1983

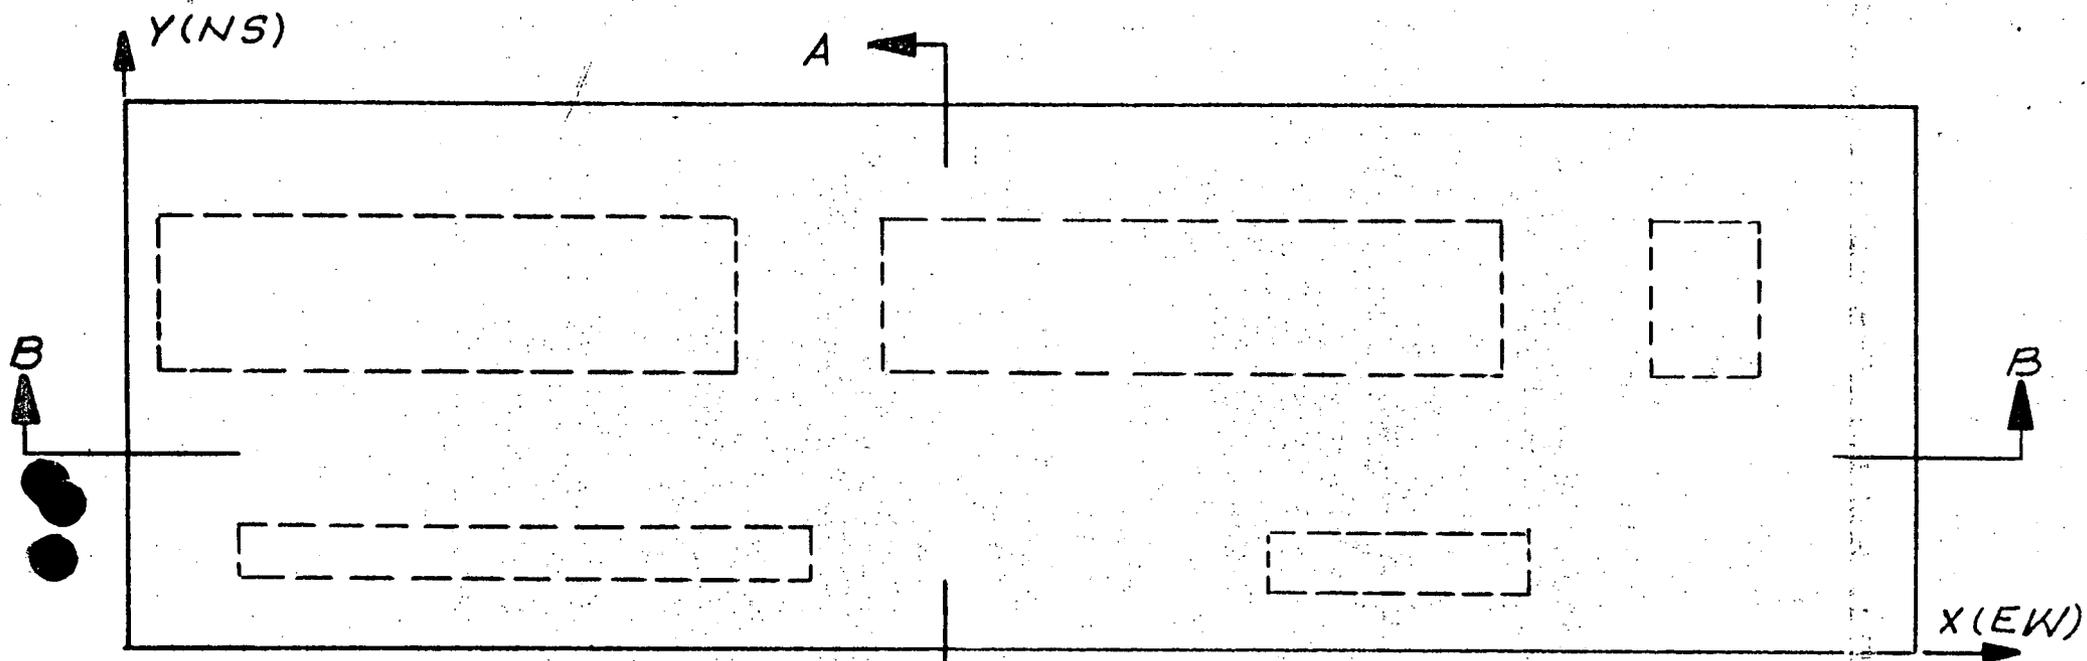
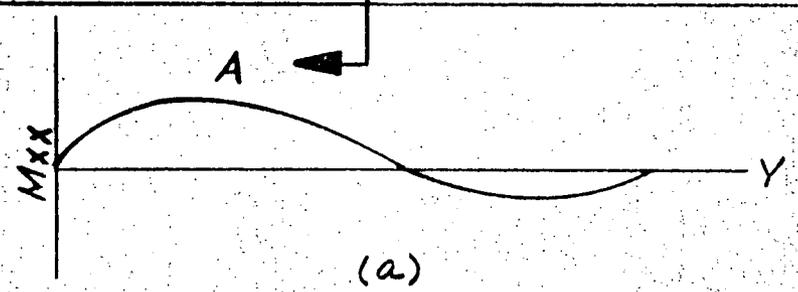
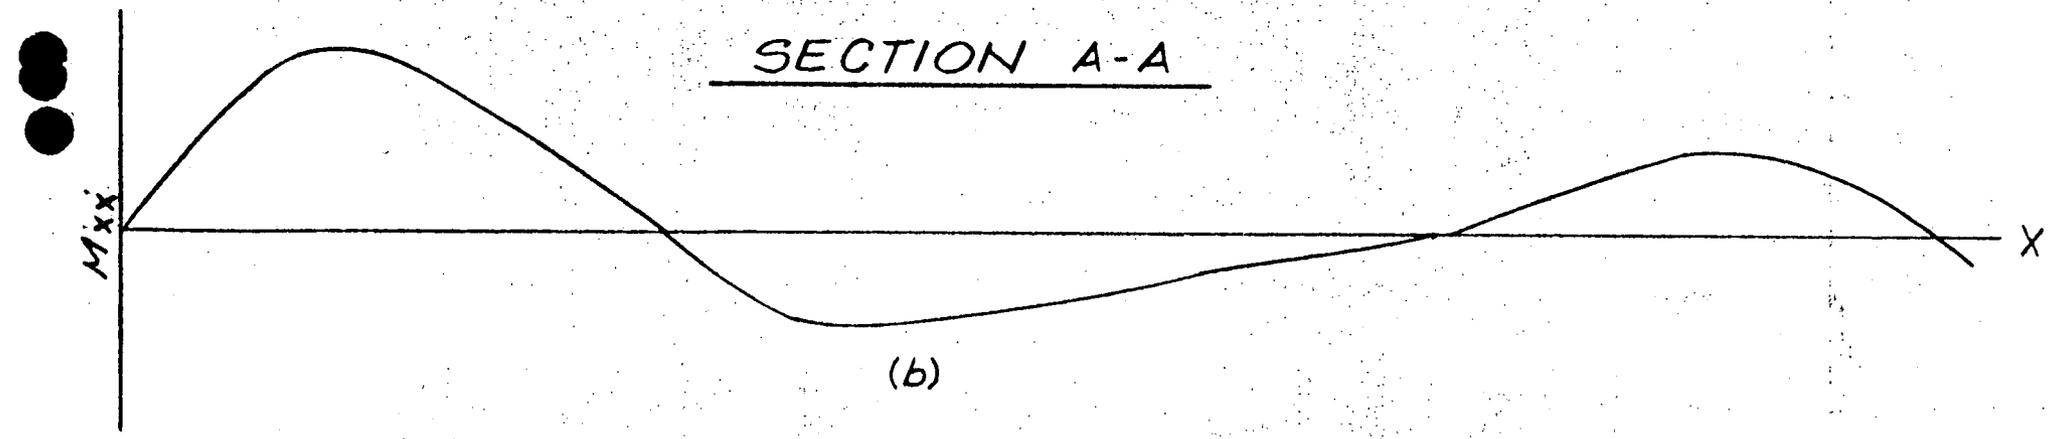
FIGURE 2.2 MOMENT DISTRIBUTION IN 480 V SLAB

If a slight amount of settlement were to occur in the northern 10 feet of the slab (the portion over backfill) due to slab self weight and the equipment weights, bending of the slab could occur as shown in Figure 2-2a. The cracking could then be hypothesized to be the result of tension in the top fiber of the slab caused by negative moment. A similar distribution of moments about a north-south axis is shown in Figure 2-2b. The negative moment causing bending about a north-south axis will generally result in cracks with north-south propagation. Cracks deviating from direct north-south or east-west directions can be found to follow the path of maximum resultant moments from orthogonal directions. Cracks adjacent to the switchgear, which are mounted on 4 inch concrete slabs atop the 6 inch building slab, could be caused by localized stress concentrations.

It is therefore concluded that the slab is supported on backfill at the northern portion and on native soil on the southern portion. Since there is general agreement between the observed crack locations and the expected pattern of cracking, the areal extent of the fill as shown in Figure 5-1 of Reference 3 is concluded to be reasonably accurate.
