SAFETY EVALUATION BY THE OFFICE OF NUCLEAR REACTOR REGULATION

SOUTHERN CALIFORNIA EDISON COMPANY

STEAM GENERATOR INSPECTION PROGRAM AND RETURN TO POWER REPORT (SEPT. 1982)

SAN ONOFRE NUCLEAR GENERATING STATION, UNIT NO. 1

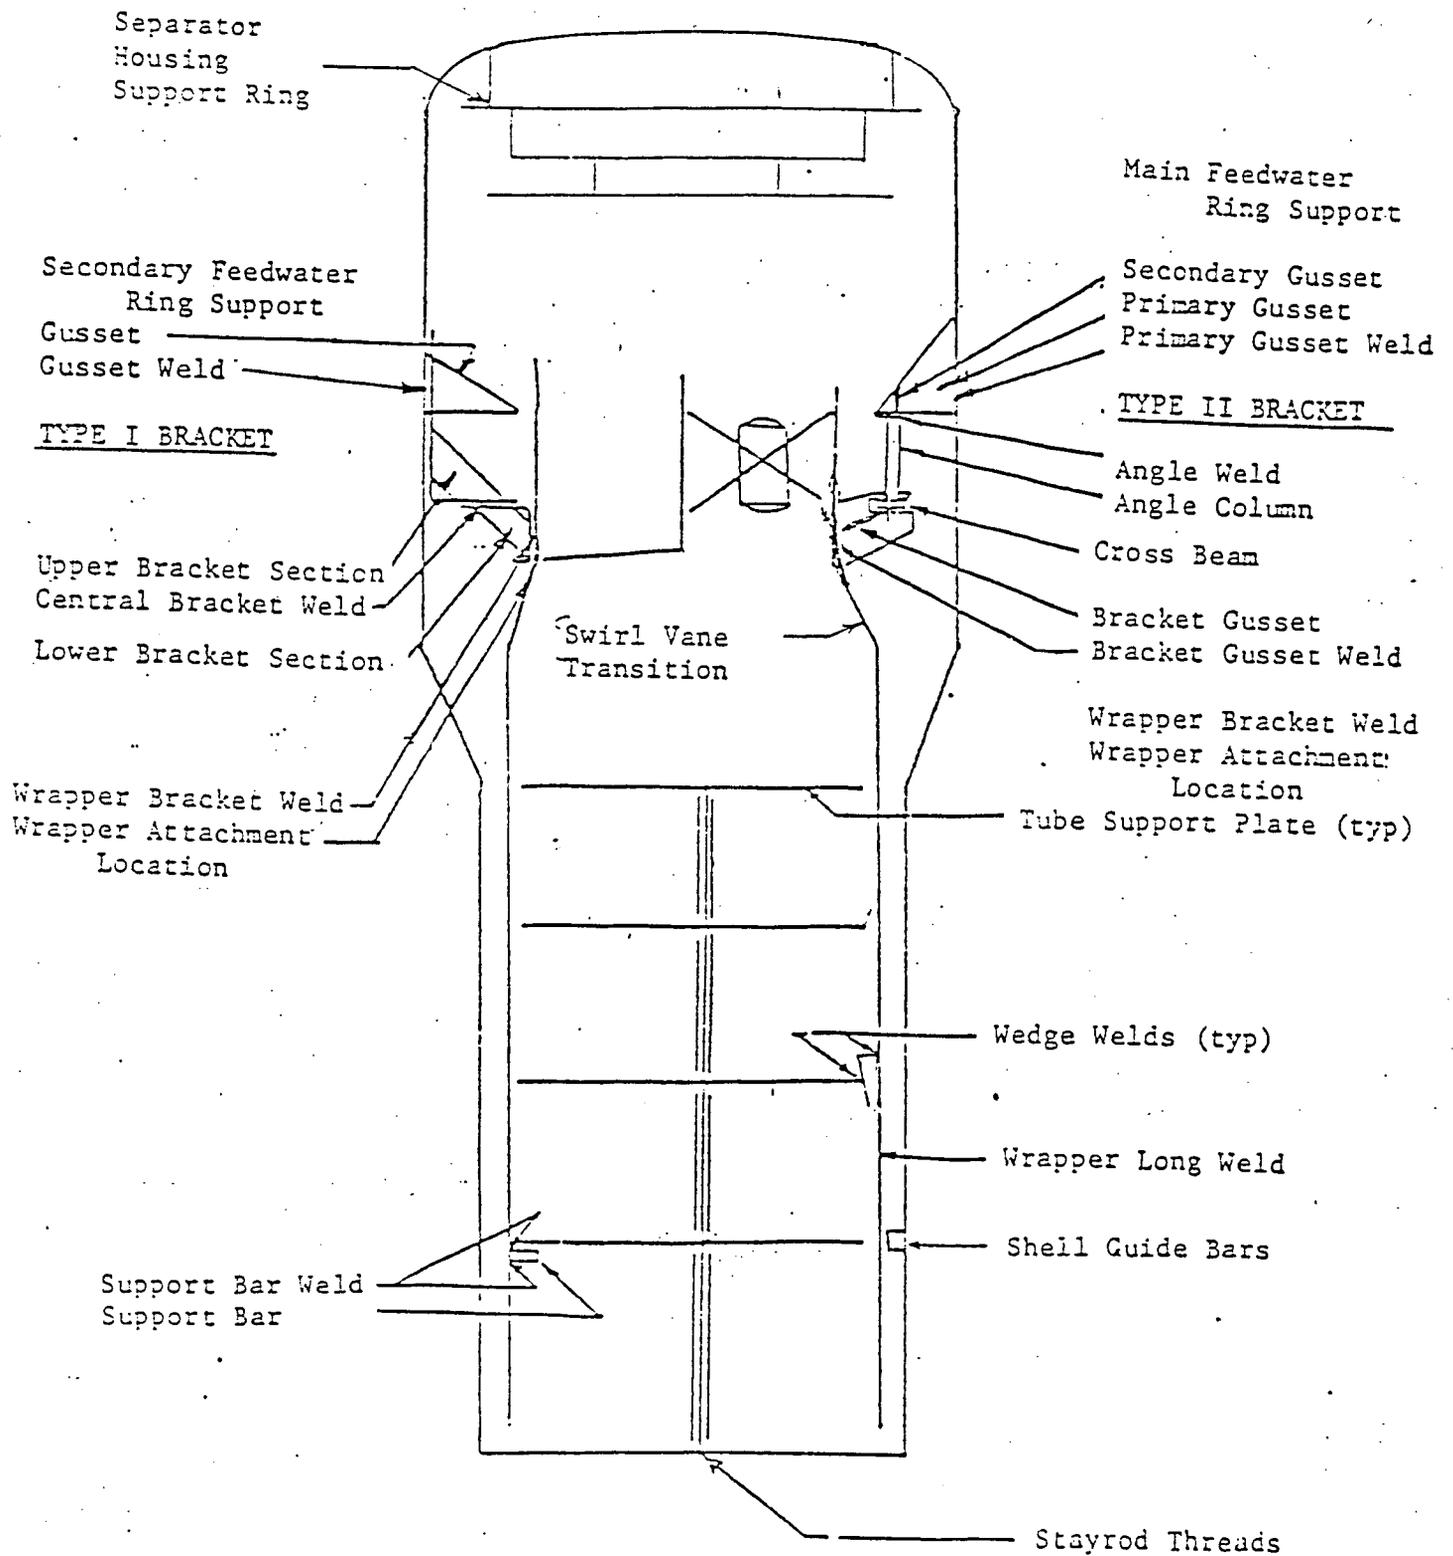
Figure 1  
 LOCATIONS EVALUATED FOR SLB AND SSE

The Westinghouse analysis demonstrates that under the assumed conditions the internals behave so as to not affect the structural integrity of the primary pressure boundary. A summary of the Westinghouse analysis results are provided in Table 1. The location of each of the regions included in these analyses is presented in Figure 1.
