**TDI DIESEL GENERATOR**

**DESIGN REVIEW  
AND  
QUALITY REVALIDATION  
REPORT**

**SAN ONOFRE NUCLEAR GENERATING STATION**

**VOLUME 3**

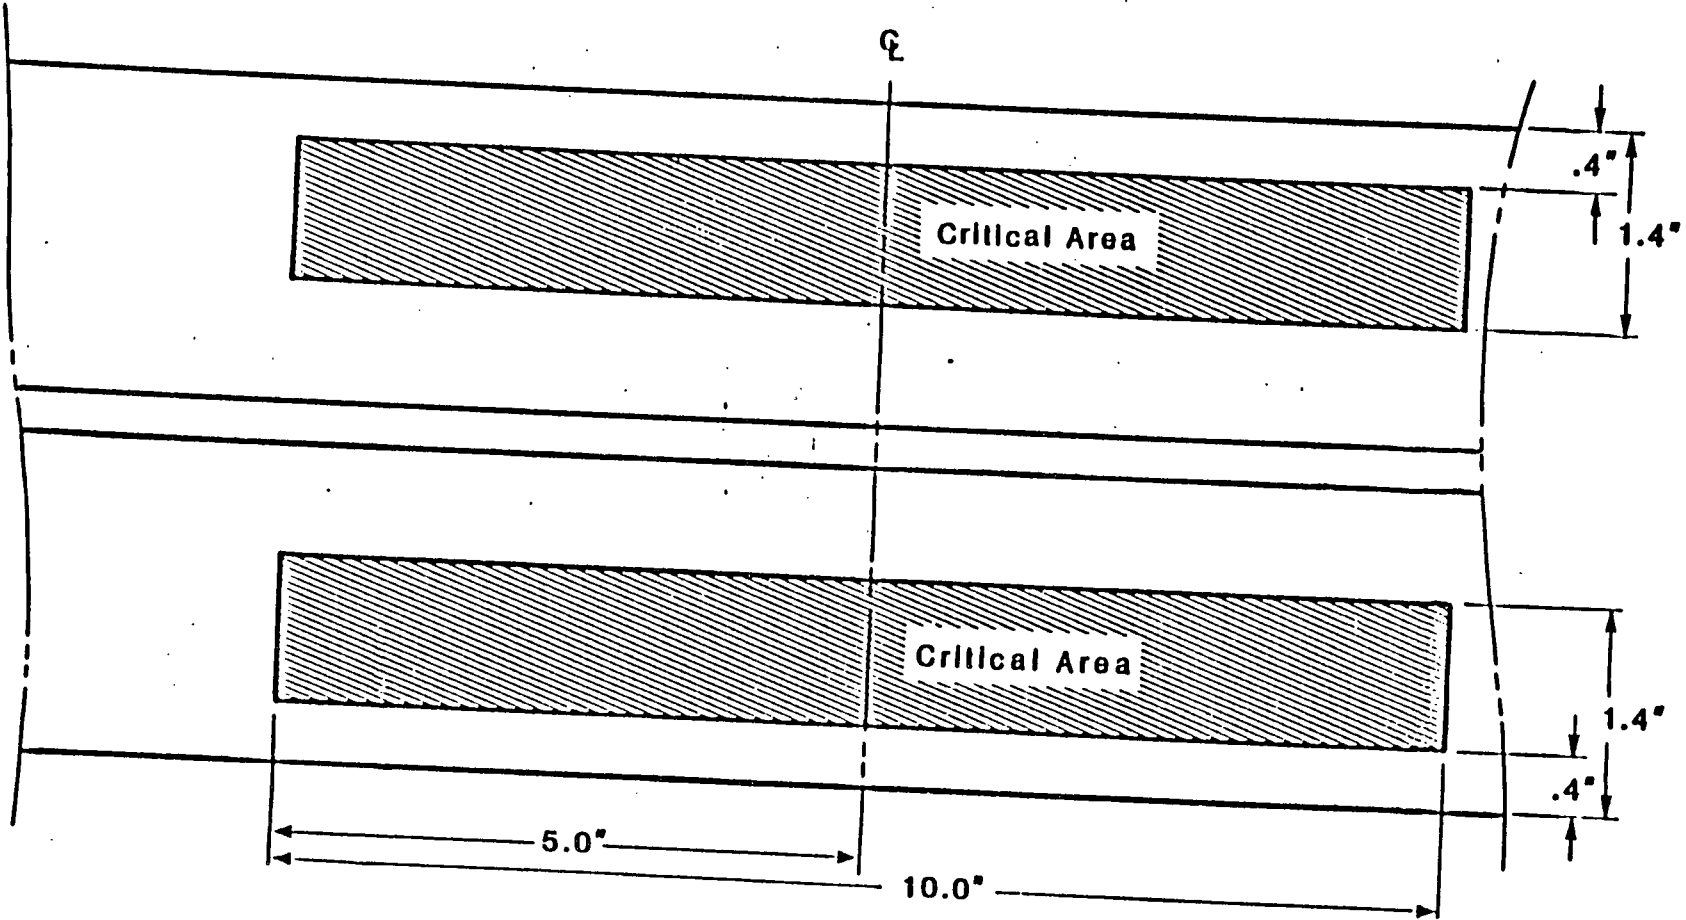
Ref: FaAA NDE 9.3

DESCRIPTION: BEARING SHELL CRITICAL AREA; TDI V-12, V-16, V-20

- Perform an X-ray examination on all of the replacement bearing shells to acceptance criteria developed by Owners Group Technical Staff. This is to be performed prior to installation of any replacement bearing shells.

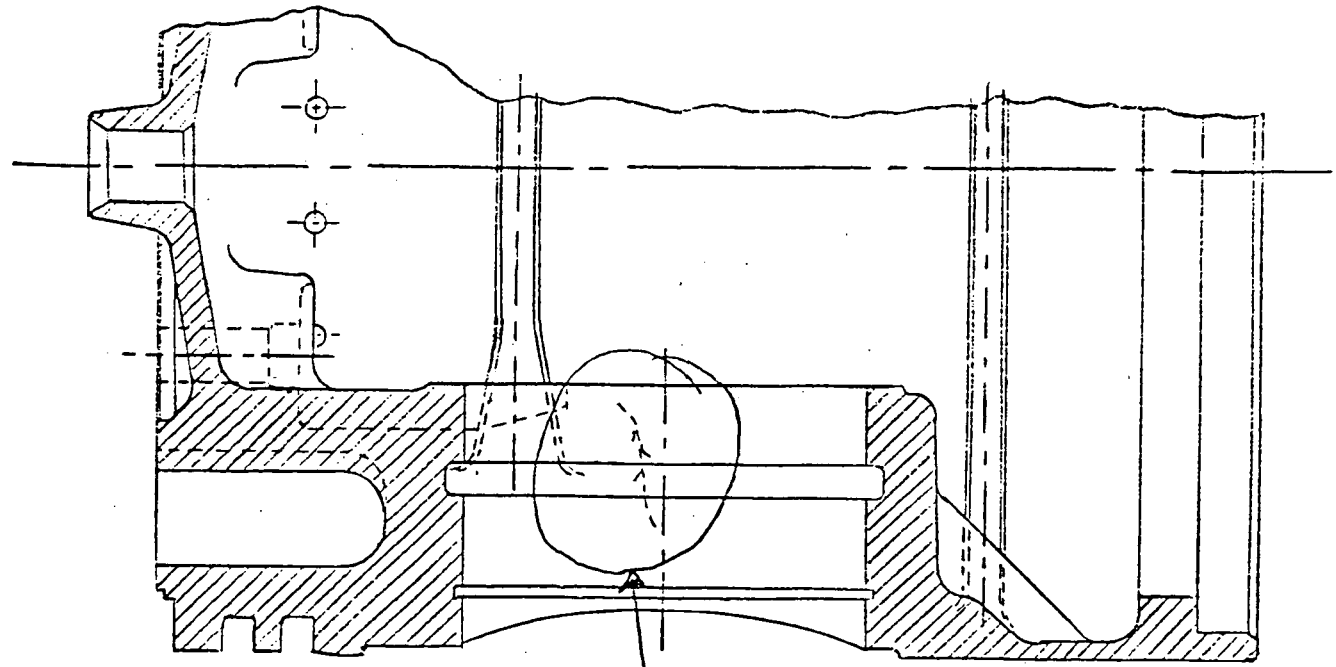
AREA TO BE INSPECTED  
(“NE” Piston only)
