Subject: **Docket No. 50-206**
Responses to NRC Questions on Intake Structure Degradation
San Onofre Nuclear Generation Station, Unit 1 (TAC No. 74168)

RESPONSES TO THE NRC'S "REQUEST FOR ADDITIONAL INFORMATION
RE: INTAKE STRUCTURE DEGRADATION
SAN ONOFRE NUCLEAR GENERATION STATION, UNIT 1
DOCKET NO. 50-206"

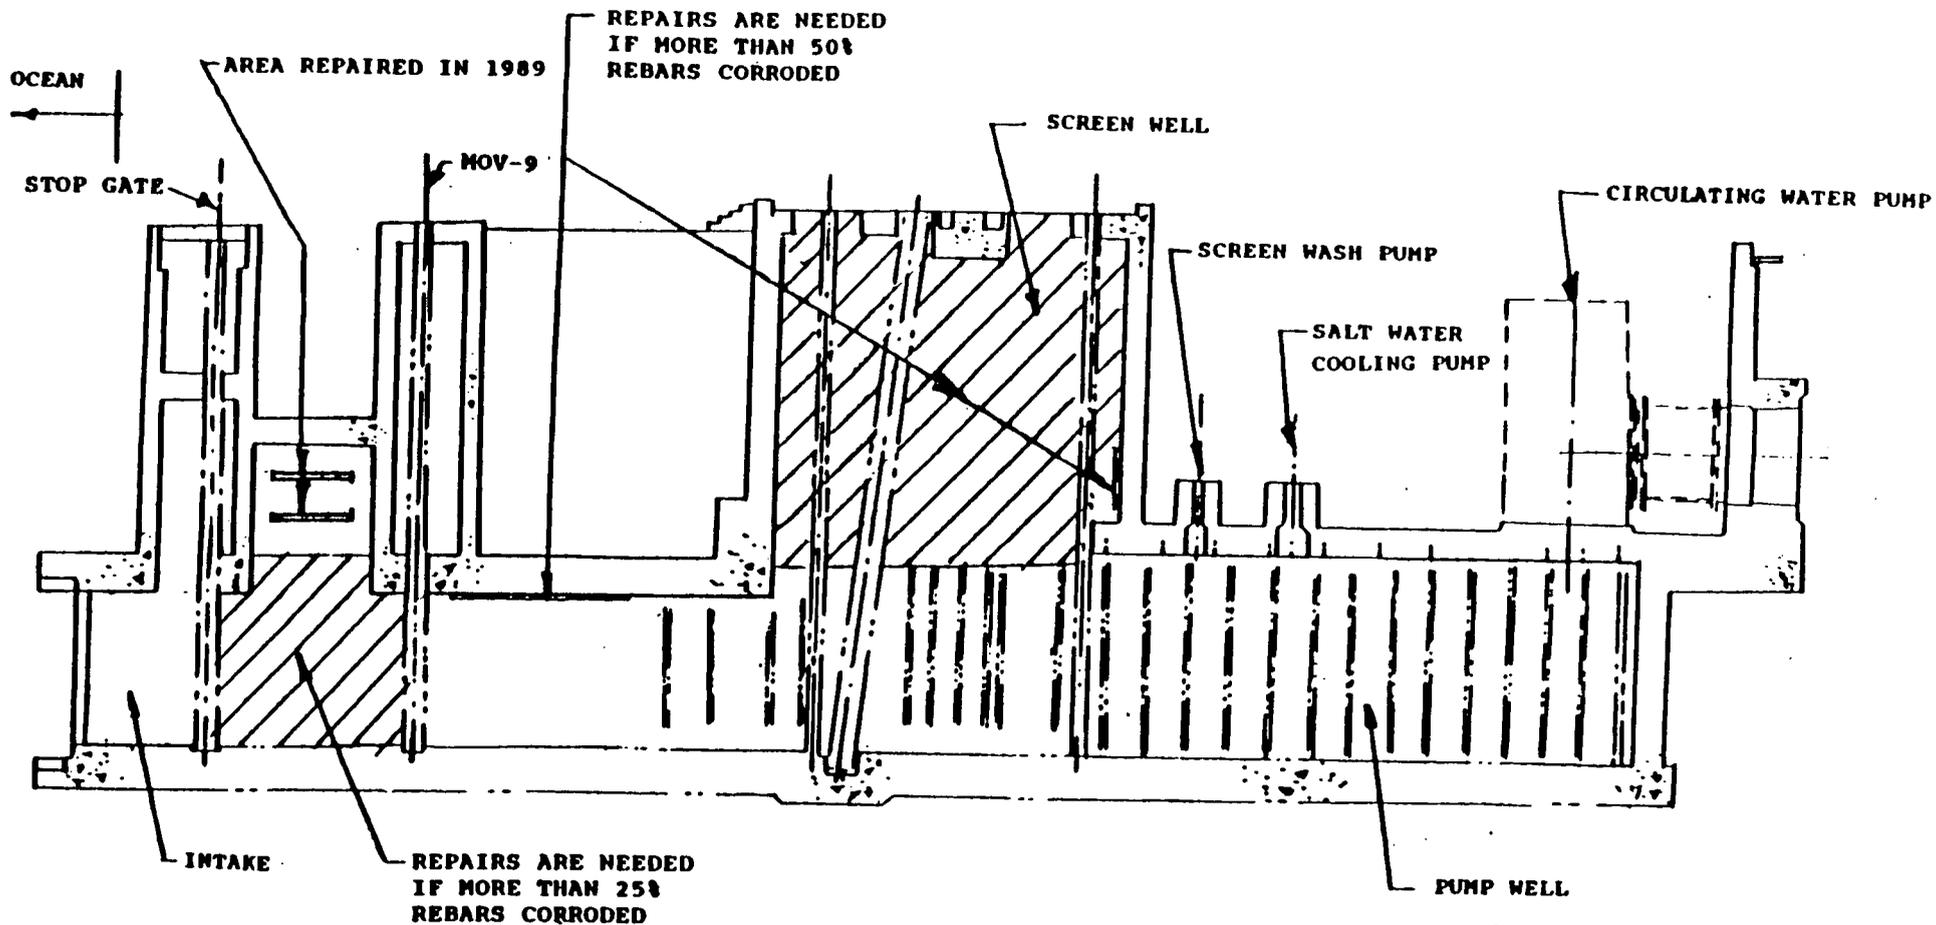
FIGURE 1

The pump bay walls and ceilings were repaired with strap plates in 1984. Repair details are designed for other areas that may require repairs in the future. Structural evaluations are performed after each surveillance to determine the need for repairs. Figure 2 shows the areas which require inside rebar to withstand design loads and repairs if deemed necessary during future surveillances.

- AREA THAT MAY NEED REPAIRS

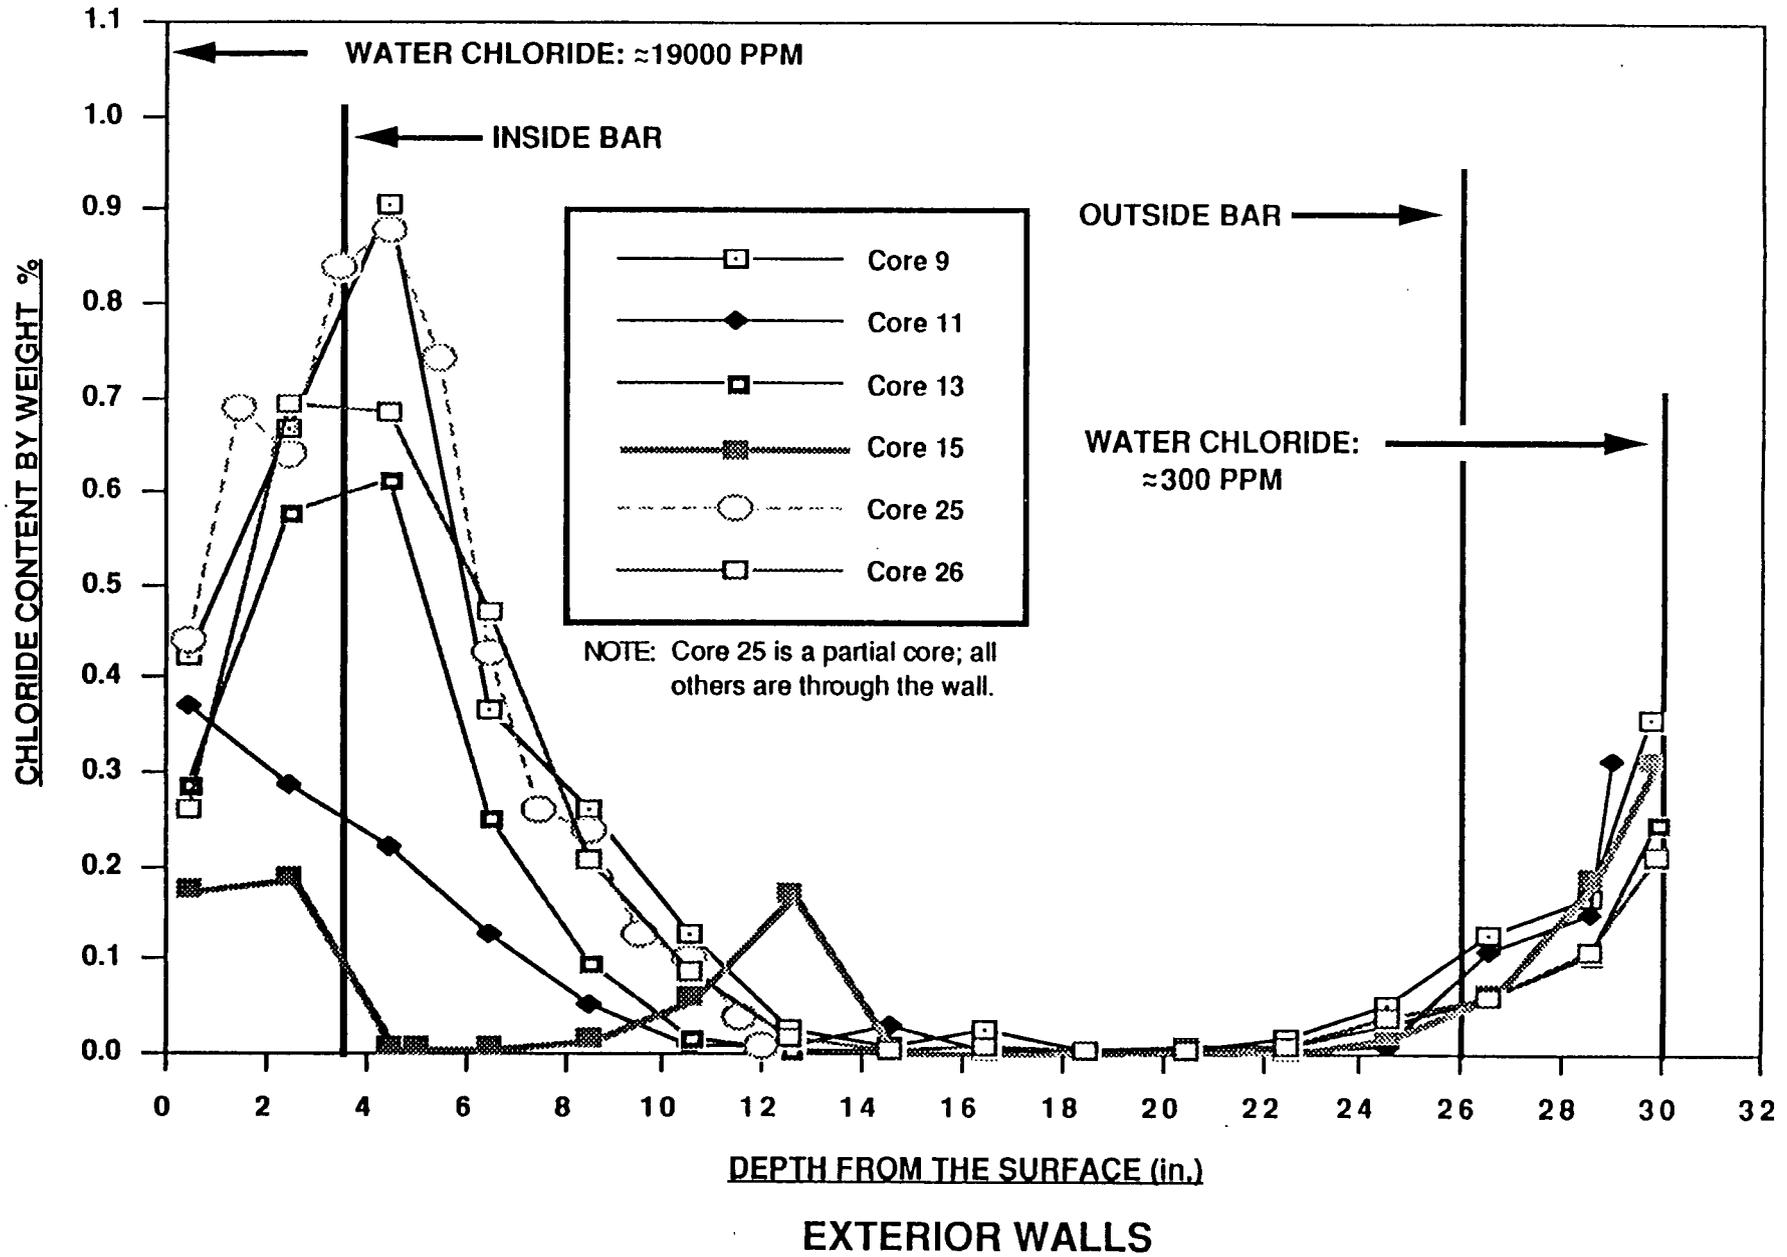
Fig. 3 - VARIATION OF CHLORIDE CONTENT WITH DEPTH

The chloride penetration curves included in the submittal from M. O. Medford (SCE) to W. A. Paulson (NRC), titled "Intake Structure Degradation and Repair, San Onofre Nuclear Generating Station Unit 1", dated October 18, 1984, are graphical representations of the amount of chloride found in the concrete core samples. These curves are included in this writeup as Figures 3, 4, and 5. The sea water on the inside of the concrete (left side of graphs) has a chloride content of approximately 19,000 ppm and the ground water on the outside of the concrete (right side of graphs approximately 30" from the inside surface) contained about 300 ppm of chloride. The inside and outside reinforcing steel are located approximately 3.5" and 26" (i.e., 3.5 to 4 inches from the structure's exterior surfaces) from the inside surface of the concrete, respectively. The core numbers correspond to the core sample numbers included in the October 18, 1984 submittal. All core samples were taken through the entire thickness of the walls and floor except Core 25 which is a partial depth core. The penetration curves indicate, as expected, that the percentage by weight of chloride is highest at the inside rebar and is very low at the outside rebar that is exposed to the ground water.

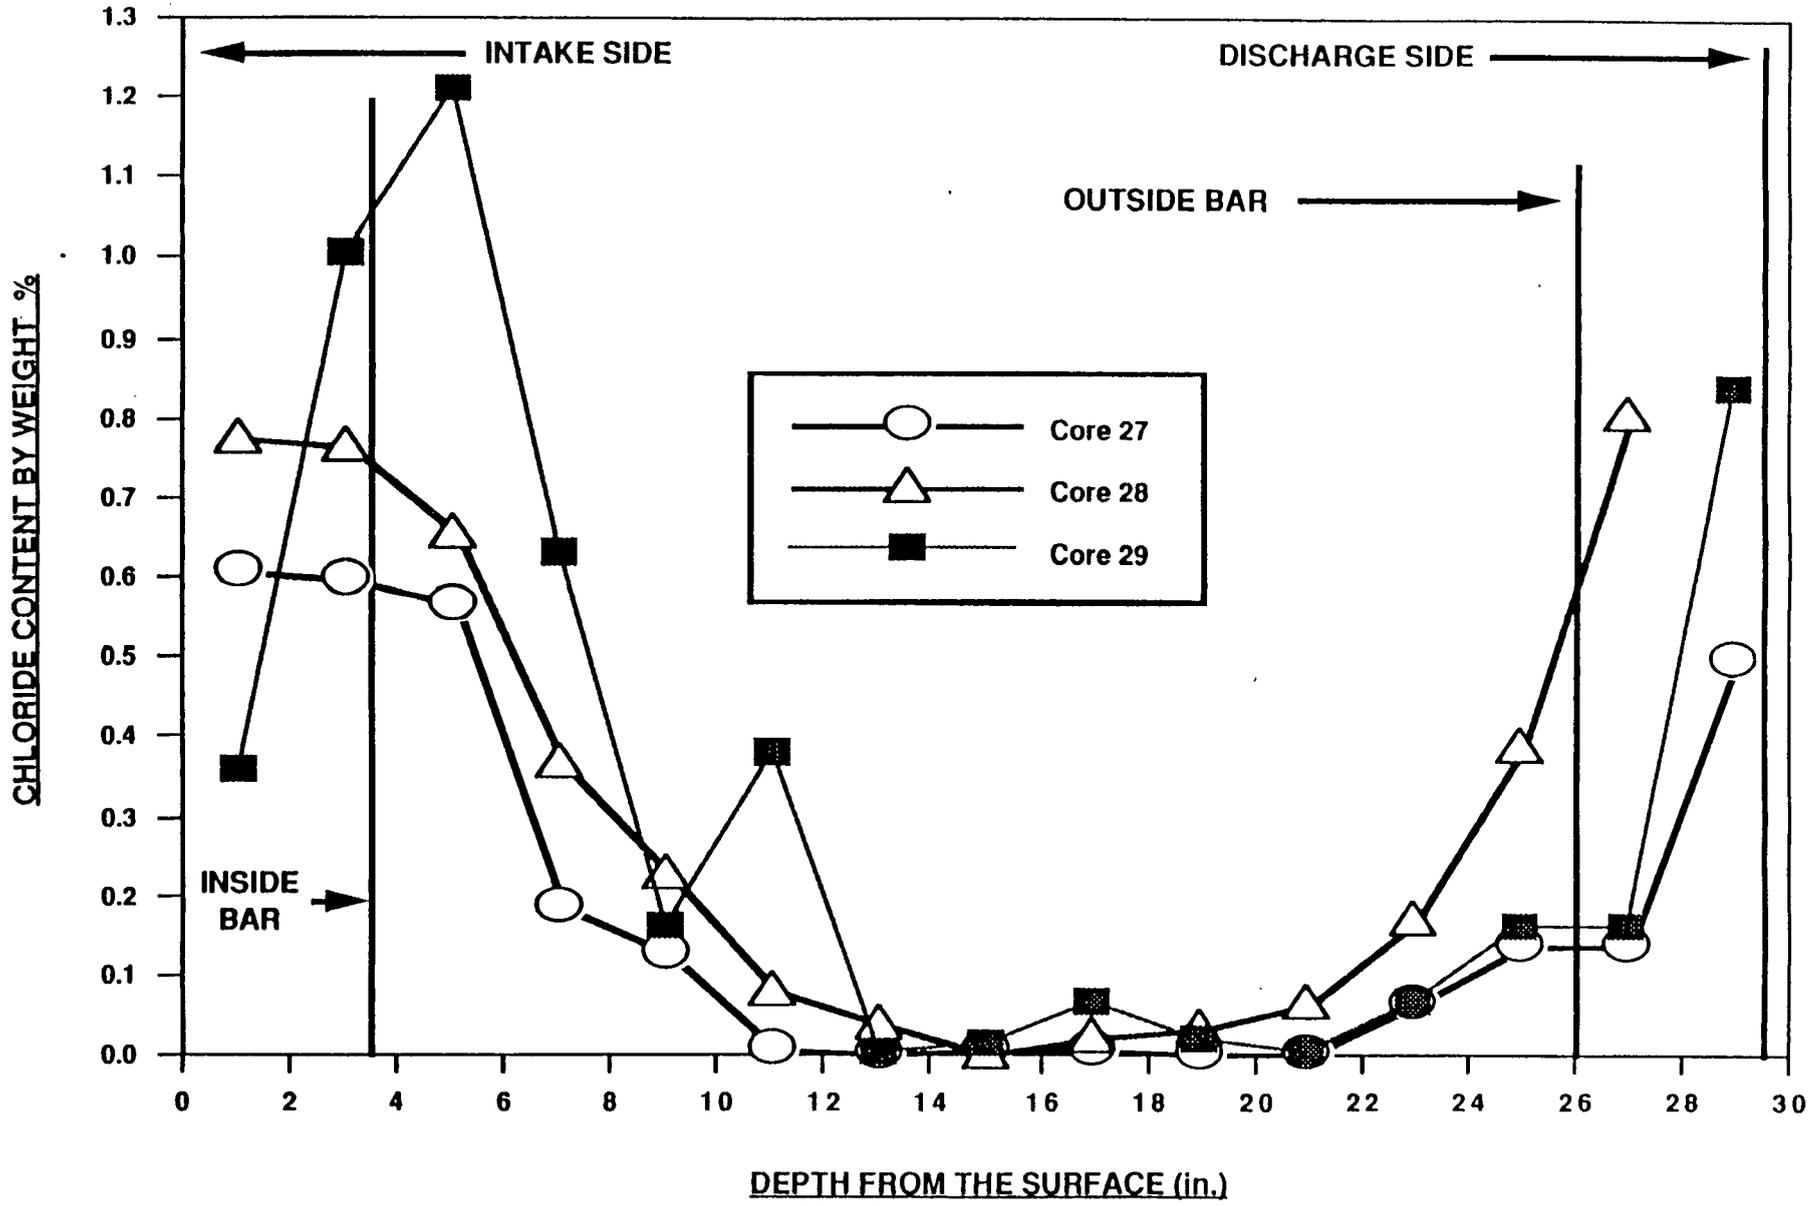
Fig. 4 - VARIATION OF CHLORIDE CONTENT WITH DEPTH

Cores 27, 28, and 29 were taken on the south wall of the south pump bay and south screen well (Figure 4). These cores represent chloride concentrations in concrete that is exposed to sea water on both sides (intake on the north side and discharge on the south side of the wall). The relatively high chloride content measured at both the inside and outside rebar of the south wall indicate that corrosion could be occurring on both surfaces. The inspection of the discharge side of the south wall showed only minor signs of corrosion during the Cycle 11 outage. In contrast, the north side of the wall exhibited many indications of corrosion. As previously stated, the north side of the wall was repaired in 1984. The difference in the degree of corrosion on the north side is attributed primarily to the higher sea water oxygen levels caused by pumping turbulence in the pump bays.

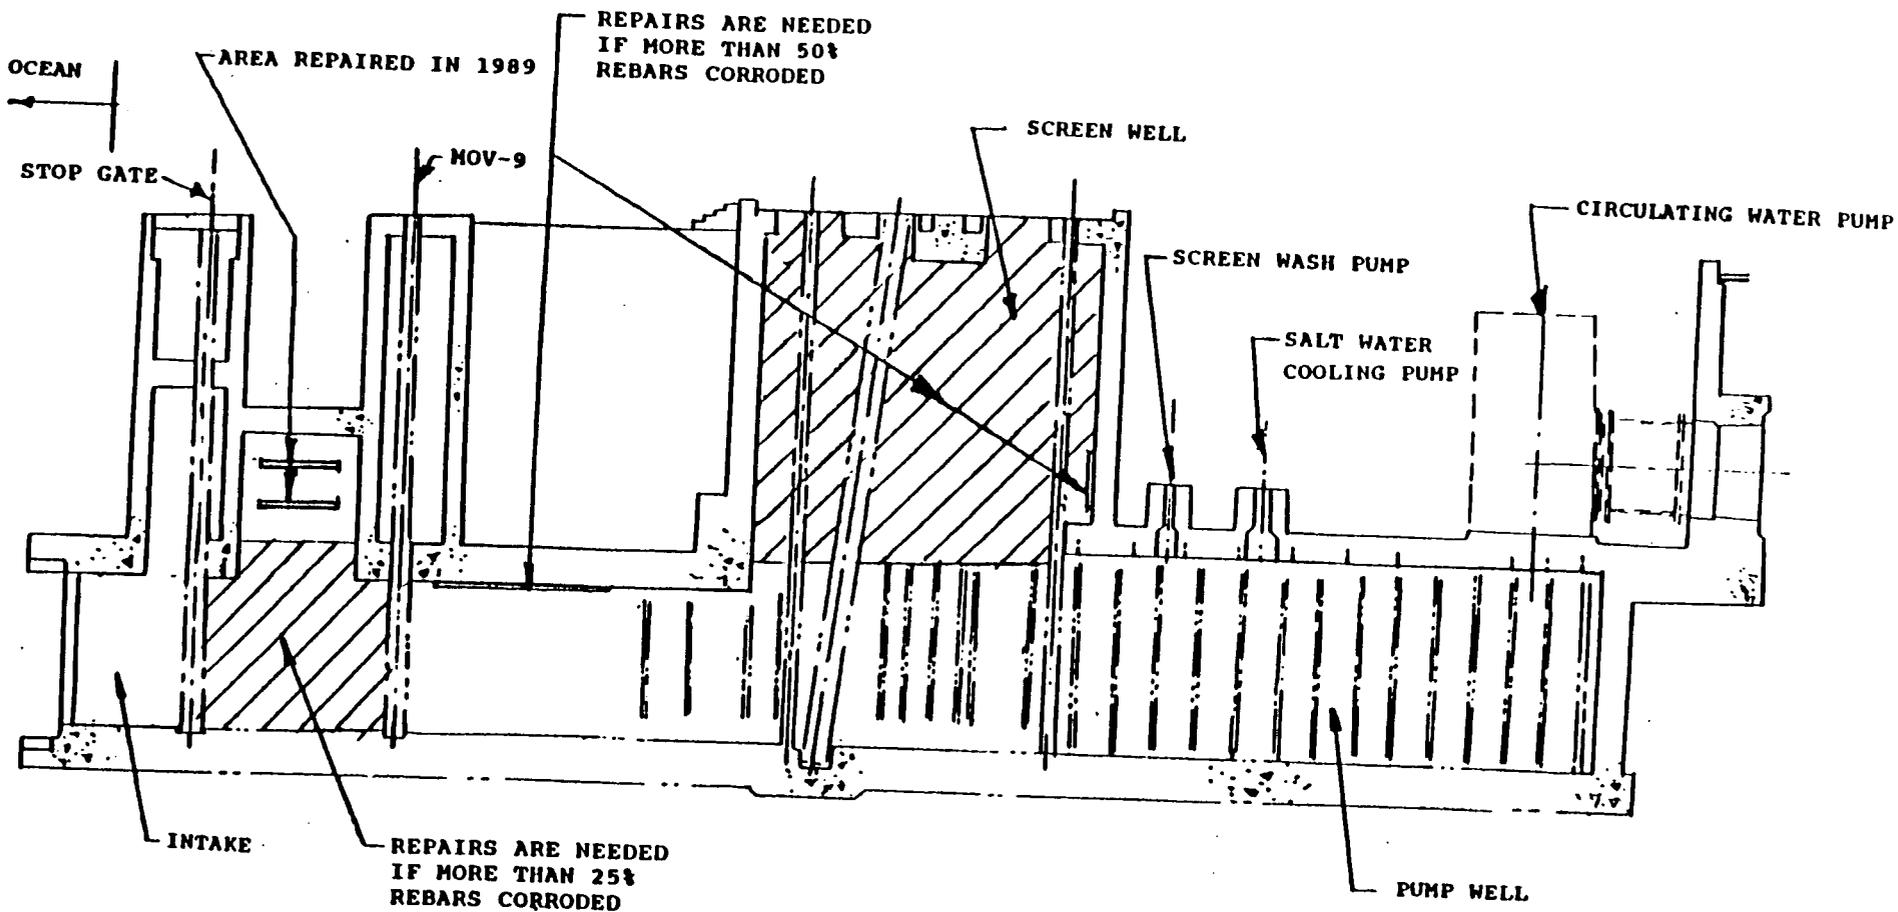
Prior to the second surveillance, the unrepaired concrete structural elements (those areas not repaired in 1984) of the intake structure were re-evaluated to determine reinforcement requirements to maintain the operability of the safety-related salt water cooling system during a Design Basis Earthquake (DBE). The areas evaluated were the north and south walls of the intake tunnel including the ceiling, screen well walls, concrete beams, MOV 9 and 11 gate structures and the transition segment. All other areas were either repaired in 1984 with strap plates, or classified as Quality Class Non-Safety Related, Seismic Category B since their failure would not affect the 4% minimum salt water flow to the salt water cooling pumps. The analysis identified the portions of walls and ceilings that would require repairs if the rebars were found to be corroded beyond acceptable limits. The analysis also identified the areas where the concrete strength is sufficient to withstand design loads without considering the inside face rebar (Calculation ISR-CC-01). The areas of potential repair (Figure 1) include the lower section of the north wall (below El. (-)14') between the stop gate slot and recirculation gate MOV 9 (the upper portion was repaired in 1988 during the Cycle 10 refueling outage), the ceiling between MOV 9 and the turning vanes, the lower portion of the east screen well walls, and the north and south walls of the upper screen well areas. The repairs for the above areas were designed based on the conservative assumption that the layer of rebars closest to salt water (inside face) was completely corroded and the concrete cover was delaminated. Repair details are shown in DCP 1-3440.1SC and DCP 3078.01BC.

— AREA THAT MAY NEED REPAIRS

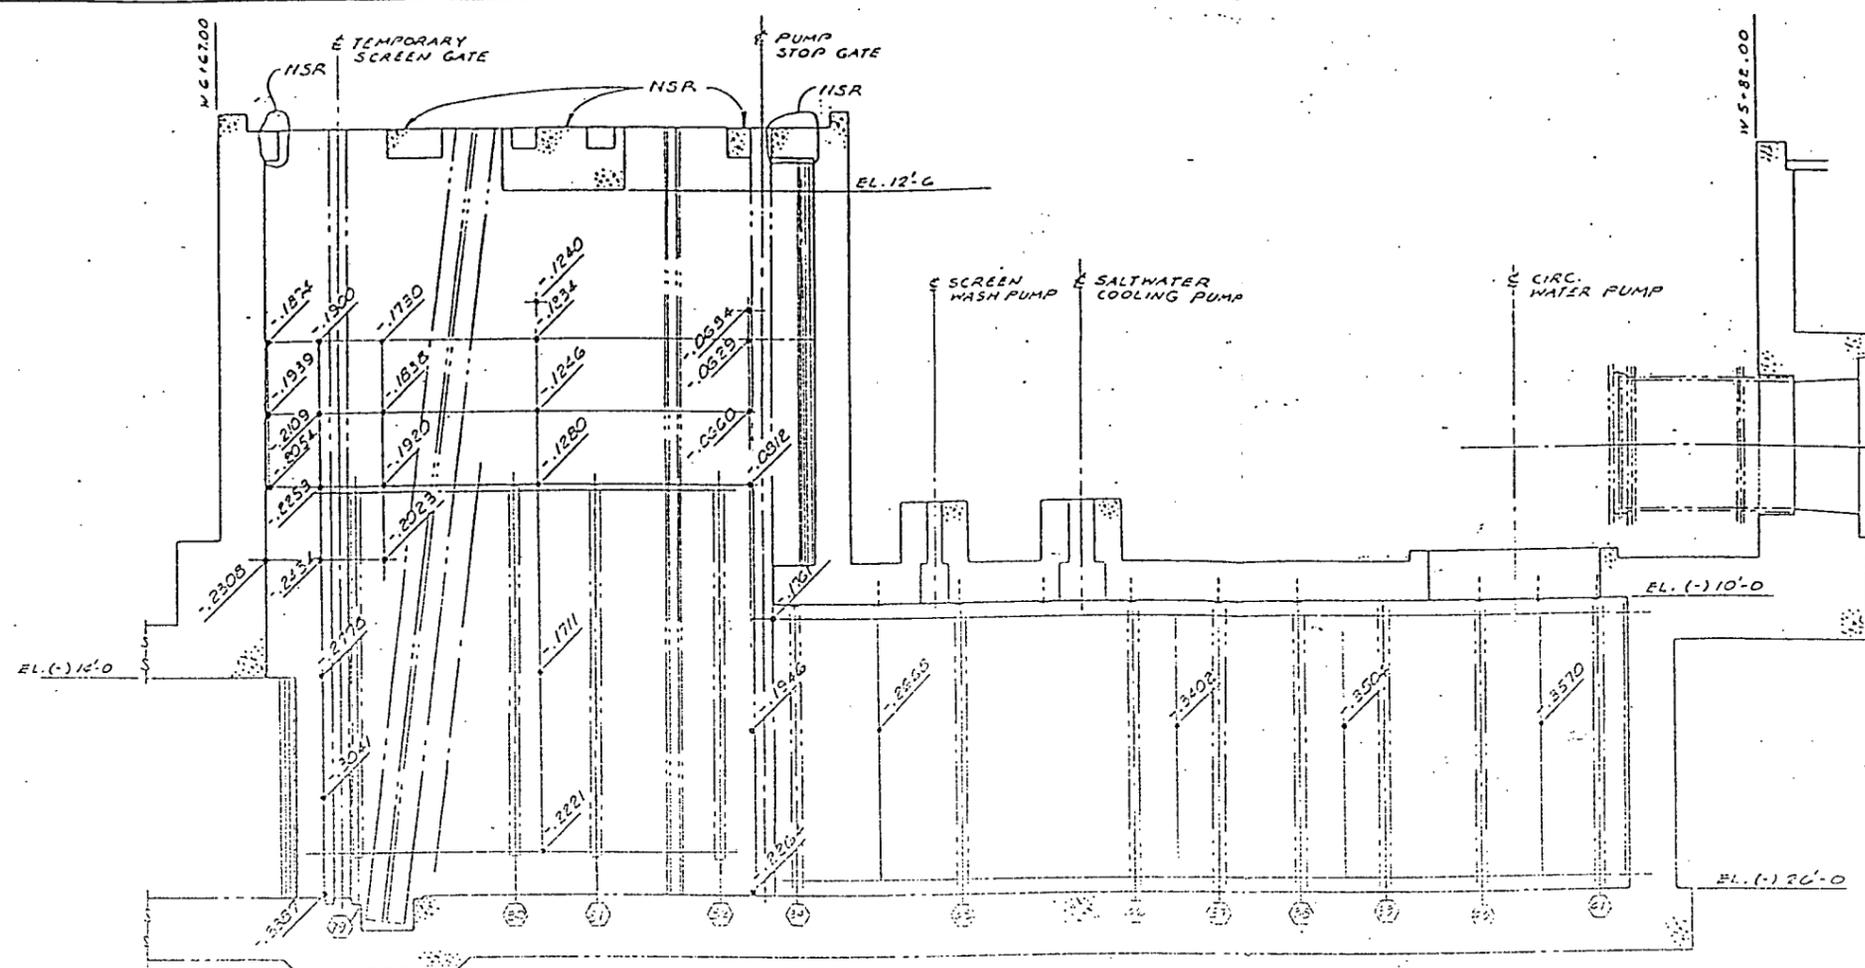
SECTION C
SOUTH INTERMEDIATE WALL
1/4" = 1'-0"

On the intermediate wall a number of new rust spots and small clusters of rust spots were found. Most of the rust spots were concentrated along the abandoned pump stop gate slot, the traveling screen slot on the line of a concrete construction joint and in previously repaired areas. The calculated moments for the intermediate wall are smaller than the unreinforced moment capacity. Therefore, its structural integrity is not compromised.

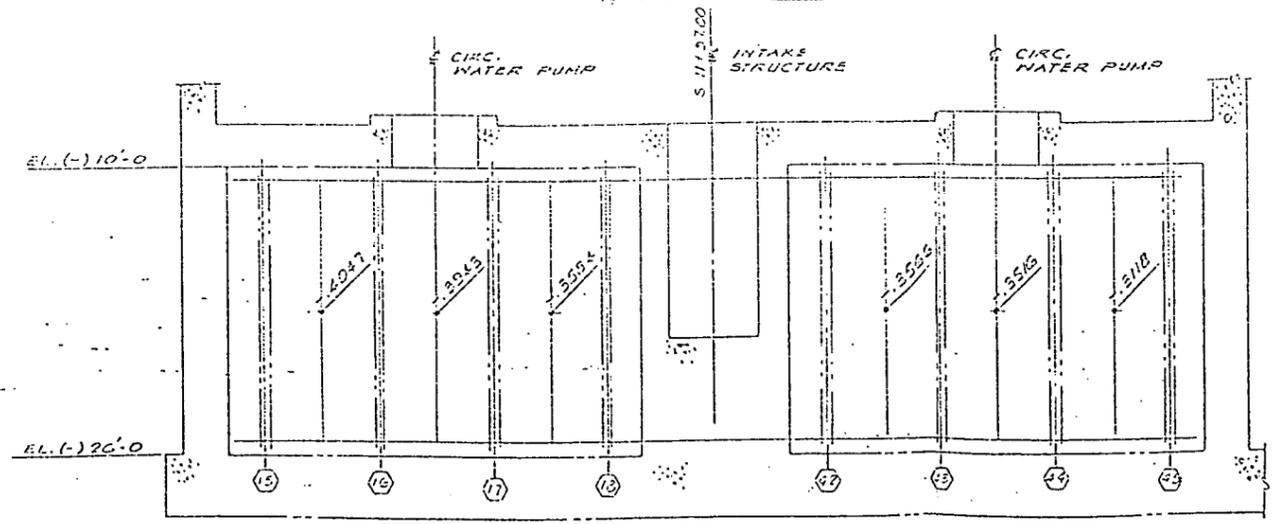
SECTION D
EAST WALL
1/4" = 1'-0"

The east wall above the ledge at El. (-)8'-0" revealed approximately eight rust spots scattered throughout the wall and ledge. This is an area where repairs are required if less than 50% of rebar is considered functional. It was determined from the scattered nature, size and color of the rust spots that the wall would continue to perform its safety-related function until at least the Cycle 12 refueling outage without any repairs at this time.

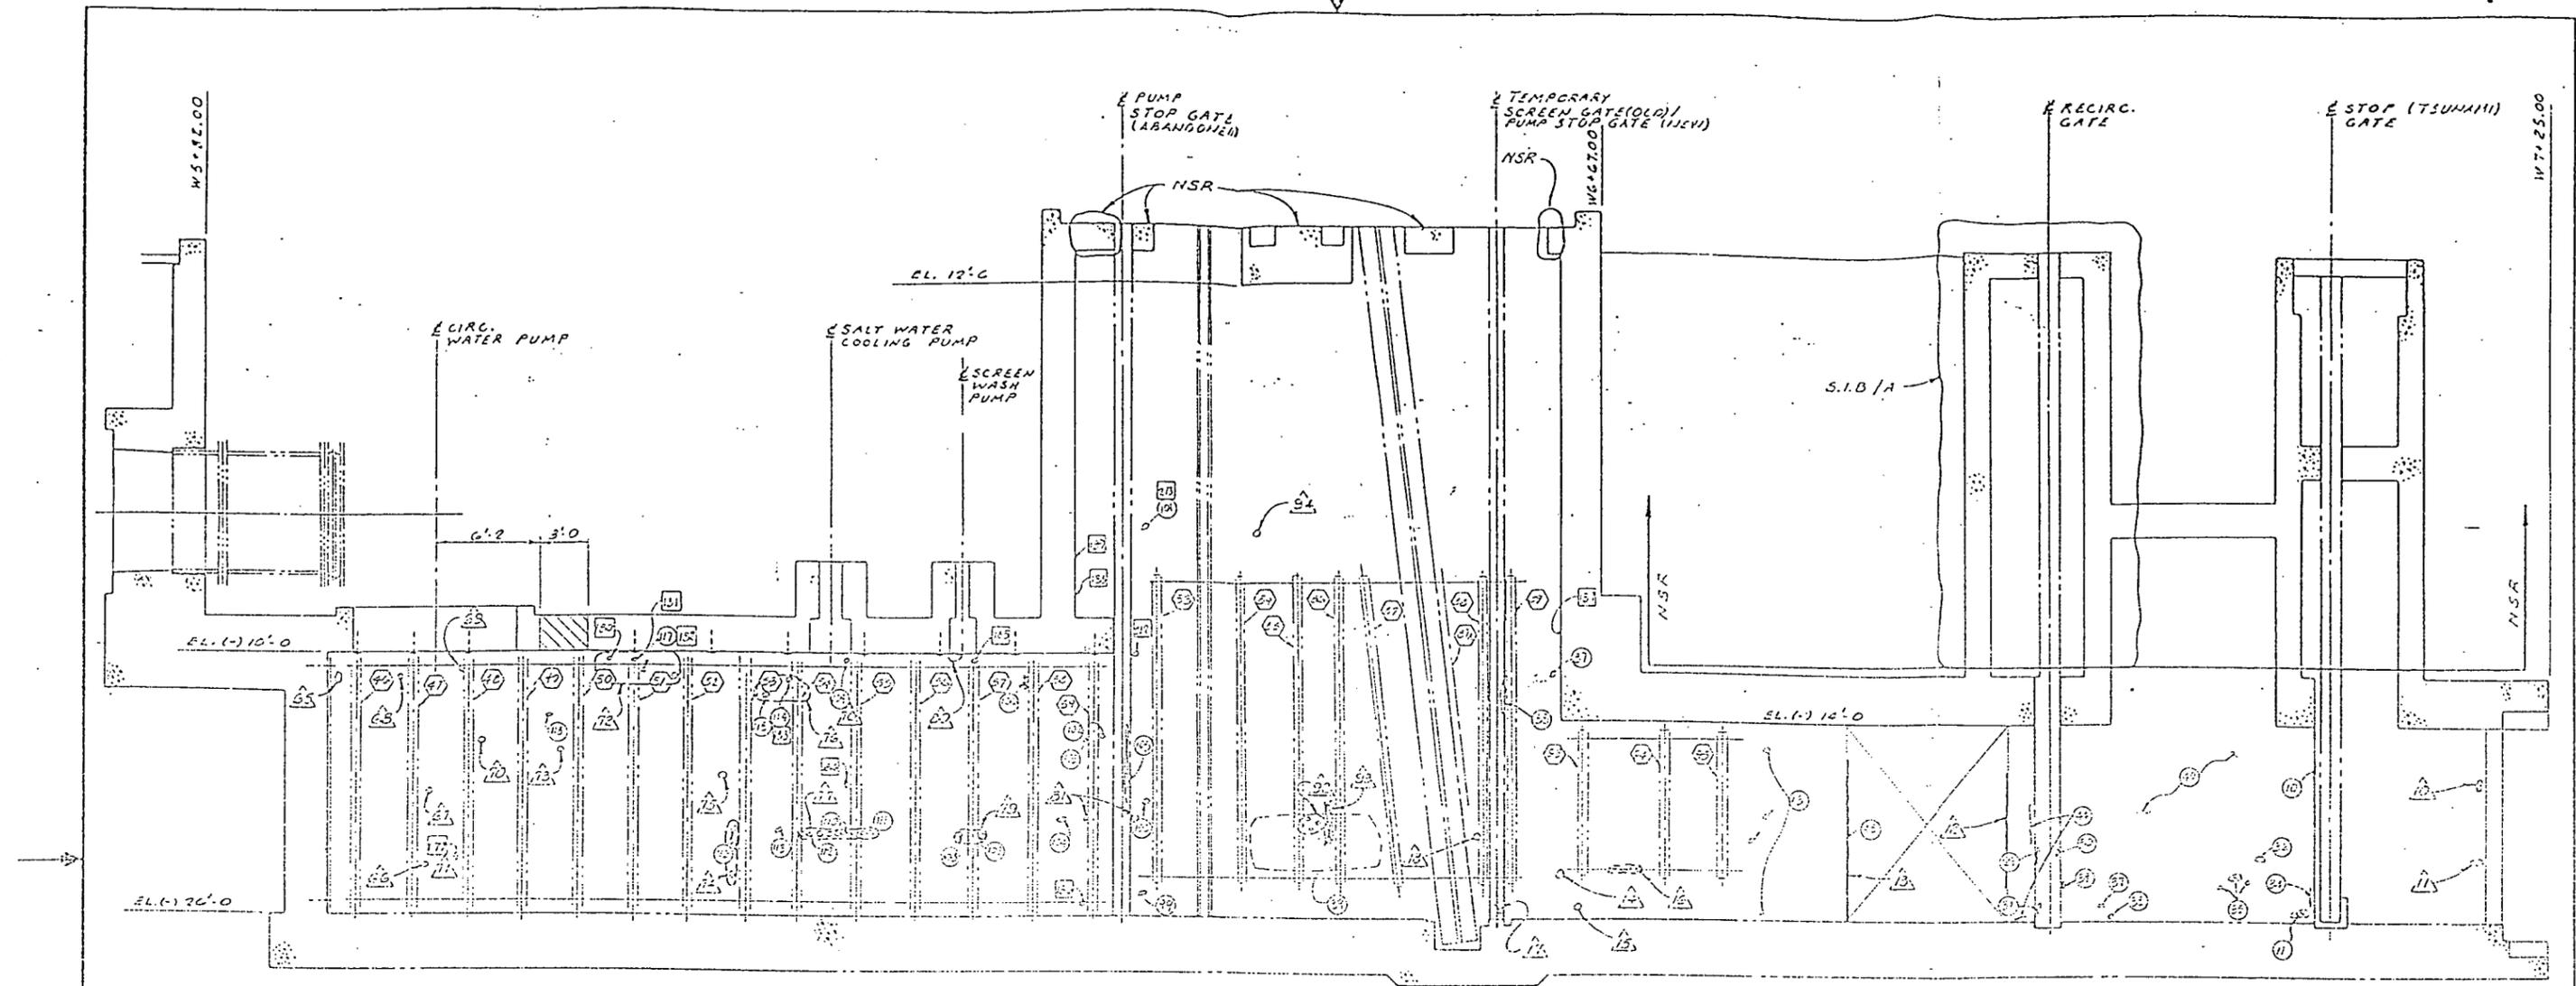
SECTION B
 SOUTH WALL
 01 2 3 4 5 6 7 8 9 10
 14'-11.0"

The south wall and the north intermediate wall have strap plates extending to approximately Elevations (-)6' and (-)4', respectively. On the south wall only one new rust spot was discovered in an unrepaired area above the strap plates. The spot does not present a structural problem since no other signs of corrosion were observed in the area. The inspection of the joints at the intersection of the floor and wall revealed no rusting. Some previously repaired areas revealed continued degradation, but the corrosion is of no structural concern because the existing strap plate repairs do not rely on the internal layer of rebars and concrete cover.
