SAFETY ASSESSMENT

SONGS 1 RESTART

March 17, 1989

San Onofre Nuclear Generating Station

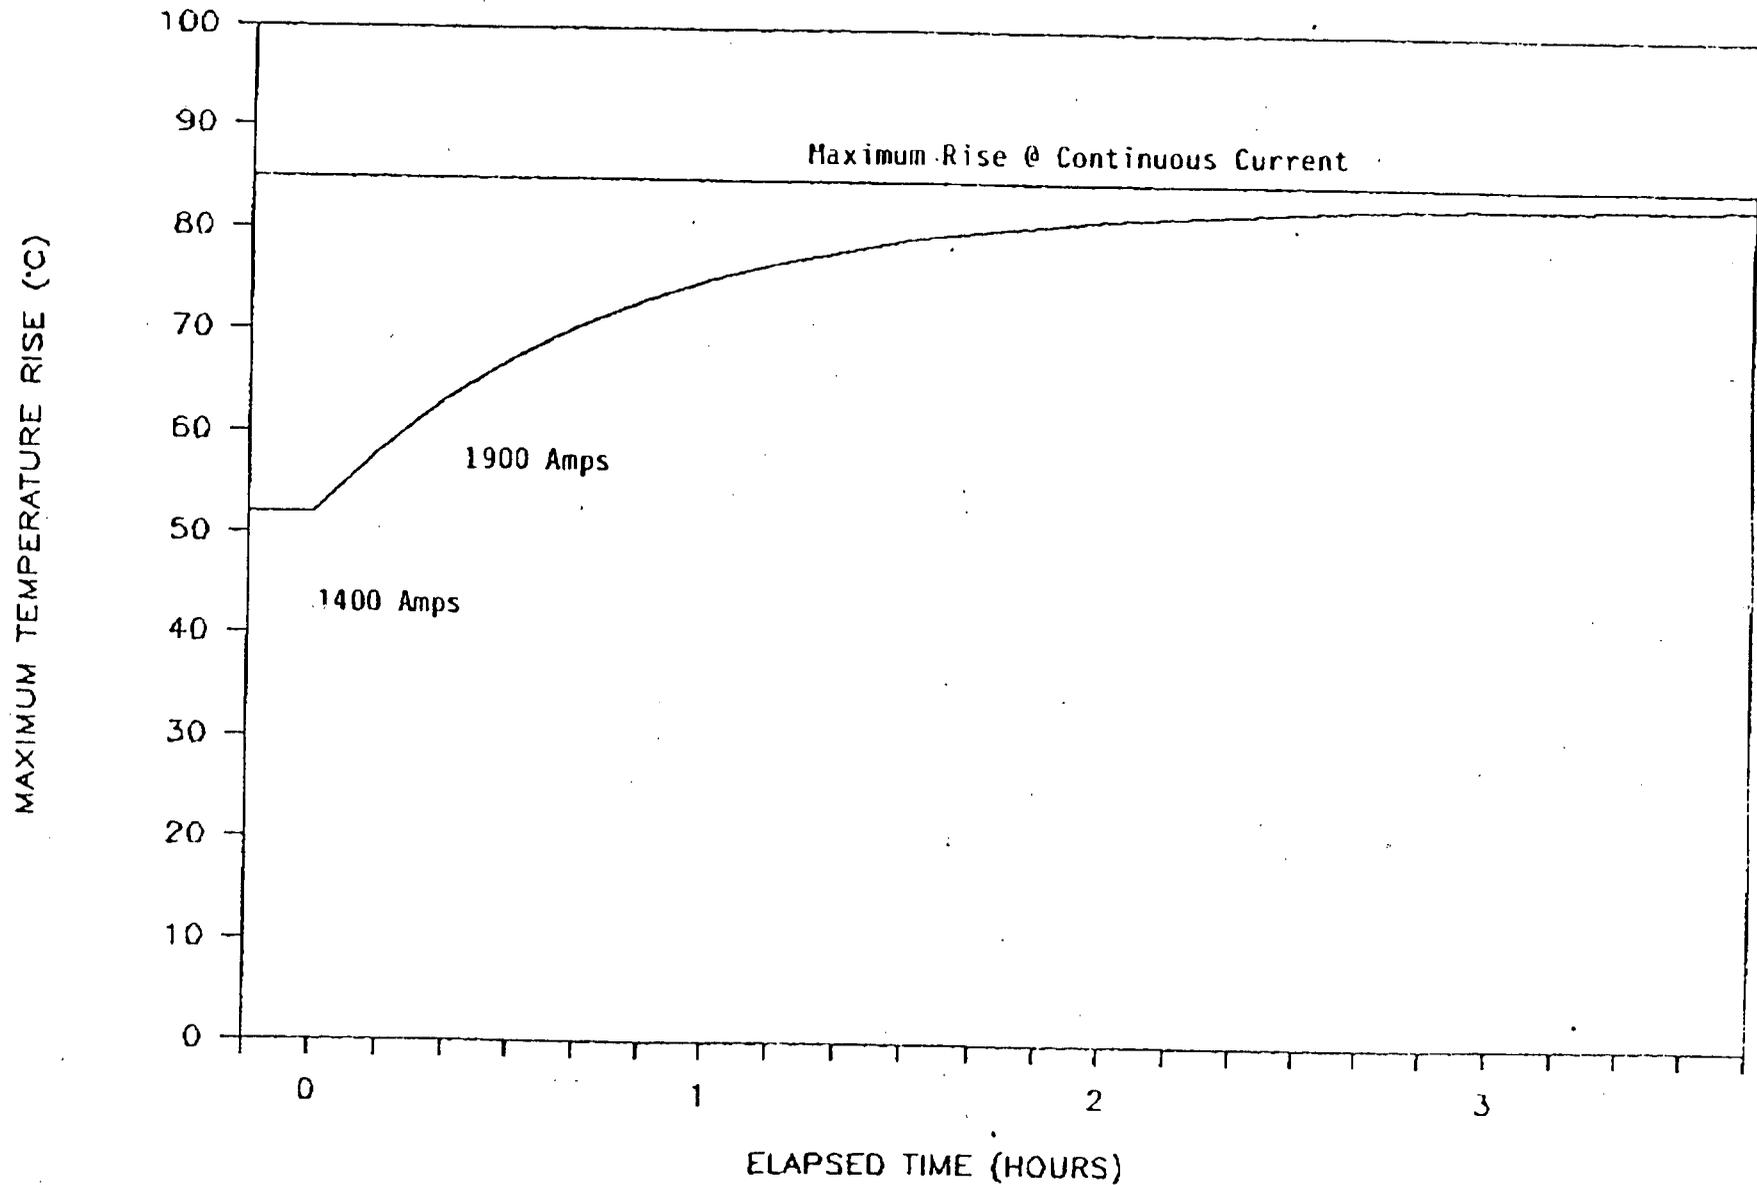
DB-50 MAIN CONTACT THERMAL RESPONSE

CORRECTIVE ACTION: In order to determine whether the breakers had sufficient design margin above the 1600 amp continuous rating to handle the worst postulated post-SIS load profile (1896 amps), a test was performed on an equivalent DB-50 breaker. The test was performed to determine the effects of heating on the breakers during the postulated overload conditions. The test guidelines were based on ANSI C37.50, "Test Procedures for Low-Voltage AC Power Circuit Breakers Used In Enclosures." The test results were used to predict temperatures of critical breaker components (contacts, insulation and bus connections) for the worst postulated current profile based on graphical and analytical techniques. The predicted temperatures were plotted against time (Attachment G) and then compared to ANSI maximum recommended values. It was found that, under worst case conditions, some of the ANSI recommended temperatures would be exceeded. However, the additional temperature rise allowed by ANSI for four-hour breaker emergency overload conditions would not be exceeded. For the purpose of this evaluation, an ambient temperature of 40 degrees Centigrade (conservative) and a switchyard voltage of 230KV (most probable) were assumed. The test breaker was inspected following the test and neither the insulation nor contacts were degraded and the breaker performed acceptably throughout the test.

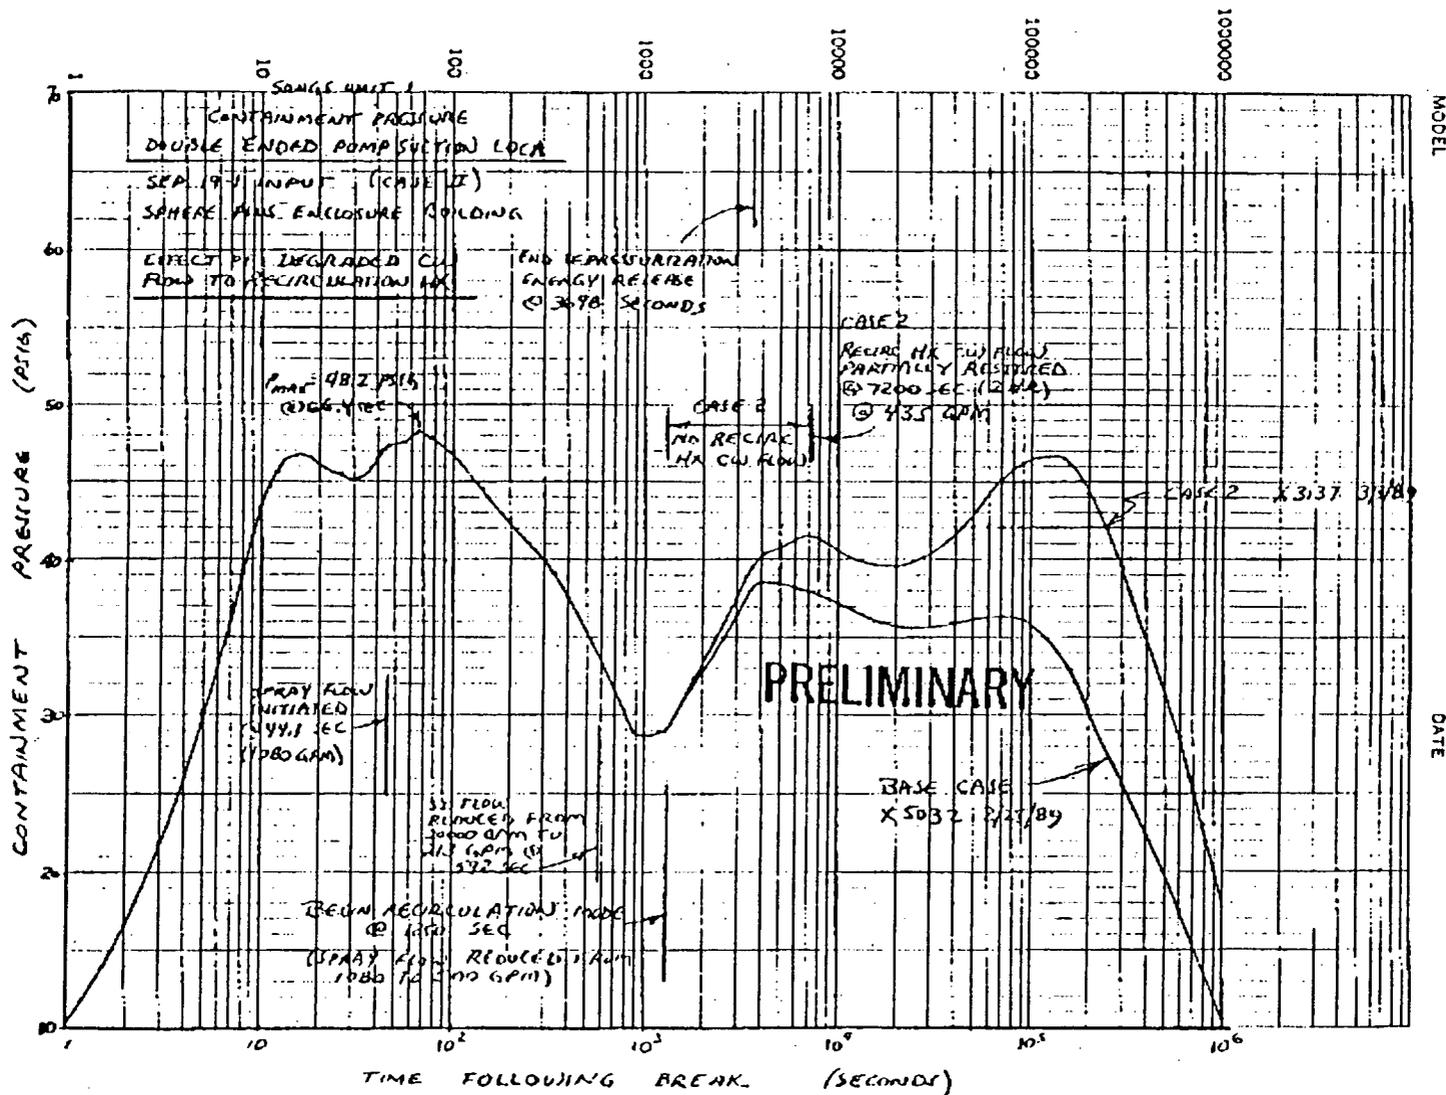
For the case where partial CCW flow to the recirculation heat exchanger is initiated at 2 hours, sufficient heat removal is provided to maintain containment pressure within design limits and below the blowdown pressure peak. The secondary pressure peak is 46.7 psig at 1.6 days. Containment temperature is 273 degrees F at 1.6 days which is approximately 11 degrees F increase compared to the design basis case. Heat removal by the recirculation heat exchanger was calculated to be 3.65 E9 BTU/hr at 10.4 days compared to 3.9 E9 BTU for the design basis case.

The results of the case with partial recirculation heat exchanger flow indicate that recovery options are available which mitigate the effect of an initial loss of CCW flow to the recirculation heat exchanger and maintain the plant well within design limits.

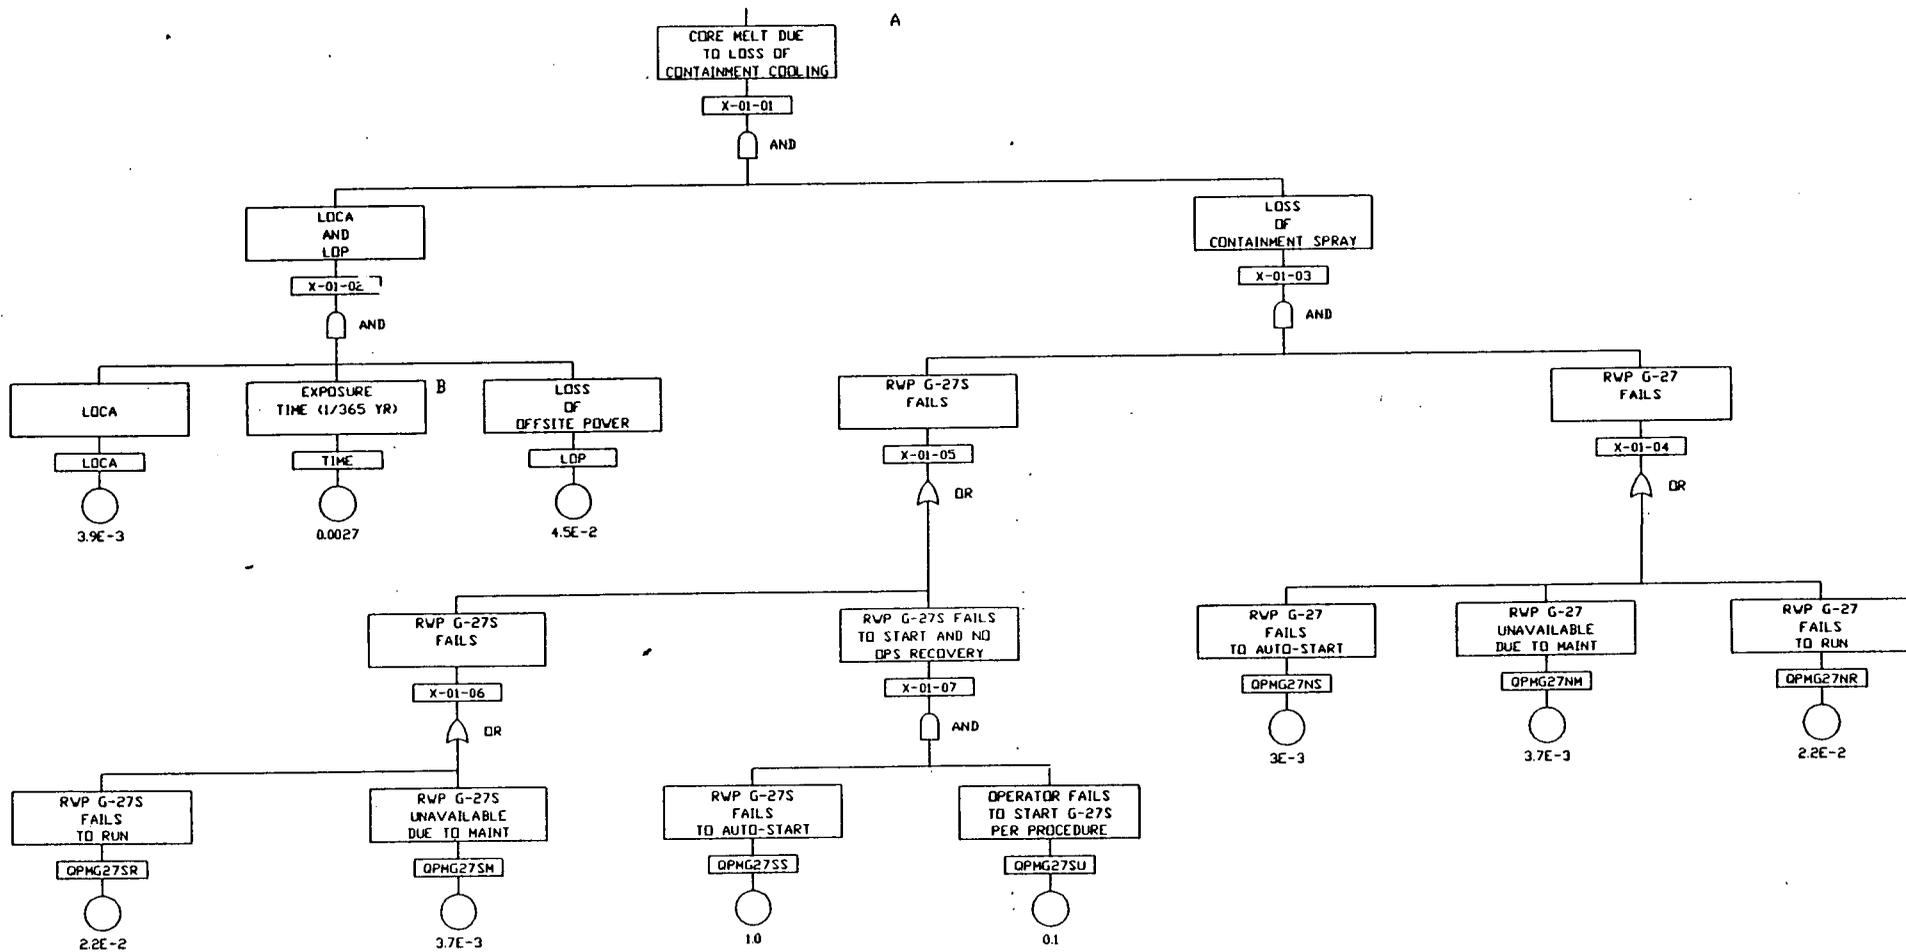
SONGS1 RWP G-27S WIRE DISCREPANCY

The calculated core melt frequency of $1.7E-9/YR$ is the expected core melt frequency due to a Loss of Offsite Power and a delayed but concurrent Loss of Coolant Accident assuming Loss of Containment Spray leads to core melt.

A) ASSUMES LOSS OF CONTAINMENT SPRAY LEADS TO CORE MELT
B) EXPOSURE TIME IS CONSERVATIVELY ASSUMED TO BE 1 DAY
