**UNITED STATES
NUCLEAR REGULATORY COMMISSION**
REGION III
2443 WARRENVILLE ROAD, SUITE 210
LISLE, IL 60532-4352

November 8, 2013

**SUBJECT: BYRON STATION, UNITS 1 AND 2, PROBLEM IDENTIFICATION AND
RESOLUTION INSPECTION REPORT 05000454/2013007; 05000455/2013007**

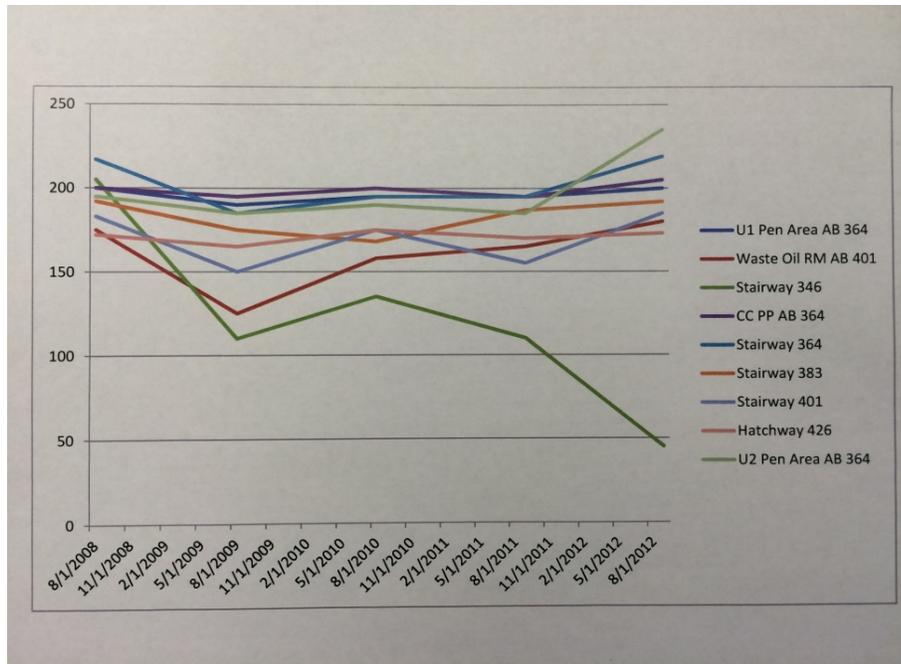
.1 Inadequate Identification of Fire Curtain Sprinkler Degradation for an Auxiliary Building Stairwell

Description: On September 18, 2013, the inspectors requested that the licensee provide an explanation for the apparent degradation of the as-found pressure readings during the annual surveillance tests performed on the elevation 346' stairwell water curtain fire barrier. On August 22, 2013, visiting NRC auditors had observed a low pressure reading for one of the auxiliary building sprinkler main drain surveillance tests. The data for the 346' stairwell indicated 45 pounds per square inch gauge (psig) although other auxiliary building sprinklers indications ranged between 173 psig and 235 psig. Section 2.3.11.3 of the Fire Protection Report stated, in part, that elevation 346' of the auxiliary building had a sprinkler system provided around the stairwell at location P-18. Licensee design drawings identified that 7 psig was required for a sprinkler head to be considered operable. Because the surveillance test readings for the subject sprinkler line were identified to be as low as 45 psig, the inspectors were concerned that the minimum pressure required for each individual sprinkler head of 7 psig may not have been met. The unusually low 346' stairwell sprinkler pressure data had not been identified by licensee personnel although the surveillance data was reviewed by the Non-Licensed Operators who performed the test and by a licensed Senior Reactor Operator. The NRC auditors requested data from previously performed annual surveillance tests for this and other sprinklers and were presented with the graph below:

This finding had a cross-cutting aspect in the CAP component of the PI&R cross-cutting area (P.1.(a)), because licensee personnel twice failed to identify the degraded sprinkler and when NRC personnel identified it and informed licensee personnel, the issue was not entered into the licensee's CAP in a timely manner.

Contrary to the above, on September 18, 2013, NRC inspectors identified that the sprinkler system at location P-18 on elevation 346' of the auxiliary building did not have the required amount of pressure to ensure the design requirement of 7 psig was met for all sprinkler heads. As part of their immediate corrective actions, the licensee declared the auxiliary building elevation 346' fire curtain inoperable and initiated compensatory measures that included fire watches until the isolation valve stem was replaced. Because this violation was of very low safety significance and because the issue was entered into the licensee's CAP as IR 1560667, "Adverse Trend in Main Drain Results for 346 AB Sprinkler System," this violation is being treated as a NCV, consistent with Section VI.A.1 of the NRC Enforcement Policy. **(NCV 05000454/2013007-01; 05000455/2013007-01: Inadequate Identification of Fire Curtain Sprinkler Degradation for an Auxiliary Building Stairwell)**

As part of the licensee's corrective actions, the licensee replaced the bent isolation valve stem. In addition, as-found pressures were taken before the isolation valve was repaired, a hydraulic analysis was performed to more accurately assess past system operability, the engineering staff was added to the list of personnel who received the surveillance test data, and the engineer who failed to initiate the IR received additional training and counseling.
