STATUS REPORT ON THE
INVESTIGATION OF THE DEWATERING SYSTEM
SAN ONOFRE NUCLEAR GENERATING STATION, UNITS 2 & 3
MARCH 1979

This report documents the status of the investigation and actions being performed on the dewatering system at the San Onofre Units 2 and 3 construction site and provides a summary of work accomplished from November 1978 through February 15, 1979.

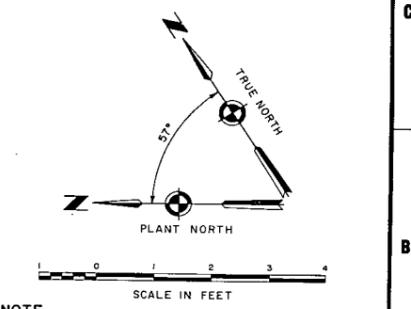
FIGURE 4

The four vertical exploration holes proposed in the October status report were drilled to 200 feet, and 4-inch diameter PVC was grouted in-place for the cross hole seismic survey. Materials encountered during drilling included backfill sand from ground surface to as deep as 10 feet below ground surface, with in-place San Mateo Formation comprising the remainder of the hole. The location of the holes and measured drift is shown on Figure 4.

Preliminary evaluations of the cross hole seismic survey data from Well 10 suggested the presence of two possible small cavity regions, one at 40 to 50 feet and another at about 120 feet.

To further investigate the presence or absence of cavities in these regions, three additional borings (10B-5 through 10B-7) were drilled as shown on Figure 4. Borings 10B-5 and 10B-6 were drilled to 130 feet and 125 feet, respectively, and 10B-7 was drilled to 70 feet. In the interval of suspected small cavities, the Standard Penetration Test interval was reduced from 10 feet to 2.5 feet to insure adequate coverage. Throughout the program at Well 10, there was no indication from the drilling that cavities exist at this well. The results of this drilling, combined with the fact that Well 10 is not located near Seismic Category I structures, suggests that no additional exploration is necessary.

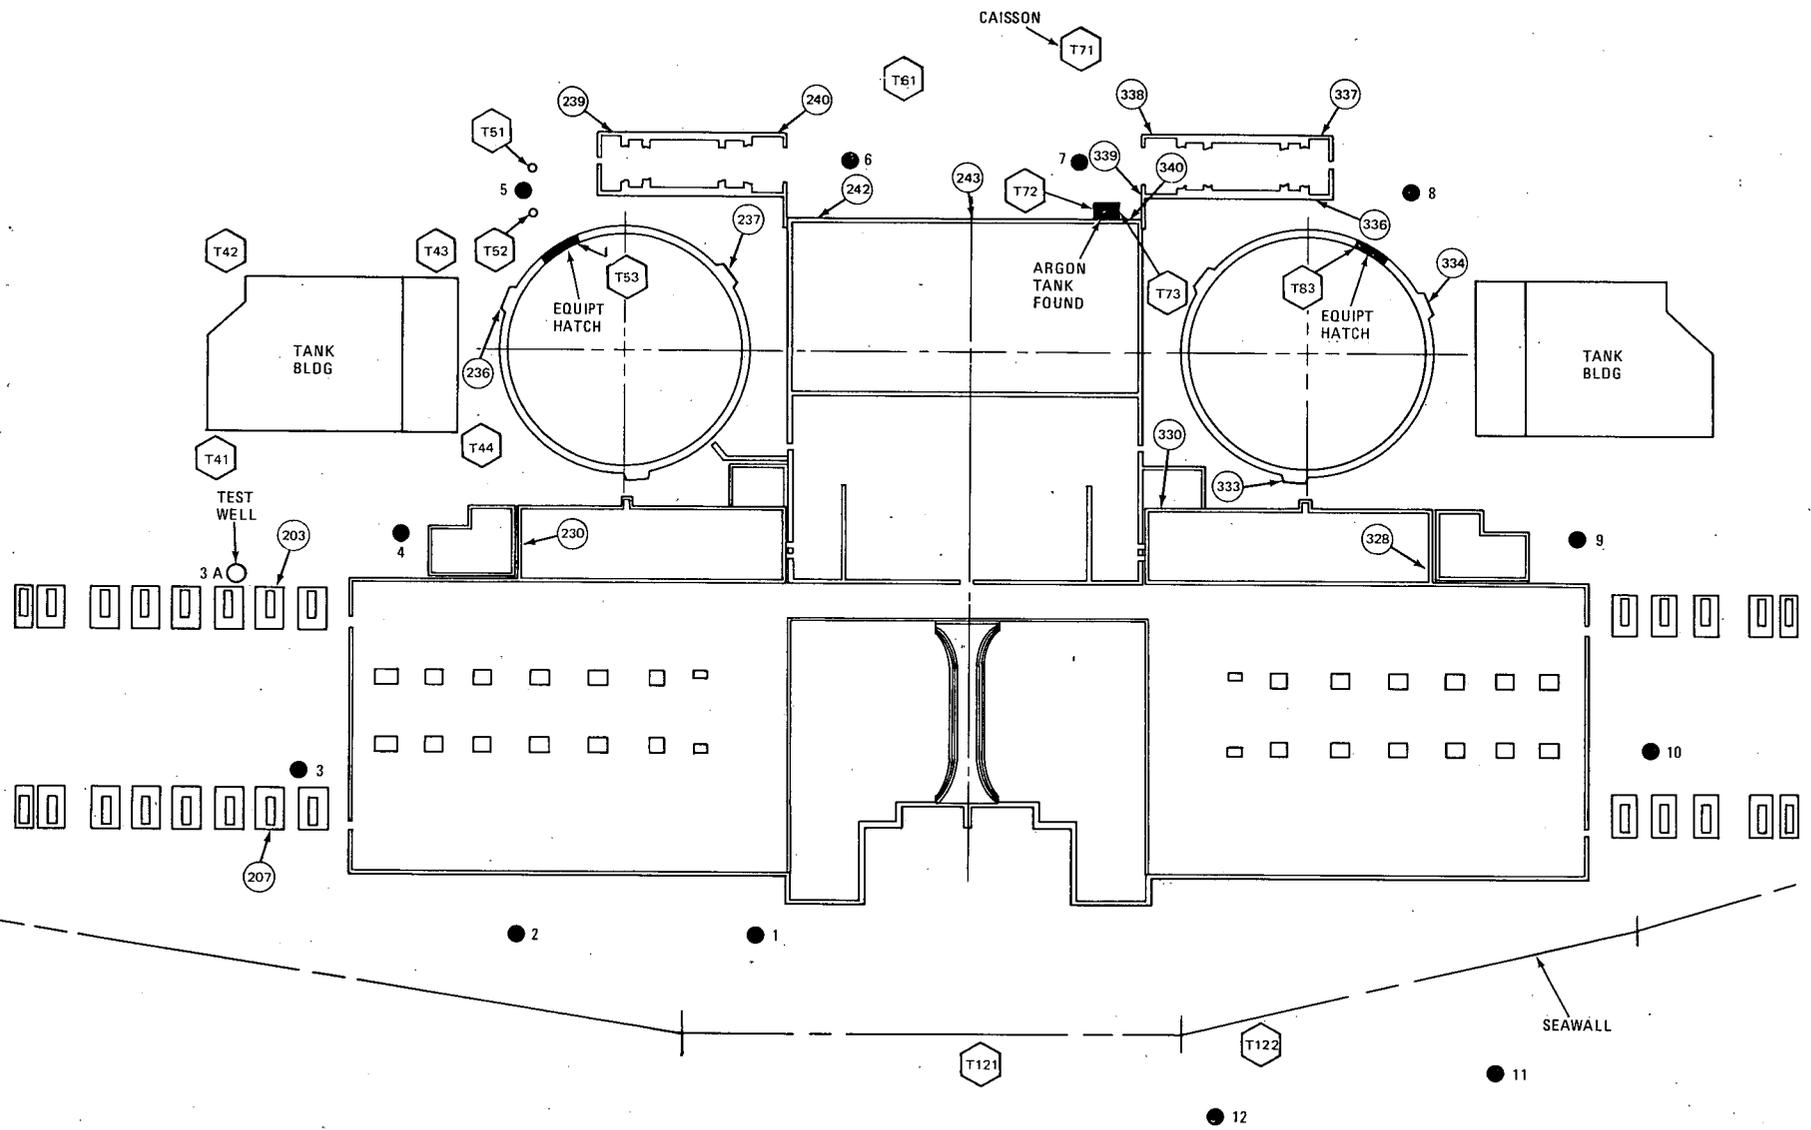
FIGURE 5

A settlement observation monitoring program is being used to monitor the possible settlement of structures or components which are founded above or around those dewatering wells being investigated and demobilized. The settlement monitoring system involves 43 observation points, 31 of which have been installed to date. Most of the observation monuments not yet installed will be located on the Unit 3 electrical tunnel and tank building when the structures are completed. For reference, Figure 5 is included to show the physical location of the various settlement observation monuments in current use.

A review of the settlement observation data indicates that no significant movement has occurred.
