U.S. NUCLEAR REGULATORY COMMISSION
REGION IV

Inspection Report: 50-206/94-23

Facility Name: San Onofre Nuclear Generating Station (SONGS), Unit 1

Inspection Conducted: October 3-6, 1994

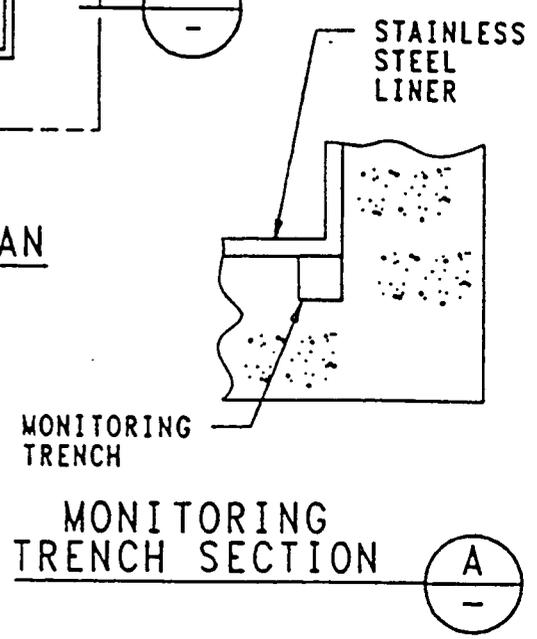
FIGURE 2

The current leakage from the spent fuel pool is approximately 2 gal/week. Historical leakage rates are tabulated in Table 1 and are approximate. The leakage paths will follow the gap between the liner plate and concrete, and go to either the 1 inch square or 2 inch square trenches underneath the liner plate. The water is then drained to the leak detection monitoring well (see Figure 2).
