SUBJECT: LER 87-012-00: on 870622, During safety injection tank (SIT) filling, nitrogen cover pressure decreased to 580 psig. Caused by operator failure to properly implement fill procedure. Operator diciplined & fill procedure revised. W/870722 ltr.

TITLE (4)
TECHNICAL SPECIFICATION 3.0.3 ENTRY DURING SAFETY INJECTION TANK (SIT) FILLING

SAN ONOFRE NUCLEAR GENERATION STATION UNIT 3	DOCKET NUMBER 05000362	LER NUMBER 87-012-00	PAGE 2 OF 4
---	---------------------------	-------------------------	----------------

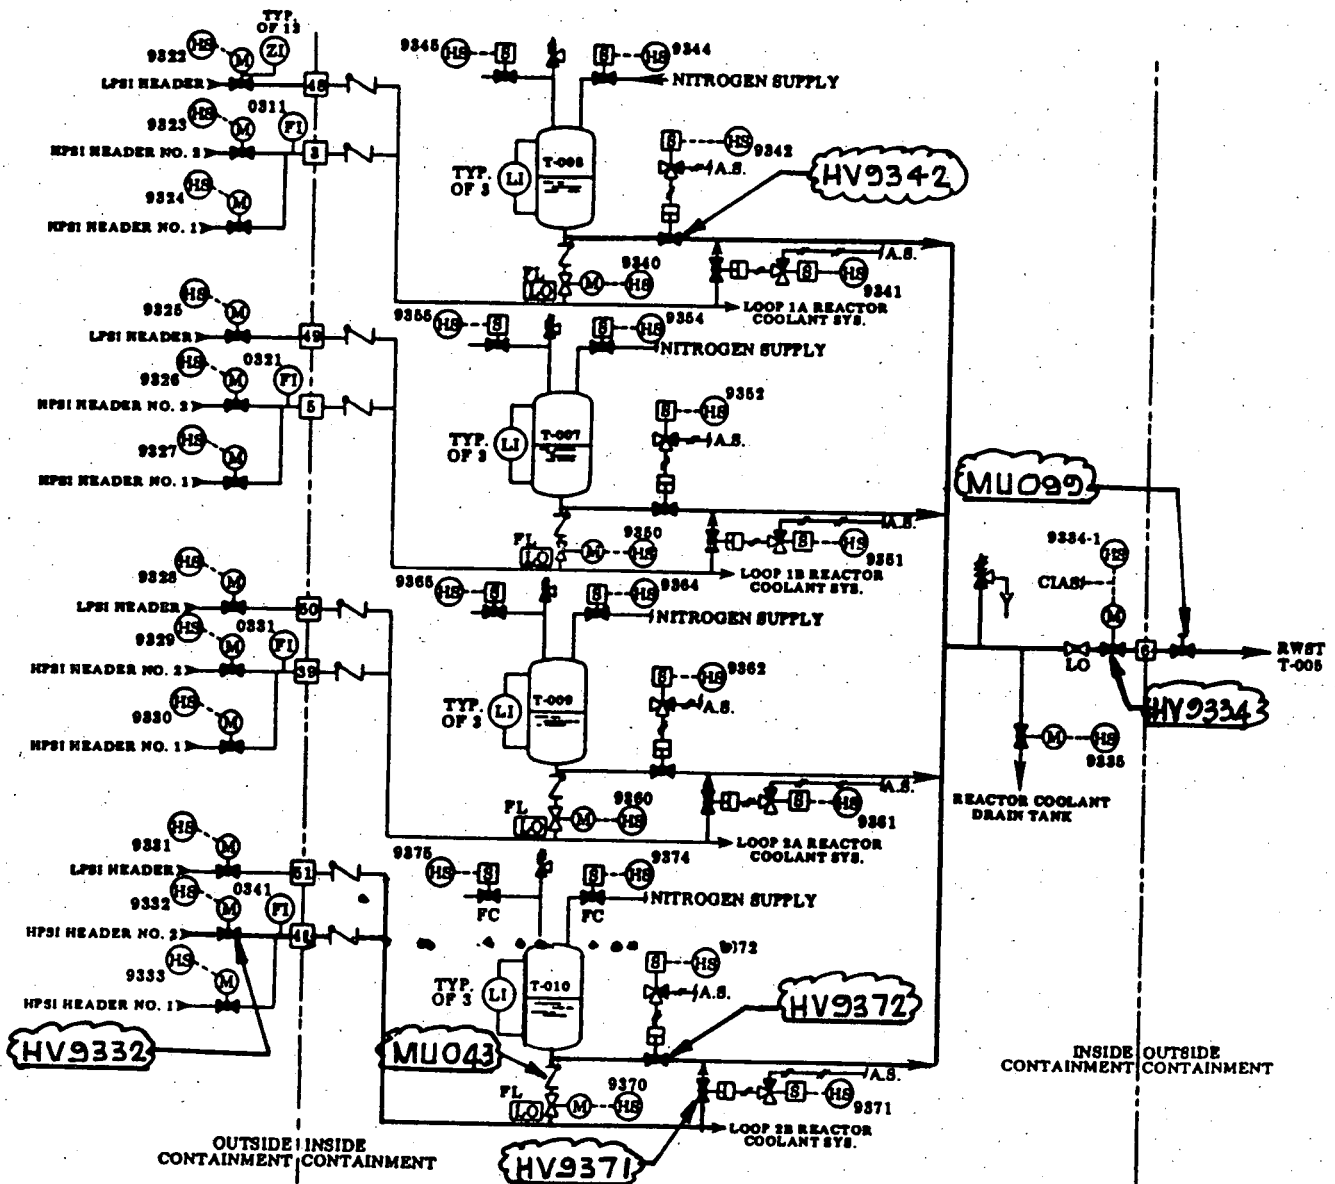
The four SITs (EIIS Component Code TK)(EIIS System Code BP) are aligned to the four Reactor Coolant System (RCS) loop injection lines, and provide borated water to the RCS during large break loss of coolant accidents (LOCA) using a nitrogen cover pressure as the motive force for flow. The loop injection lines are all cross connected to each other via the SIT common fill and drain header (normally depressurized) through associated recirculation/fill valves (normally closed). Each SIT discharge line contains (in order starting nearest the SIT) a fill and drain line connection, a discharge check valve, and a discharge isolation valve (normally open). Each SIT fill and drain line is connected to the common fill and drain header and contains a fill/drain valve which is normally closed. This arrangement allows the filling of a SIT from any one of the four injection loops. (See simplified piping schematic)

The common SITs drain valve (HV9334) to the RWST and SIT T-010 recirculation/fill valve (HV9371) were fully opened for recirculation and sampling of the SIT fill and drain header. However, because MU-099 had not been opened, there was no path for recirculation and the fill and drain header became pressurized to the HPSI shutoff head. This had the effect of exacerbating the in-leakage through SIT T-008 fill/drain valve HV9342.

At this time, increasing pressure in SIT T-008 was noted and venting was initiated. While SIT T-008 was being vented, the control room supervisor (CRS) noted position indication for MU-099 indicated closed and immediately directed the PEO to open the valve. The PEO immediately opened MU-099. Although the CRS initiated this action to mitigate the SIT T-008 pressure rise, he did not recognize that opening MU-099 would result in depressurizing the fill and drain header and safety injection loop 2B to below SIT T-010 cover pressure.

The root cause of the event was failure of the CO involved to implement the procedural steps in their proper sequence. As corrective action, the CO involved received appropriate disciplinary action. The importance of properly following procedures and attention to detail were re-emphasized to all Unit 2 and 3 Operators during shift briefings. Also, the SIT fill and drain procedure will be further revised to include a precaution on operating valves in the proper sequence. Additionally, SIT T-008 fill and drain valve is scheduled to be inspected during the next outage of sufficient duration, and repairs will be made as appropriate.
