UPDATE REPORT ON IE BULLETIN 79-17

INSPECTIONS OF STAINLESS STEEL SAFETY RELATED
PIPING CONTAINING STAGNANT, OXYGENATED,
BORATED WATER

SAN ONOFRE NUCLEAR GENERATING STATION
UNIT 1

October 5, 1979

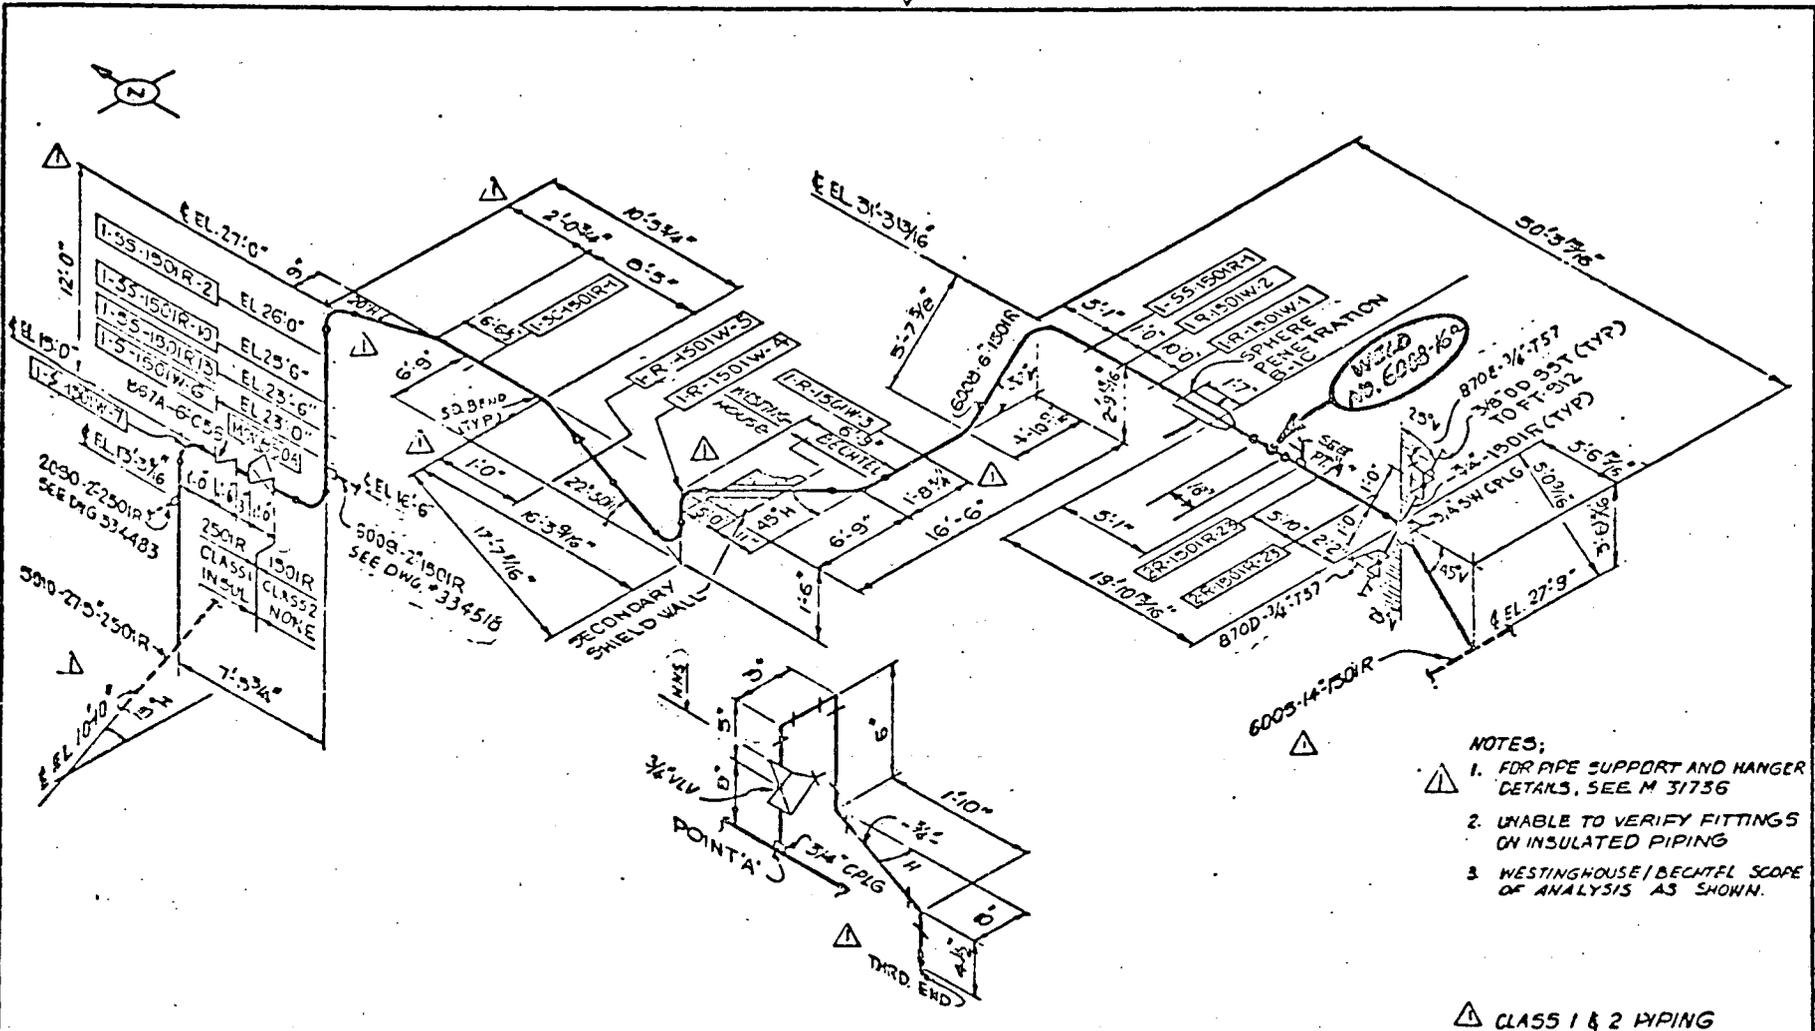
△ 334583-2

An indication in Weld No. 6008-16a of Line No. 6008-6"-1501R was detected by ultrasonic methods on September 15, 1979. When radiographic examination produced inconclusive results, the decision was made to remove and replace the section in question.

An 18" section containing Weld No. 6008-16a was cut from the line and a replacement piece welded in. (Reference attached Dwg No. 334583 for weld locations.) The replacement piece was SA-312, type 316, schedule 80 pipe.

Repair, visual inspection and in-service leak testing was in accordance with the requirements of ANSI-B.31.1-1977. The hot pass of each new weld was dye penetrant inspected and the completed welds were radiographed.
