U.S. NUCLEAR REGULATORY COMMISSION

Report Nos. 50-206/88-16, 50-361/88-15, 50-362/88-16  
Docket Nos. 50-206, 50-361, 50-362  
License Nos. DPR-13, NPF-10, NPF-15  
Licensee: Southern California Edison Company  
P. O. Box 800, 2244 Walnut Grove Avenue  
Rosemead, California 92770

Facility Name: San Onofre Units 1, 2 and 3  
Inspection at: San Onofre, San Clemente, California  
Inspection conducted: May 22 through July 2, 1988

Inspection on May 22 through July 2, 1988 (Report Nos. 50-206/88-16, 50-361/88-15, 50-362/88-16)

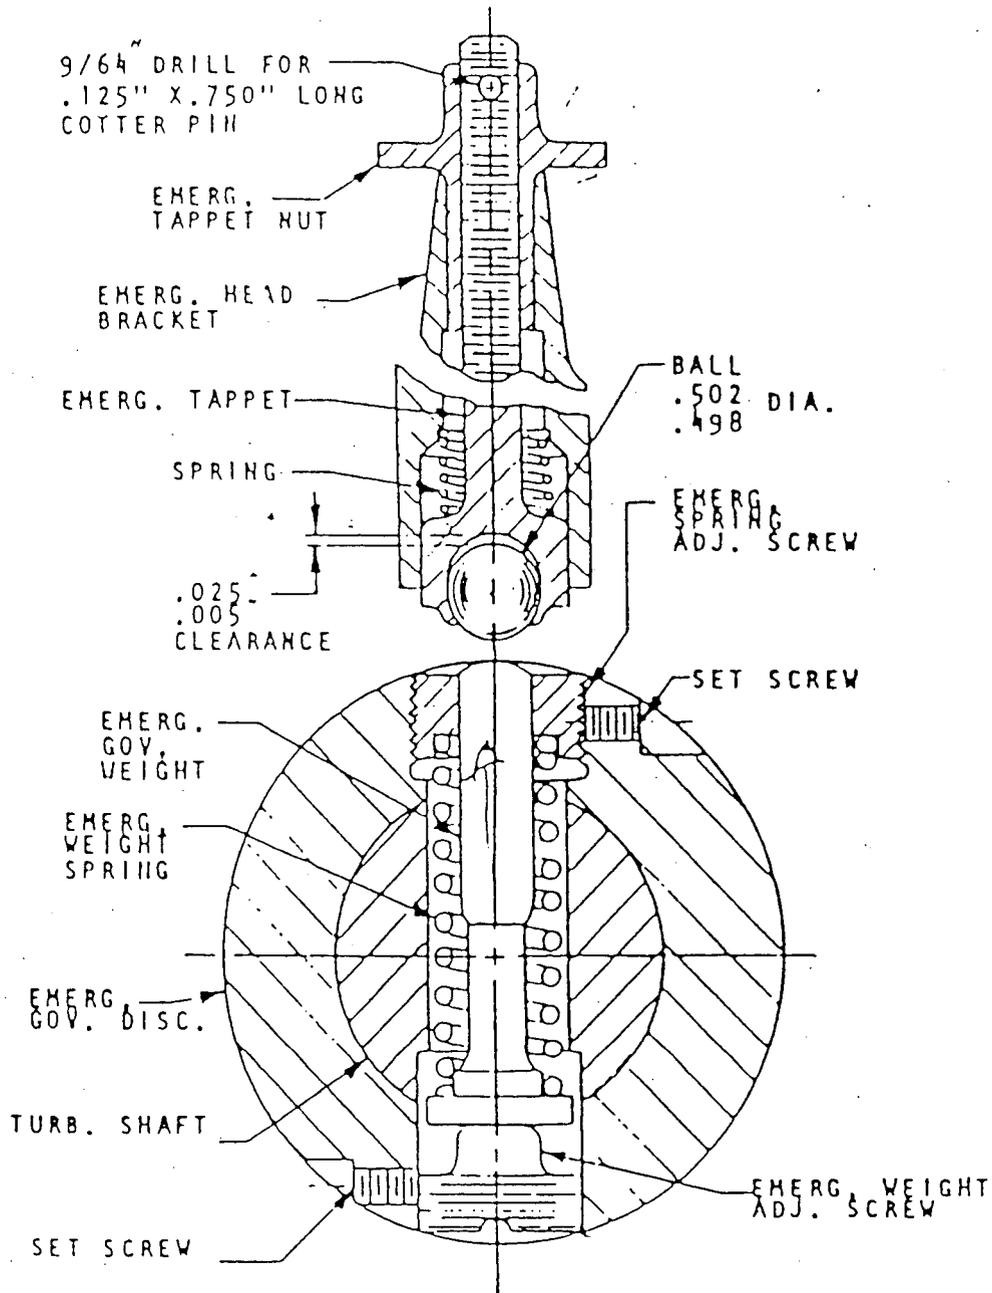
FIGURE 1

- ° Cause of Turbine Overspeed: Upon loss of power, turbine governor valve 2HV-4700 is designed to fail in the open position to allow for manual control of the turbine. When open indication on valve 2HV-4716 was not received and the technicians disconnected the test power supply, the governor valve failed open, admitting full steam flow to the turbine. The turbine did not trip on mechanical overspeed at 3900 rpm due to a damaged emergency tappet ball (see Figure 1, attached). The ball is made of polyurethane and a piece was missing such that the emergency governor weight could not impact the ball during the overspeed condition. The licensee discussed this condition with the vendor (The Terry Turbine Company) and learned that there have been other occurrences of emergency tappet ball failures. The vendor had changed the design of this part and currently recommends a yearly inspection to verify integrity. The licensee learned that the vendor did not issue any bulletins relative to these changes. The licensee was also considering the resportabilty of this failure pursuant to 10 CFR Part 21.

- Portions of the auxiliary feedwater system exposed to 2P-140 discharge pressure were visually inspected, including pipe supports.
- The emergency tappet ball assembly was replaced. The licensee has ordered replacement parts to conform with the vendor's current design and plans to install the new design in Units 2 and 3 upon availability of parts. The emergency tappet ball assembly on the turbine for 3P-140 (Unit 3) was to be inspected prior to returning the unit to service. The licensee will require visual inspection of the emergency tappet assembly annually as recommended by the vendor.

TERRY TURBINE EMERGENCY OVERSPEED TRIP DEVICE

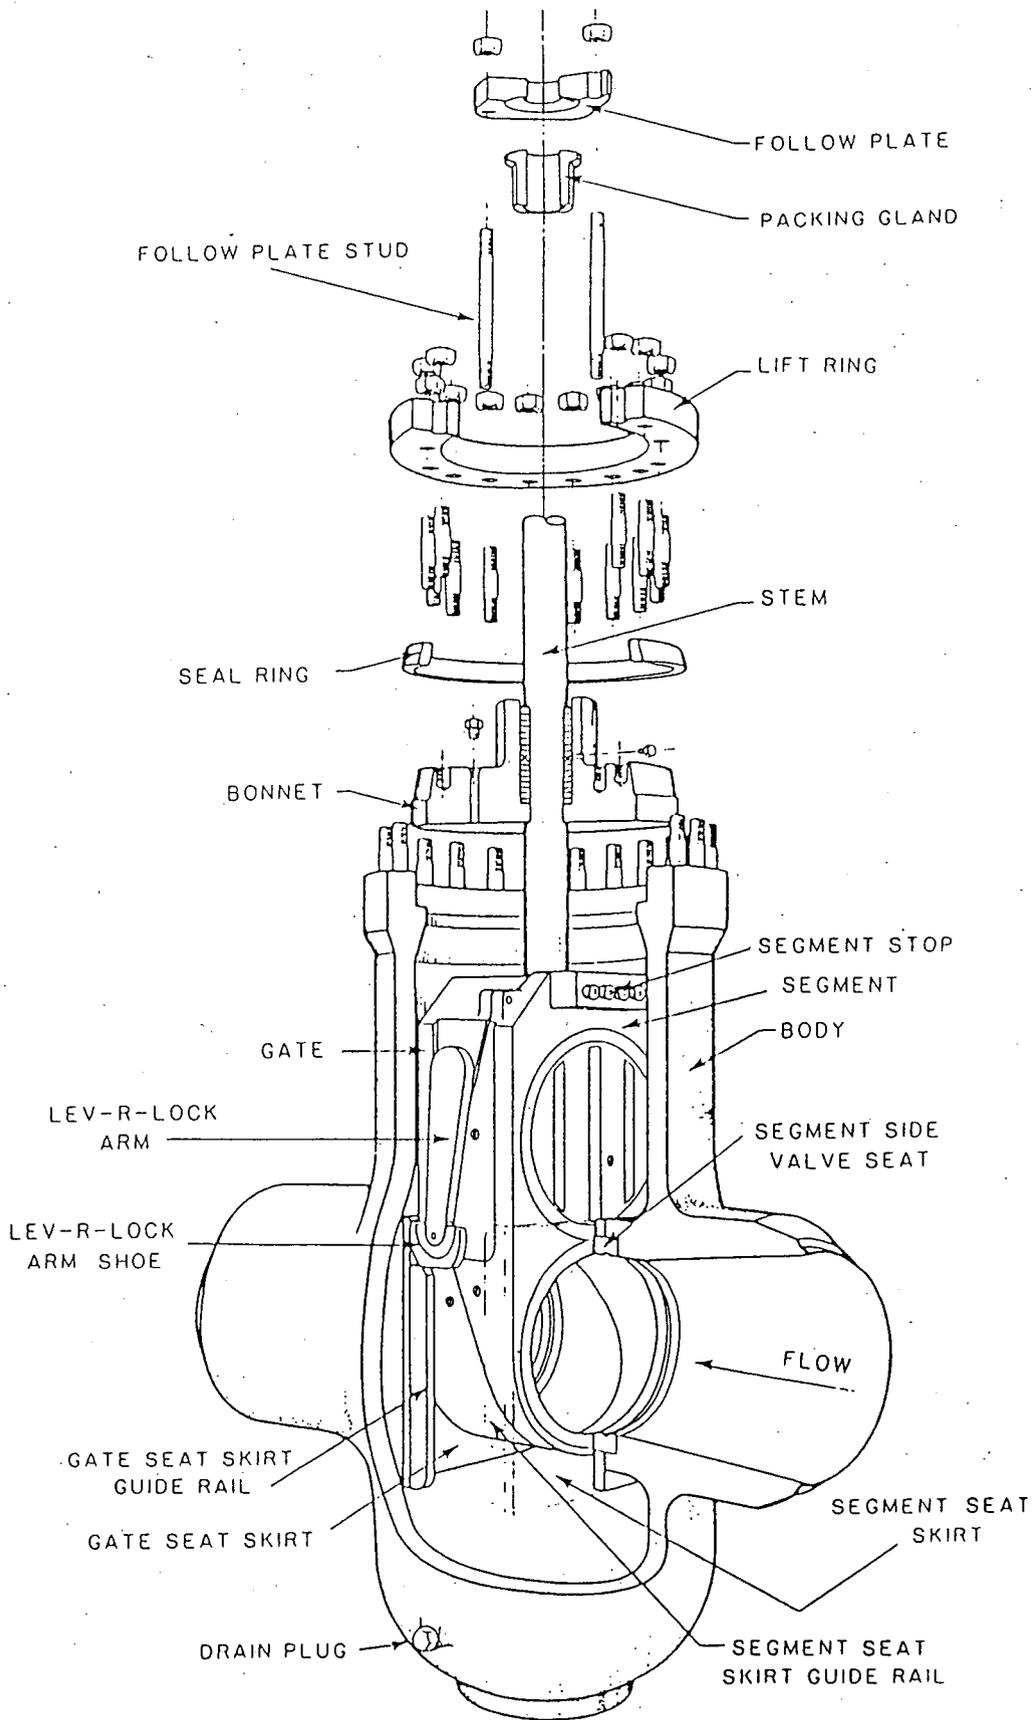
FIGURE 2

On June 2, 1988, work was being done in accordance with M088030500 to adjust the Limatorque actuator limit switches for shutdown cooling suction isolation valve 3HV-9378. The valve was manually opened and, as the electricians started manually closing the valve to set the open limit switches, the valve became difficult to operate at approximately 10% closed. Nonconformance report (NCR) 3-2002 was initiated to investigate and resolve this condition. Valve 3HV-9378 is a 10" Pow-R-Seal gate valve manufactured by WKM Flow Control Division of Cooper Industries, and is similar in design to (but smaller than) the main steam isolation valves discussed in paragraph 5.d of this report (see Figure 2).

- ° The top capscrew on each guide rail for the gate skirt assembly was sheared off.
- ° The guide rail skirt ("gate seat skirt" in Figure 2) had failed in tension into two pieces. The failure occurred through the second bolt hole from the top of the skirt on each side, where the metal thickness was at a minimum.
- ° The gate guide rails were intact and still bolted to the bottom half of the skirt. The top horizontal and beveled surfaces of the guide rails were severely galled.
- ° The Lev-R-Lock arm shoes were galled on the bottom horizontal surfaces and one shoe was wedged into the Lev-R-Lock arm pivot slot.

Based on the discrepancies identified, the licensee's preliminary evaluation concluded that valve failure was caused by valve overtravel in the open direction. Due to the gear reduction ratio provided by the Limitorque actuator, the electrician was able to overtorque the valve in the open direction which resulted in this "overtravel" condition.

WKM POW-R-SEAL GATE VALVE

- All defective components associated with 3HV-9378 were replaced with qualified spare parts.
- Procedures were changed to limit the amount of travel allowed when manually opening this type of valve.
- Additional MOVATS testing was conducted on other shutdown cooling suction isolation valves to confirm that anomalies did not exist in the current traces.
