Subject: Palo Verde Nuclear Generating Station (PVNGS)

American Society of Mechanical Engineers (ASME) Code, Section XI, Request for Approval of an Alternative to Flaw

Removal and Characterization - Relief Request 51

Relief Request 51 Proposed Alternative in Accordance with 10 CFR 50.55a(a)(3)(i)

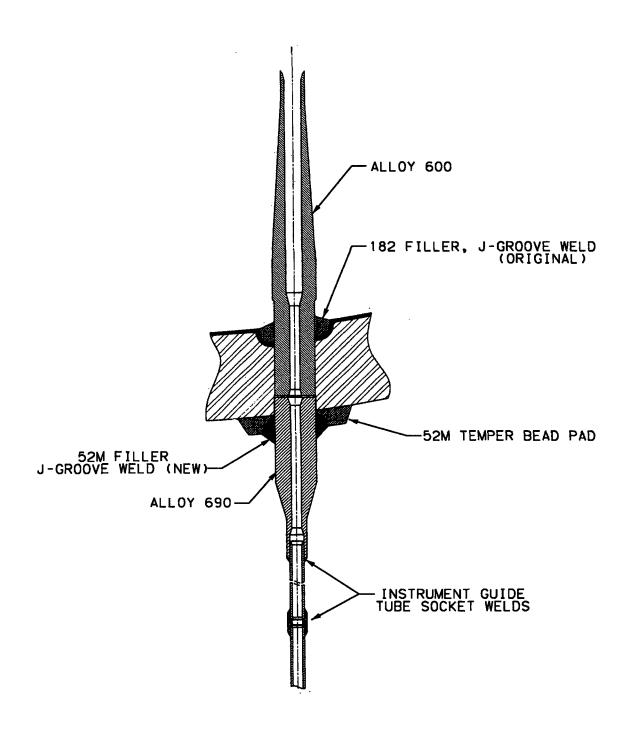
Figure 1 -Half-Nozzle Repair Details

The original nozzle at BMI penetration #3 is Alloy 600 material and has an inner diameter of 0.75 inches, an outer diameter of 3 inches. The nozzle is welded to the inner surface of the reactor vessel. The exterior portion of the nozzle extends approximately 9 inches below the reactor vessel where it is welded to the 0.75 inch, schedule 80 instrument guide tube. The upper portion extends approximately 20 inches above the J-groove weld. The instrument guide tube extends to the seal table located in the reactor cavity. The RCS pressure boundary is formed by the J-groove weld between the nozzle and the reactor vessel and the nozzle to instrument guide tube weld.

The half-nozzle repair relocated the nozzle pressure boundary from the inner reactor vessel to the outside of the vessel. The existing Alloy 600 nozzle was cut within the reactor vessel wall and approximately five inches of the remnant nozzle portion will remain inside the RV BMI penetration. A new Alloy 690 nozzle was inserted in place of the bottom portion of the original nozzle with was removed. The Alloy 690 nozzle inner and outer diameters are nominally 0.75 inches and 3 inches, respectively (unchanged from original design). A J-groove weld joined the new half-nozzle to a new Alloy 52M ambient temperature temper bead weld pad.

With the installed repair, the new RCS pressure boundary for this penetration is formed by the J-groove weld between the Alloy 690 outer nozzle and the temper bead weld pad and by the welds between the nozzle and the ICI guide tube.

Upon completion of the repair, the remnant nozzle and J-groove weld serve as an attachment to the reactor vessel and no longer serve as the RCS pressure boundary for this penetration.
