Subject: Palo Verde Nuclear Generating Station (PVNGS) Unit 3 Docket No. 50-530 American Society of Mechanical Engineers (ASME) Code, Section XI, Request for Approval of an Alternative to Flaw Removal and Characterization - Relief Request 51

Relief Request 51 Proposed Alternative in Accordance with 10 CFR 50.55a(a)(3)(i)

ATTACHMENT 1 – Half-Nozzle Repair Details

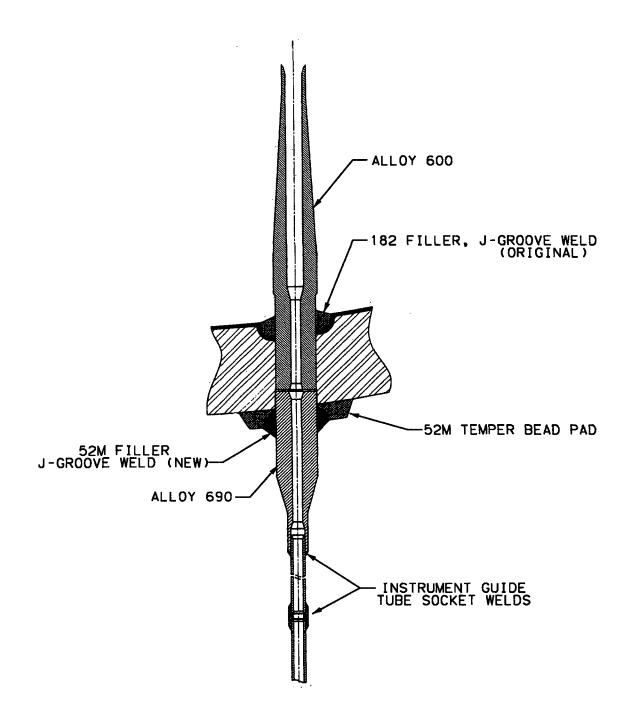
Figure 1 -Half-Nozzle Repair Details

The original nozzle at BMI penetration #3 is Alloy 600 material and has an inner diameter of 0.75 inches, an outer diameter of 3 inches. The nozzle is welded to the inner surface of the reactor vessel. The exterior portion of the nozzle extends approximately 9 inches below the reactor vessel where it is welded to the 0.75 inch, schedule 80 instrument guide tube. The upper portion extends approximately 20 inches above the J-groove weld. The instrument guide tube extends to the seal table located in the reactor cavity. The RCS pressure boundary is formed by the J-groove weld between the nozzle and the reactor vessel and the nozzle to instrument guide tube weld.

With the installed repair, the new RCS pressure boundary for this penetration is formed by the J-groove weld between the Alloy 690 outer nozzle and the temper bead weld pad and by the welds between the nozzle and the ICI guide tube.

Upon completion of the repair, the remnant nozzle and J-groove weld serve as an attachment to the reactor vessel and no longer serve as the RCS pressure boundary for this penetration.

The half-nozzle repair relocated the nozzle pressure boundary from the inner reactor vessel to the outside of the vessel. The existing Alloy 600 nozzle was cut within the reactor vessel wall and approximately five inches of the remnant nozzle portion will remain inside the RV BMI penetration. A new Alloy 690 nozzle was inserted in place of the bottom portion of the original nozzle with was removed. The Alloy 690 nozzle inner and outer diameters are nominally 0.75 inches and 3 inches, respectively (unchanged from original design). A J-groove weld joined the new half-nozzle to a new Alloy 52M ambient temperature temper bead weld pad.

See Figure 1 for BMI nozzle penetration #3 configuration.
