Attachment to
SCE-90-695
MED-RPV-3056

REVIEW AND ASSESSMENT OF SONGS 1
LOWER REACTOR INTERNALS AND VESSEL INSPECTION
(SUMMER 1990)

WESTINGHOUSE ELECTRIC CORPORATION
Nuclear and Advanced Technology Division
P.O. Box 2728
Pittsburgh, Pennsylvania 15230-2728

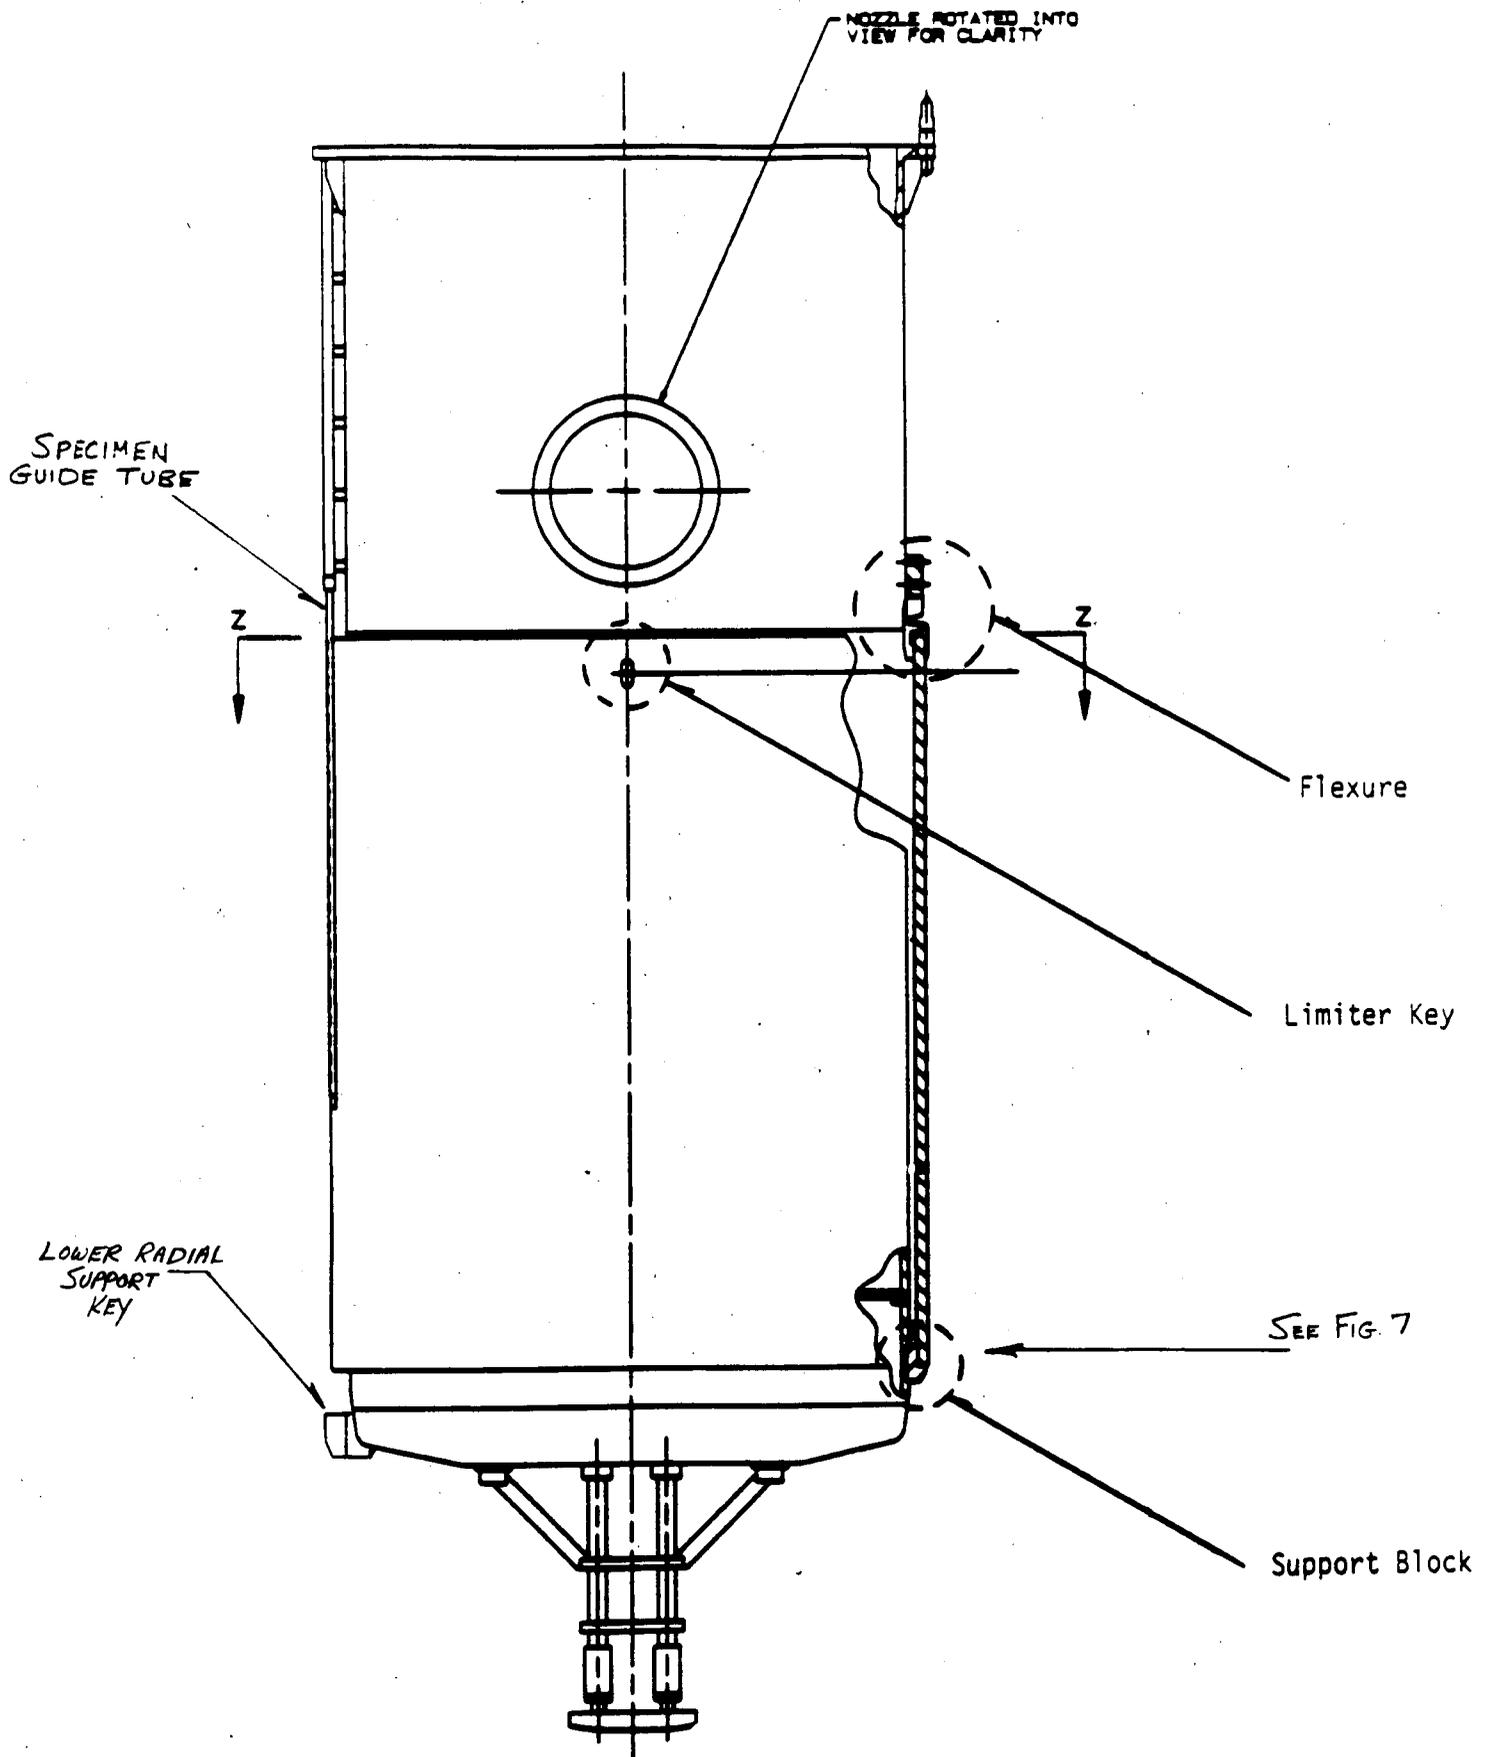
FIGURE 1

Of particular interest was the condition of the Internals Thermal Shield and its various attachments and contacts with the Lower Core Barrel; namely the Flexures, Limiter Keys, and Irradiation Specimen Guides near the top of the Shield, and the Support Blocks and Fasteners near the bottom. (See Figures 1 & 2 for the disposition of these components.)

F. Lower Radial Support Keys and Vessel Keyways (See Figure 1)

1. An examination of the 6 Lower Radial Support keys showed no anomalies. The keys, situated near the lower end of the separate Reactor Internals, engage 6 keyways in the Pressure Vessel, (tight fit), to position the Internals and limit the amplitude of any flow induced vibration. The vessel keyways looked equally good, with all their attachment bolts and locking bars appearing unimpaired. Bearing surfaces appeared clean and burnished with no obvious signs of severe wear or impact damage. (The clearance in this fit is .010 inches per surface, tangentially.)

G. Reactor Internals and Vessel Outlet Nozzles (See Figure 1)

1. A scan of the three outlet nozzle faces on both the Pressure Vessel and Lower Reactor Internals disclosed nothing unusual. No striations or signs of impact damage or fretting wear is evident. The fact that these close-fitting interfacing surfaces are "clean" denotes a stable Lower Internals Assembly. The condition of the Lower Radial Support Keys and Keyways, (F above), also support this conclusion.

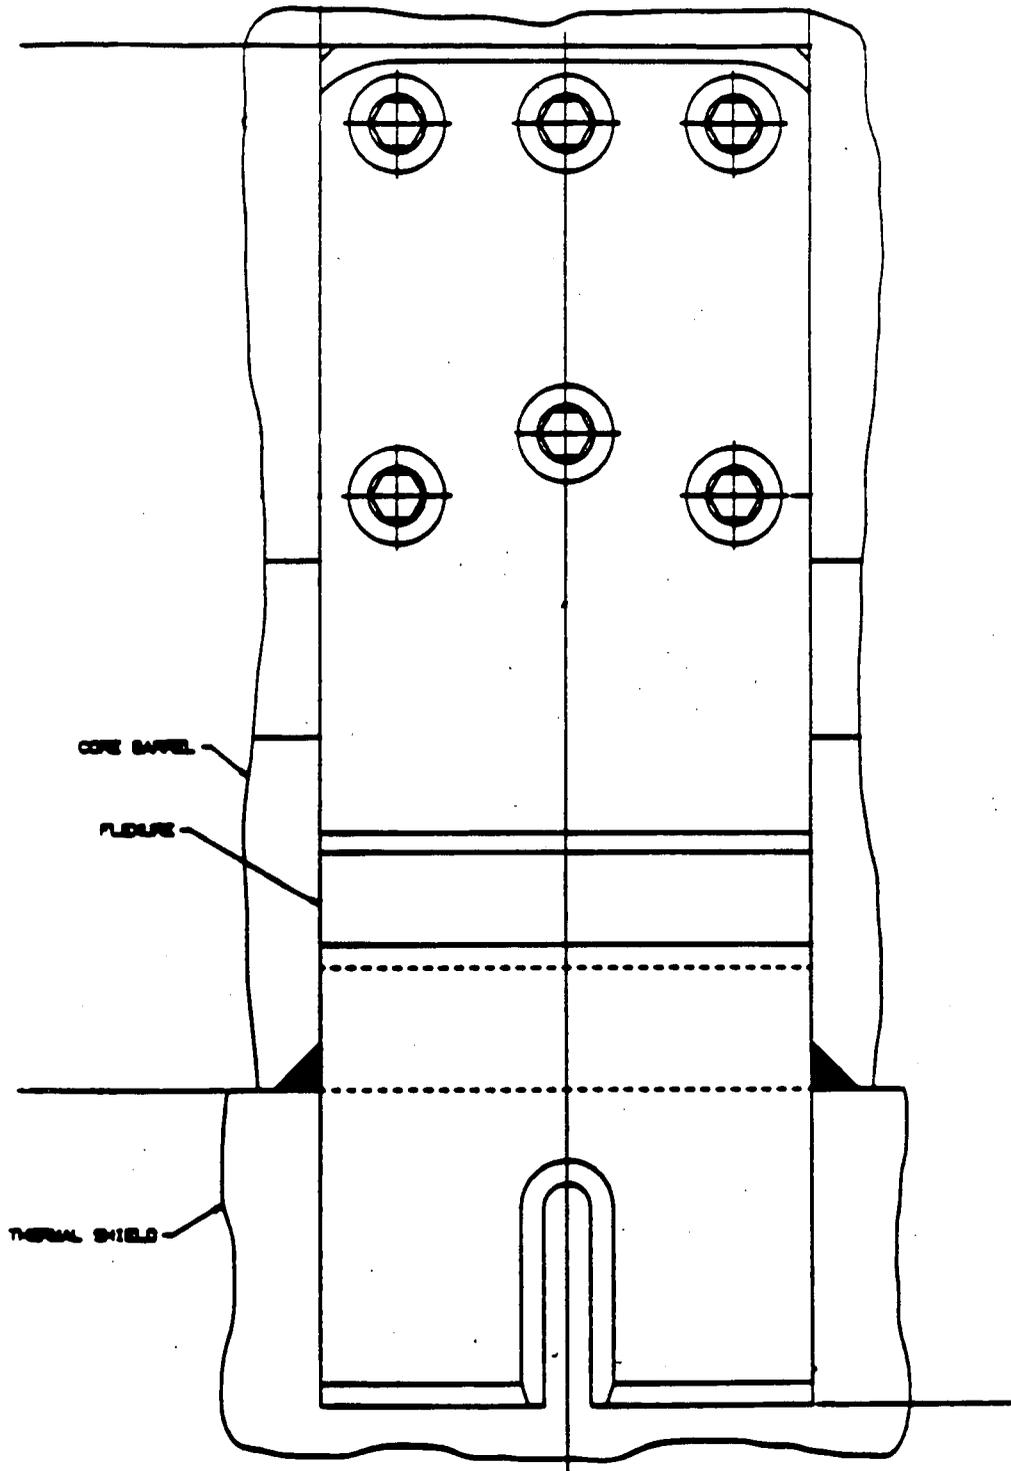
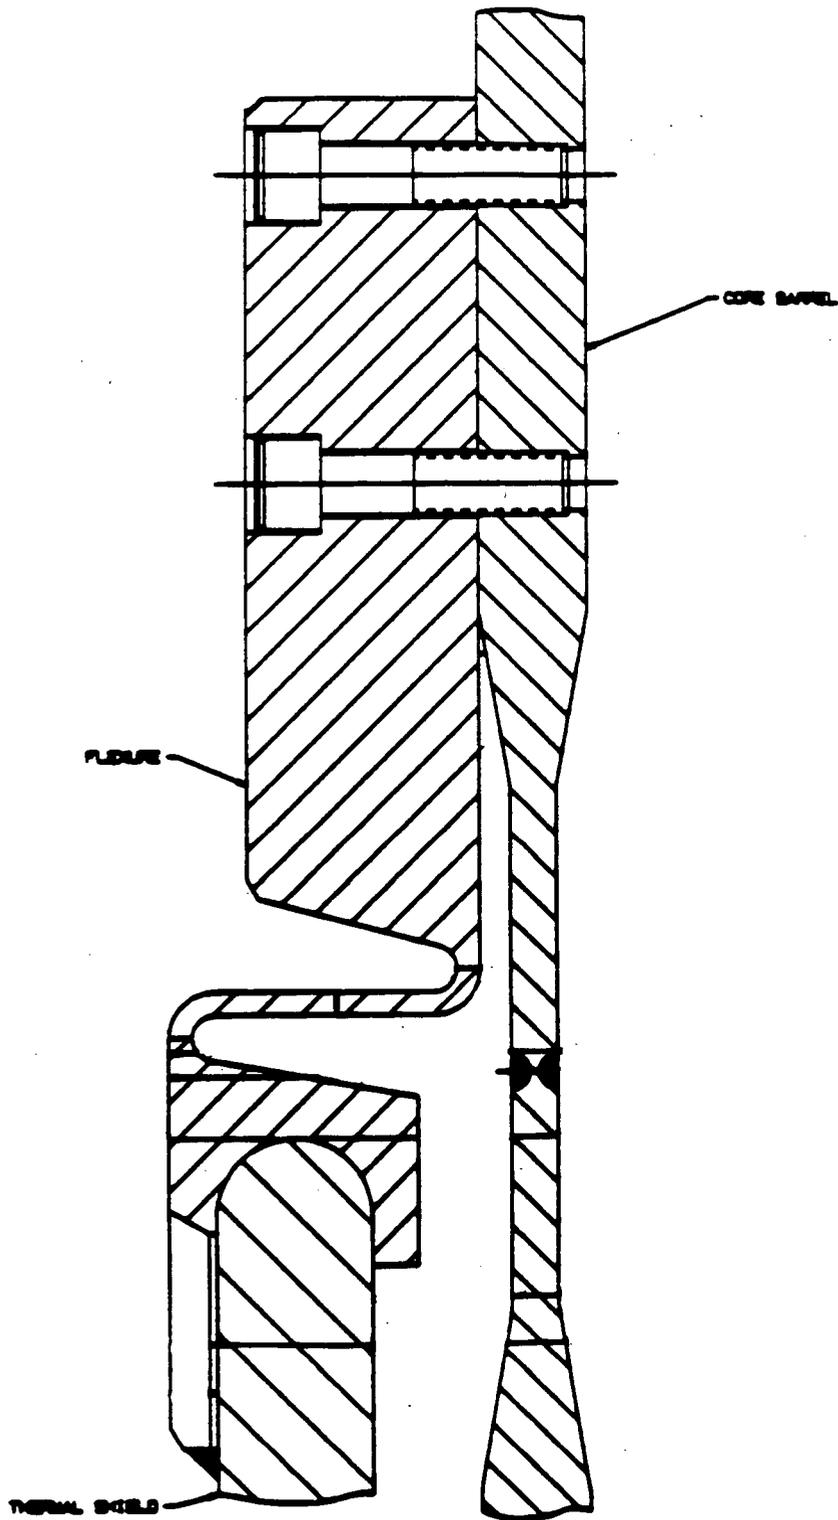
FIGURE 3

A. Flexures (See Figures 3 & 4)

1. 5 of 6 cracked and fully severed across entire 8.0 inch width.
2. Locations - 21°, 85°, 205°, 244°, and 325°. These same 5 flexures were seen to be broken in 1988 when the Lower Internals were partially inspected.
3. The 124° flexure remains undamaged.
4. All cracks appear to have emanated from the Heat Affected Zone (HAZ) of each flexure blade, (thermal shield side exclusively), and then randomly progressed across the 8 inch width until the blades were completely separated.

5. The "widest" gap in the cracked flexure blades appears to be the 325 flexure, where the gap width is estimated to be 3/16 inch at its widest.
6. The welds attaching the flexures to the thermal shield have no anomalies and the flexure block and the screws which attach them to the core barrel are as they should be.

4. 21°, 325°, and 244° Flexures are fractured with the 325° flexure exhibiting the largest "gap" between the separated sections of the flexure blade, 3/16 inch.

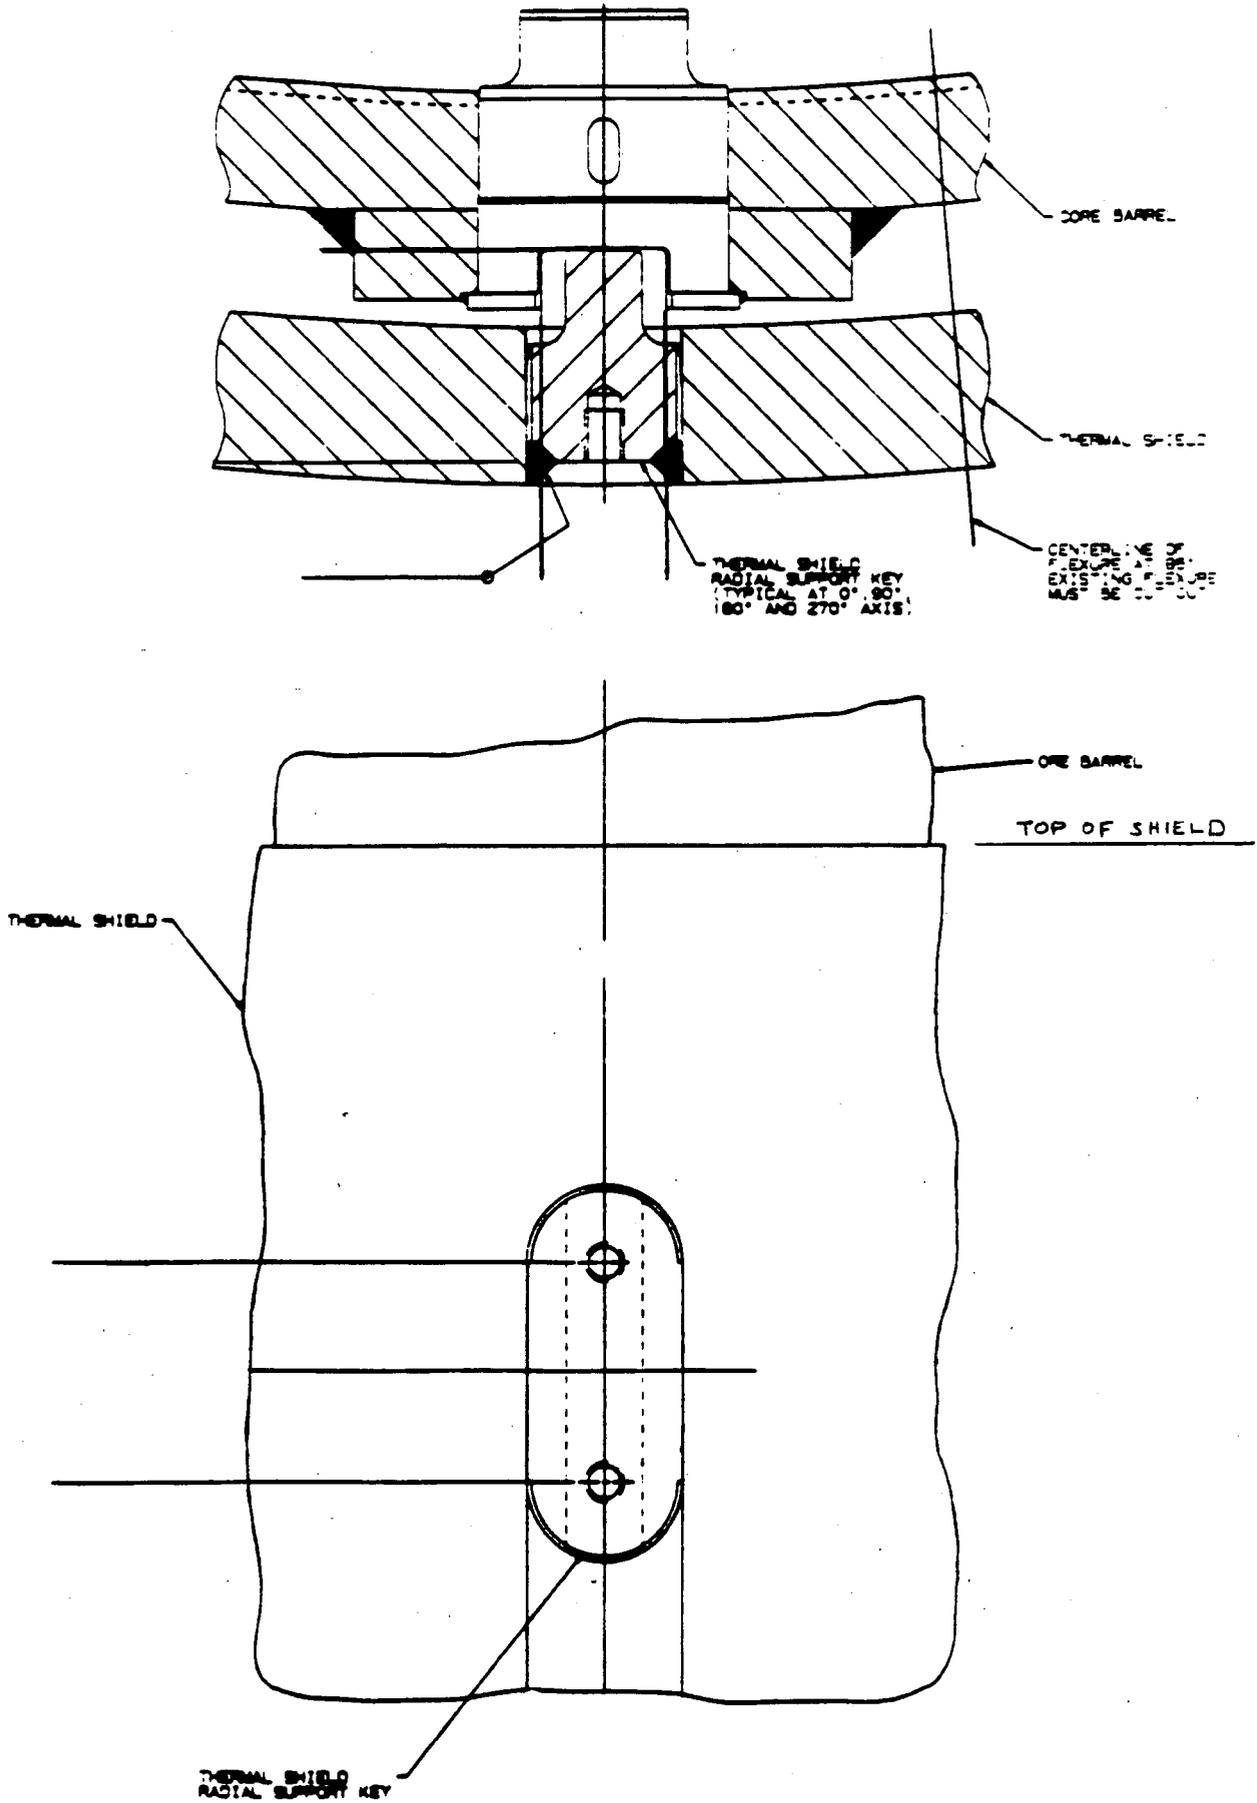
FIGURE 5

B. Limiter Keys (See Figure 5)

1. The four limiter keys (0°, 90°, 180°, 270°) each initially had a "cold" radial clearance or "gap" of .024 inches between the "nose" of the key and the opposing point on the core barrel.
2. The "gaps" measured during this repair outage were:

0° - .100 - .170 inches (range)
 90° - .024 inches
 180° - .028 inches
 270° - .213 - .233 inches (range)

4. The tangential gaps between the Limiter Pin noses and the side of the keyway type configurations in the core barrel component were nominally 3/8 inches as installed. Recent measurements disclose: (looking down, standing outside the thermal shield)

<u>Left Side</u>	<u>Key</u>	<u>Right Side</u>
.446 in.	- 0° -	.241 in.
.398 in.	- 90° -	.378 in.
.472 in.	- 180° -	.350 in.
.405 in.	- 270° -	.371 in.

The 90° and 180° Limiter Keys have maintained their close radial gaps to the core barrel within several mils, leading to the conclusion that there was minimal motion or perturbation of the thermal shield in this segment of its arc. Further confirmation of this observation derives from the fact that other support and restraining hardware in this general vicinity appear to be in reasonably good condition:

Conversely, the 0° and 270° Limiter Keys reveal that radial gapping to the core barrel has increased from .024 inch to as much as .170 inch and .233 inch respectively. The condition of nearby support and restraint hardware is consistent with the conclusion that significant thermal shield motion has occurred in this area.

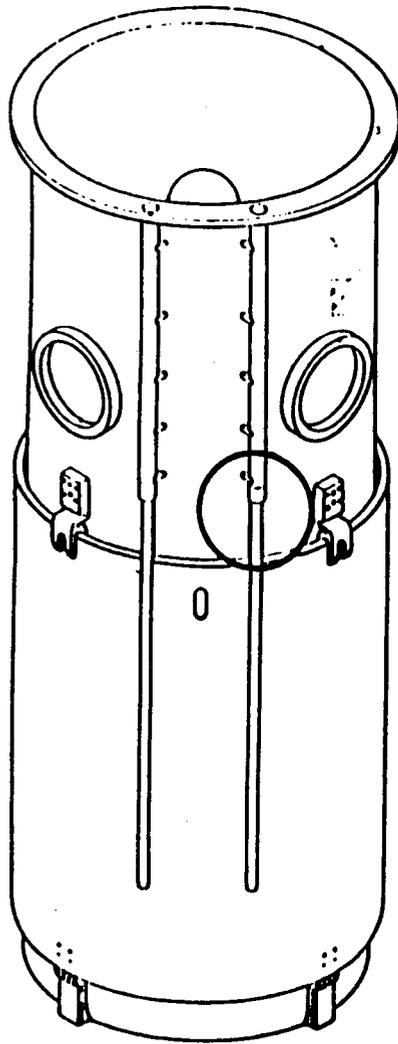
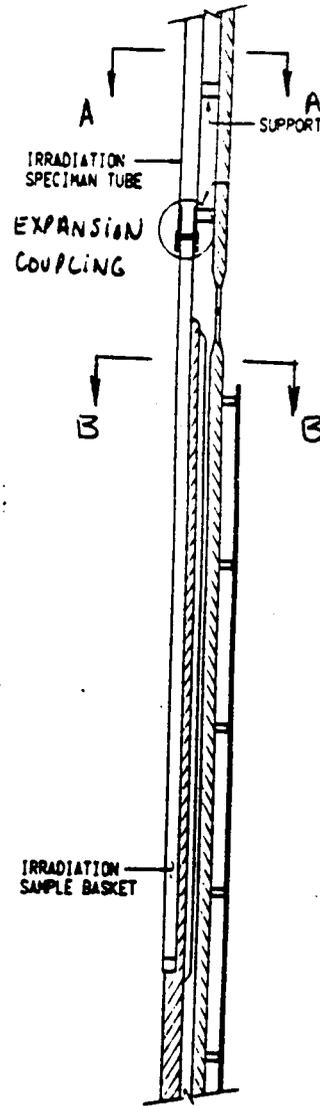
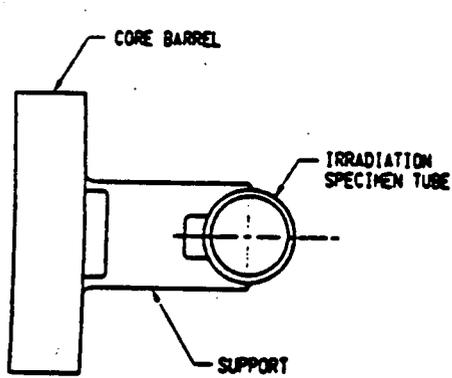
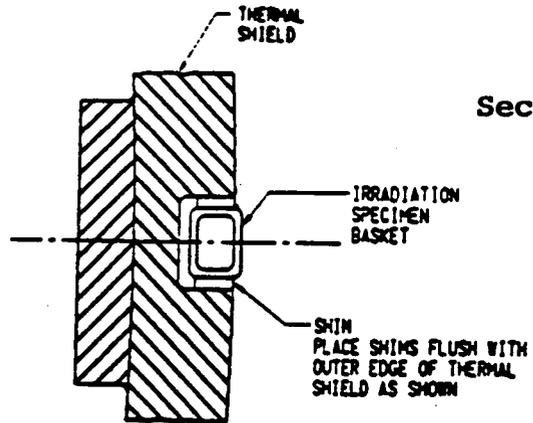
FIGURE 6

C. Irradiation Specimen Guides (See Figures 1 and 6)

1. Four of the eight Irradiation Specimen Guide Tubes, (rectangular tubing), showed fairly significant damage, (11°, 28°, 251°, 258°). The 251° tube was most severely damaged. A 5 inch long section was torn away from three sides of the rectangular tube directly below the point where it engages the round section of Guide Tubing (Extension Coupling), at about 10 inches above the top of the Thermal Shield. The 28° Tube has a crack across it's front face which begins at the right side at the beginning of the weld bead and extends about 3/4 the way across the tube's face. The 11° and 258° rectangular Guide Tubes have cracks on at least one corner beginning at their entrance into the round section of Guide Tube and extending downward for a distance of 1 inch or slightly more.

2. The 32°, 131°, 138°, and 151° rectangular Guide Tubes, (which incidentally, are consecutively located around the arc of the Thermal Shield), show little or no damage with the exception of some "fretting" where they enter the round section of Guide Tubes.

3. Four of the rectangular Irradiation Guide Tubes are shifted as much as 3/16 inch to their right, (viewed looking radially inward), as evidenced by their skewed position in the round sections of their respective Guide Tubes. These are the 11°, 28°, 32° and 131° Tubes. On the other hand, the 258° Tube appears shifted approximately 1/8 inch to the left of its center.

5. Irradiation Specimen Guide Tubes 28°, 11°, 258° and 251° show signs of cracking and even worse in the case of the 251° Tube where a large section has been physically torn away.

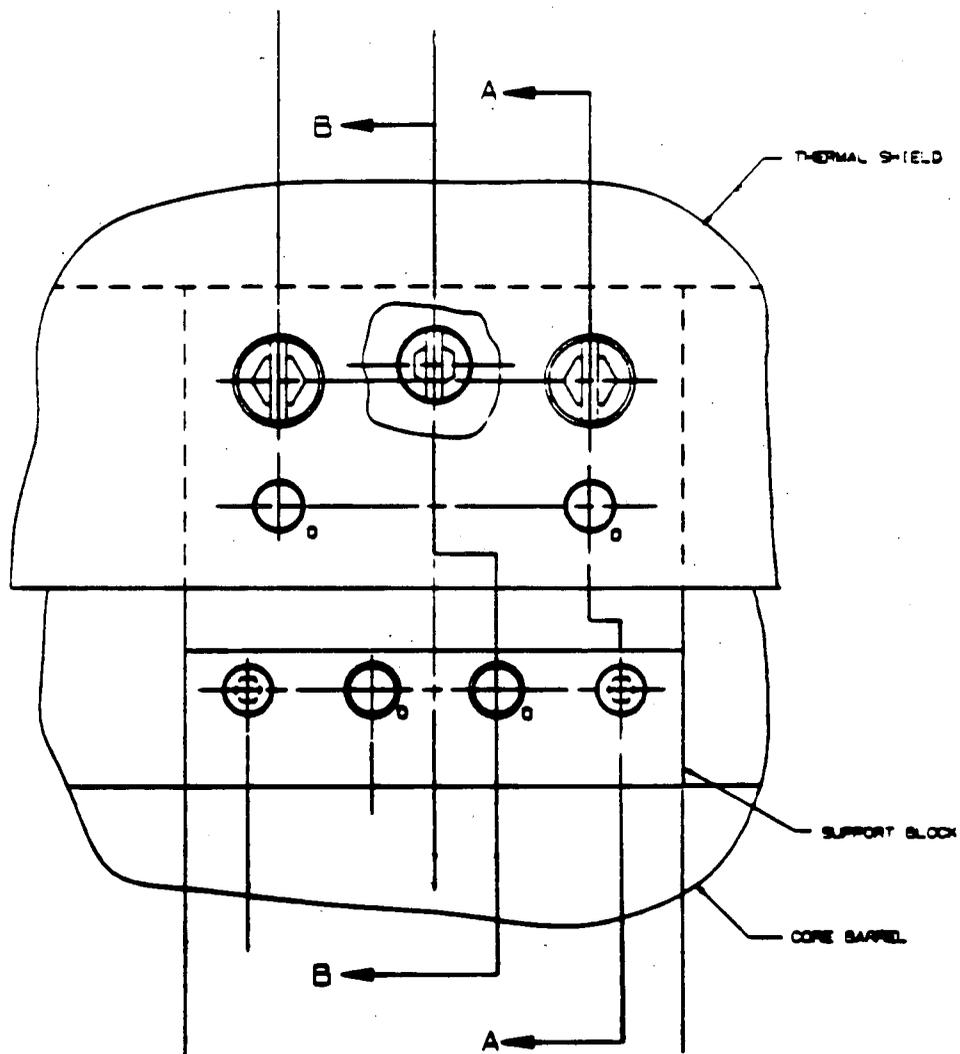
FIGURE 7

D. Lower Support Blocks and Fasteners (See Figures 1, 7 & 8)

1. Six support blocks, 0°, 60°, 120°, 240° and 300°, support the lower end of the Thermal Shield. Seating of all six blocks in the base of the circumferential groove cut into the lower core barrel appears to be normal.

2. All lower dowels and bolts which attach the lower portions of the support blocks to the core barrel show no anomalies as viewed from the outside of the thermal shield.

3. 0° Block - both dowels have cracked lock welds. There appears to be a vertical gap where the Thermal Shield rests on the Support Block. This is a comparative judgement based on the appearance of this seat on the other five support blocks. The gap appears to be of uniform thickness across the full width of the block. A bolt protruding inside the core barrel was observed during the 1988 inspection. (Broken, exiting the back of the tapped hole.)

4. 60°, 120°, and 180° Blocks outwardly appear normal. (No protruding dowels or cracked lock bar welds on the bolts.)
5. 240° Block - The left dowel protrudes 3/4 inch from the face of the Thermal Shield. Lock Bar tack welds are cracked on both bolts. A bolt protruding inside the core barrel was observed during the 1988 inspection. (Bolt broken and "backing out".)

6. 300° Block - the right dowel protrudes approximately 3/4 inch from the face of the Thermal Shield. Lock bar tack welds are cracked on the left bolt.

7. Viewing the blocks now from the outside of the Thermal Shield, the 240° location has one of its two dowels protruding, and cracked welds on the bolt lock bars. The 0° location shows both dowel pin lock welds cracked which is likely the precursor to their subsequent "backing out". The 300° block has one dowel pin emerging from the face of the Thermal Shield and a cracked weld on a bolt lock bar.

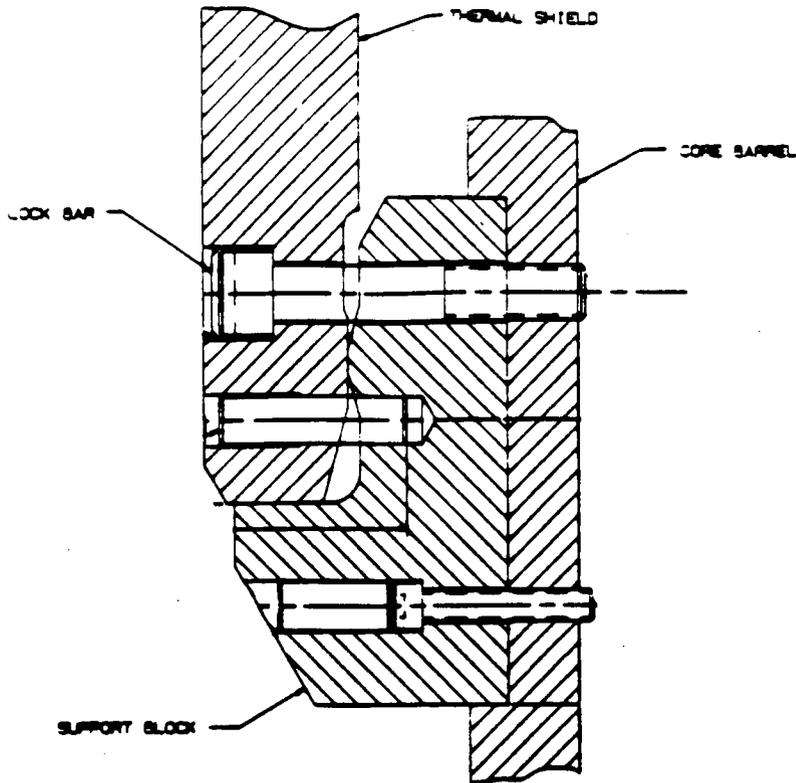
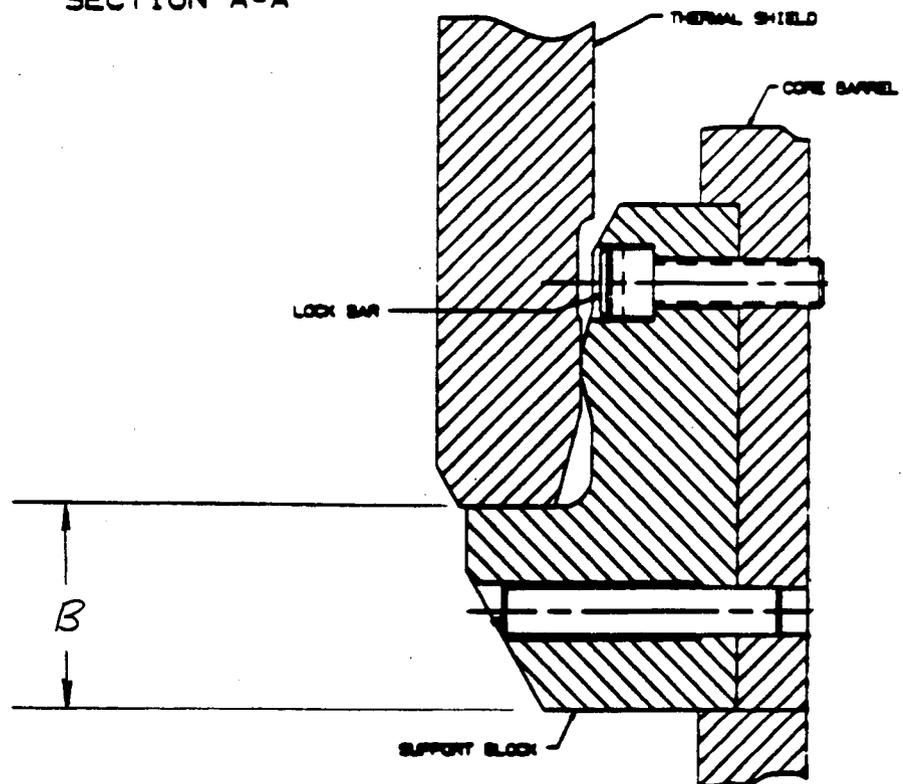
FIGURE 8

E. Lower Core Barrel Groove (Vicinity of Support Block Positions) (See Fig. 8)

On Sept. 10, and 11, 1990, a U.T. inspection was performed in regions of the Reactor Internals Lower Core Barrel where the Thermal Shield Support Blocks are attached. With the blocks removed, all six locations were scanned looking for cracks or defects in the core barrel. None were found. Although 2 indications were recorded at the 300° block location, closer evaluation (including a review of the video tapes), identified them as remnants of the broken bolts which remained in the tapped holes of the core barrel.

(See figure 8 Sect. B-B) Dimension "B" at original assembly was nominally 3.190 inches as measured in the vicinity of each of the 6 Blocks. These measurements now show the Shield to be slightly "tipped" along the 120° - 300° axis, with the Shield lifted .020 inches at 120°, and sitting low at

300° to the extent of .150 inches. Also note on Figure 11, that the only unbroken hidden bolt is at the 120° Block. (Almost directly below the undamaged 124° Flexure above.)

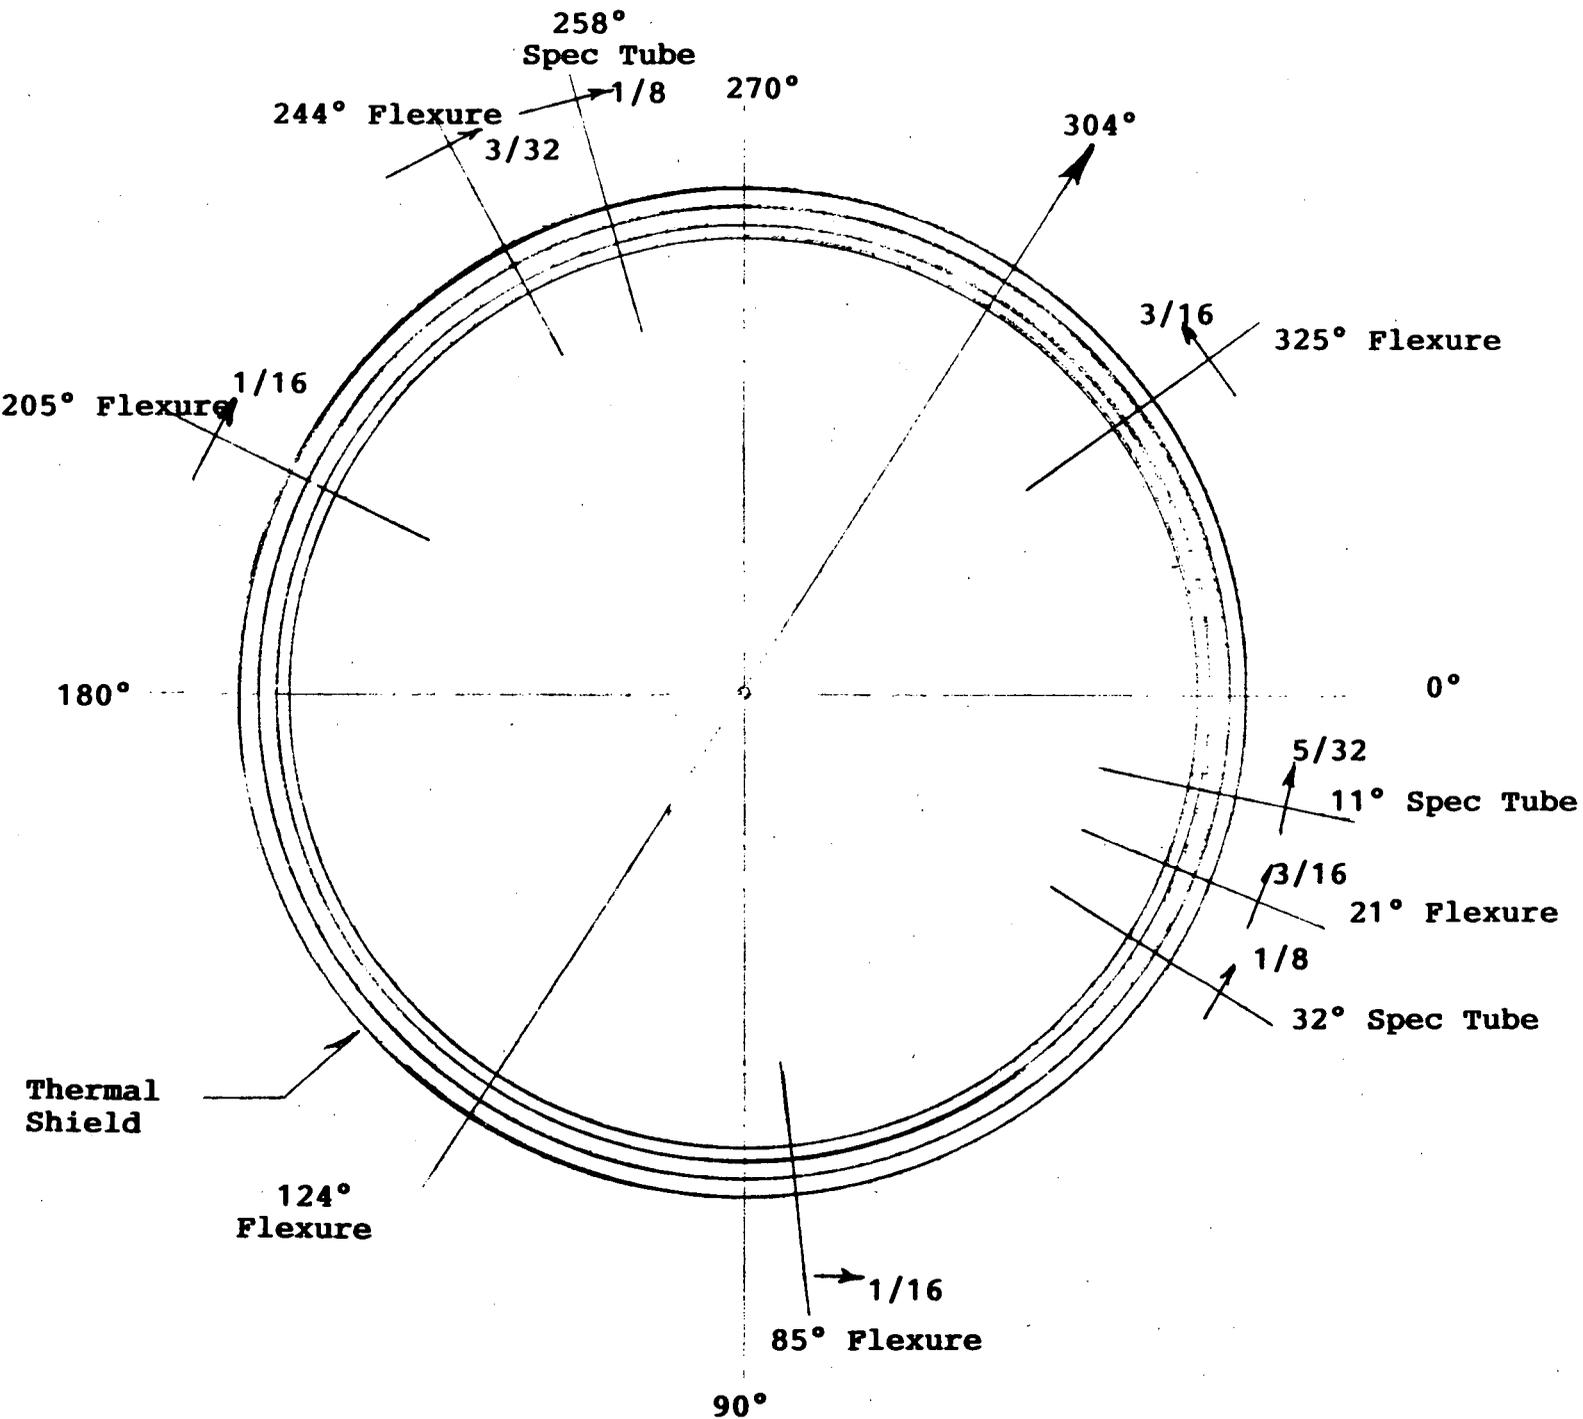
FIGURE 9

A review of the video tapes and the written comments on the inspection sheets suggest that the top of the shield has moved to the right or counter-clockwise in the arc extending from 85° to 325°. A move to the left or a clockwise "set" seems apparent in the arc from 180° thru 270°. The arc between 90° and 180° seems stable in the terms of left or right movement with the undegraded 124° flexure residing in that zone.

These observations are as viewed looking down onto the Thermal Shield as regards clockwise or counter-clockwise and outside looking in as regards left or right. (See Figure 9)

1. 85° to 325° arc - features showing displacement, in sequence, are:
(Counter clockwise rotation or left to right as viewed "looking in".)

(a) 85° Flexure	1/16 inch
(b) 32° Specimen Tube	1/8 inch
(c) 21° Flexure	3/16 inch
(d) 11° Specimen Tube	5/32 inch
(e) 325° Flexure	3/16 inch

2. 180° to 270° arc - features indicating displacement, in sequence, are:
(Clockwise rotation or right to left as viewed "looking in".)
 - (a) 1/16 inch 205° Flexure
 - (b) 1/16 - 1/8 inch 224° Flexure
 - (c) 3/32 - 1/8 inch 258° Specimen Tube

3. 90° to 180° arc - no left or right displacement; features supporting this are:
 - (a) 90° Limiter Key - change in radial gap less than .010 inch.
 - (b) 124° Flexure undamaged
 - (c) 131°, 138° and 151° Specimen Tubes - little or no damage and little or no apparent displacement.

If there is any kind of a pattern to be seen in these data, one might say, "anchor" the top of the Shield at the 124° undamaged Flexure and draw a diametral line thru 304° and say that the Shield has taken a "set" in that direction, and that might come close to explaining the direction and magnitude of the displacements seen in the various Specimen Guide Tubes and Flexures described above. (See Figure 9.) Also, the widest gap in a cracked Flexure is the 3/16 inch gap at 325° (closest Flexure to the 124° - 304° vector). The next largest Flexure blade gaps are judged to be the 244° and 21° locations which "straddle" the proposed 124° - 304° line of Thermal Shield motion.

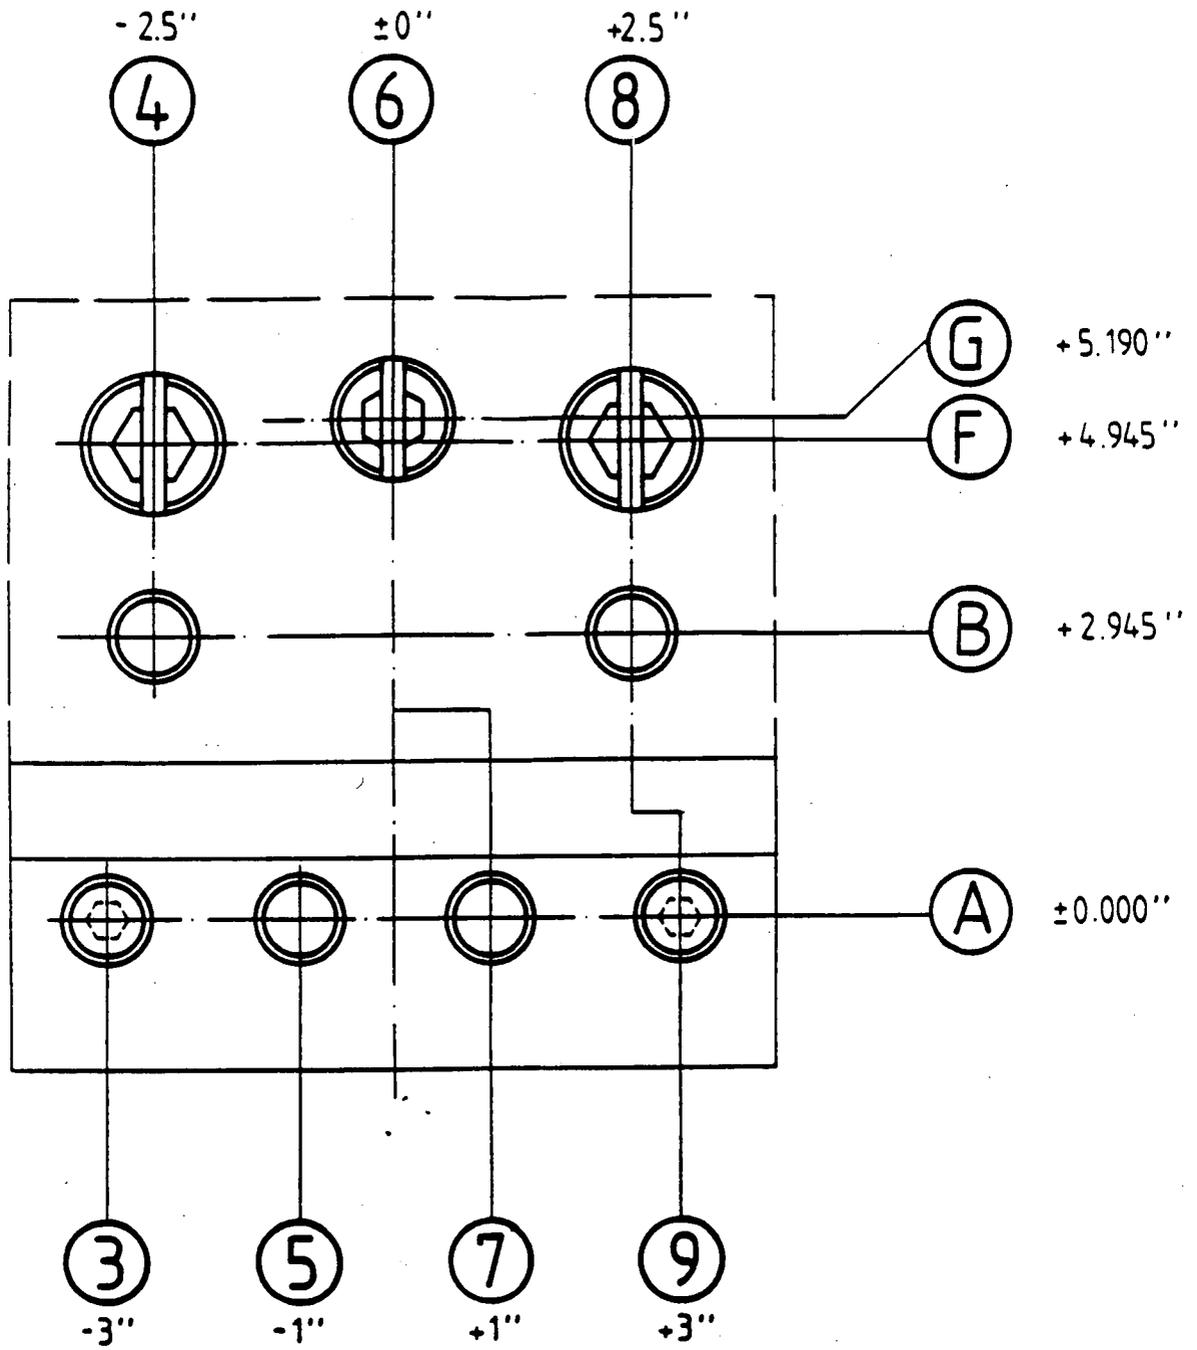
FIGURE 10

7. See Figures 10 & 11 for a summary of support block fastener damage as discovered upon block removal in Sept. 1990. Note that the 0° and 240° locations exhibit the most extensive damage, (as discerned at the 1988 inspection), and the 300° location is next, as was predicted analytically in the Westinghouse topical report WCAP 12148.
