Technical Evaluation Report

REVIEW OF  
RESOLUTION OF KNOWN PROBLEMS  
IN ENGINE COMPONENTS  
FOR TRANSAMERICA DELAVAL INC.  
EMERGENCY DIESEL GENERATORS

December 1985

Project Title: Assessment of Diesel Engine  
Reliability/Operability

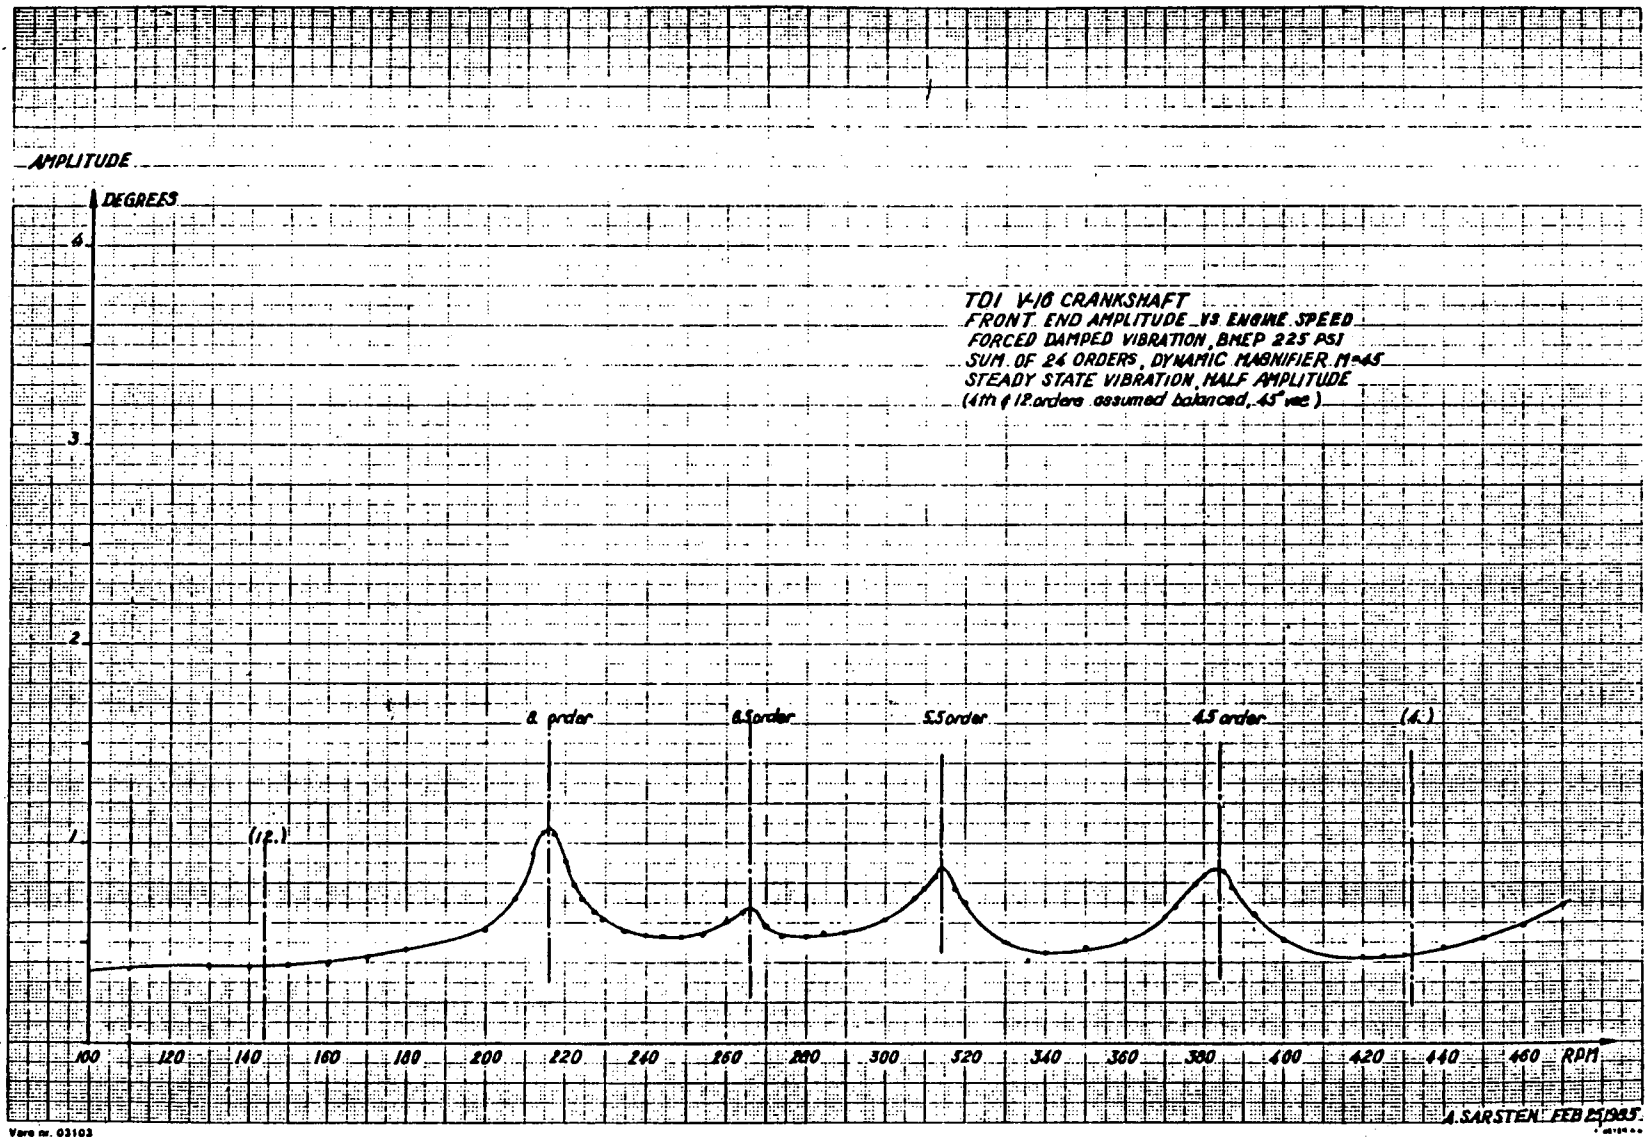
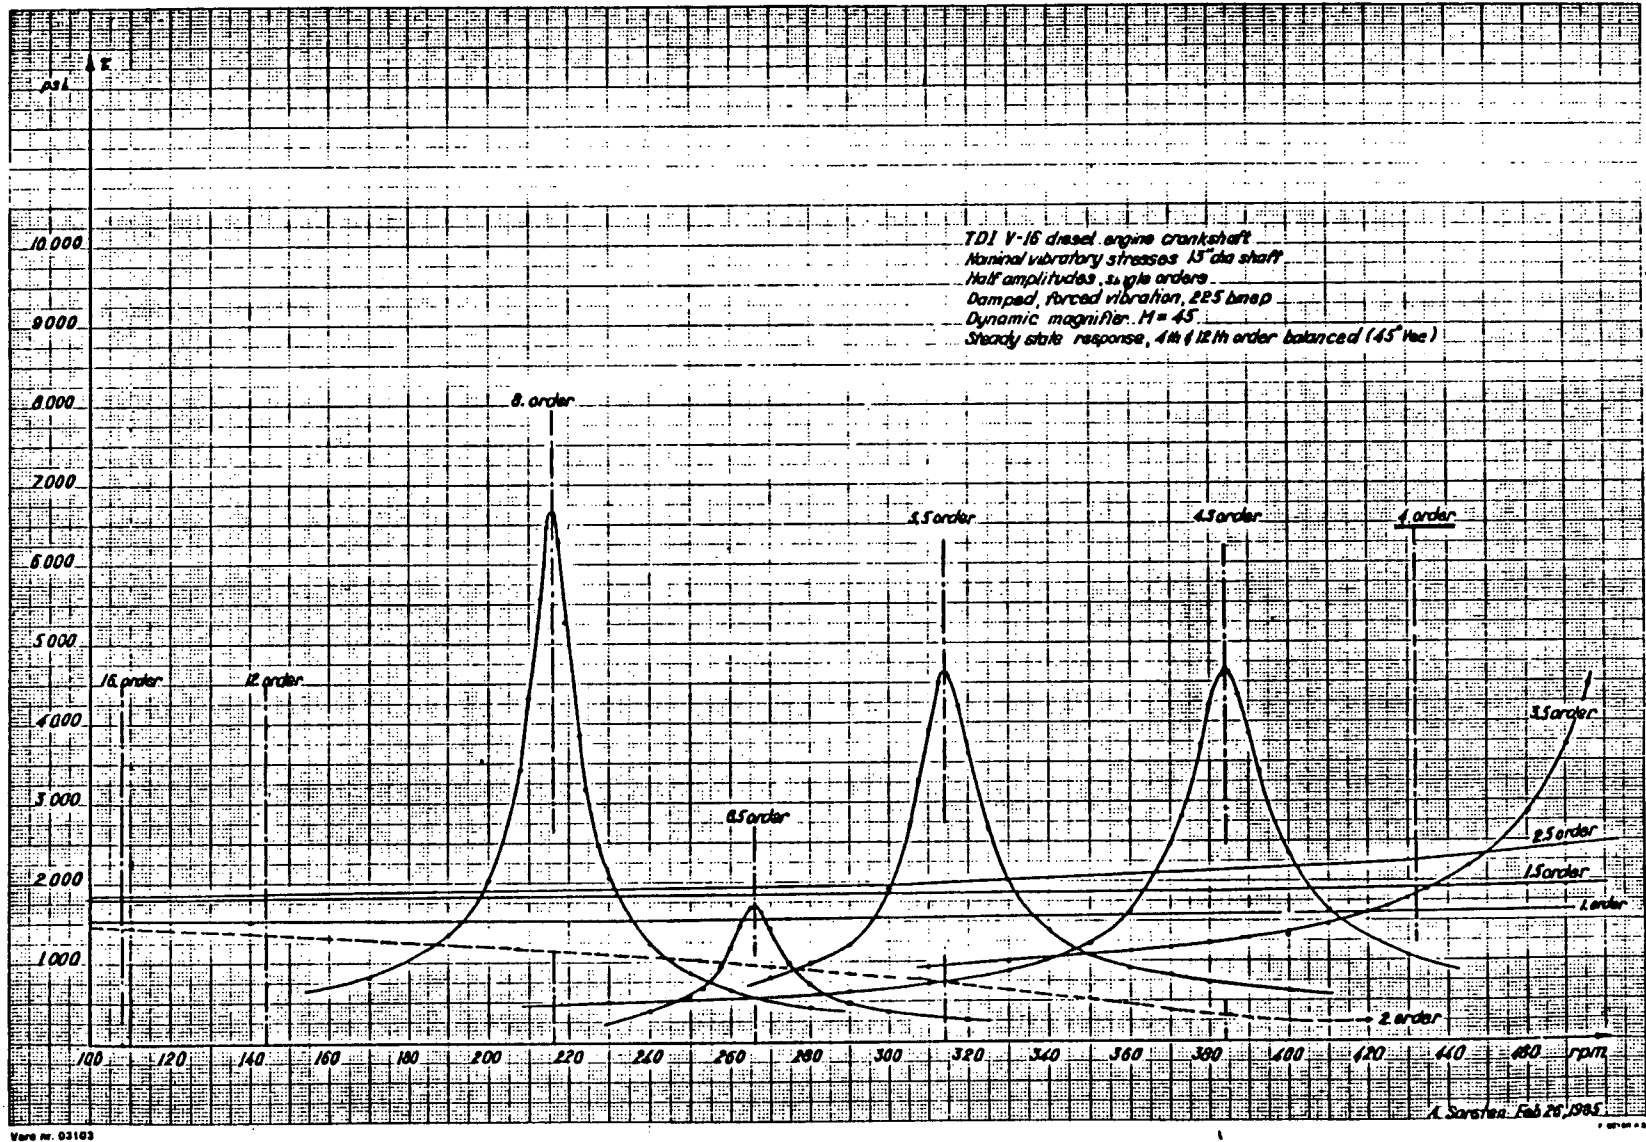
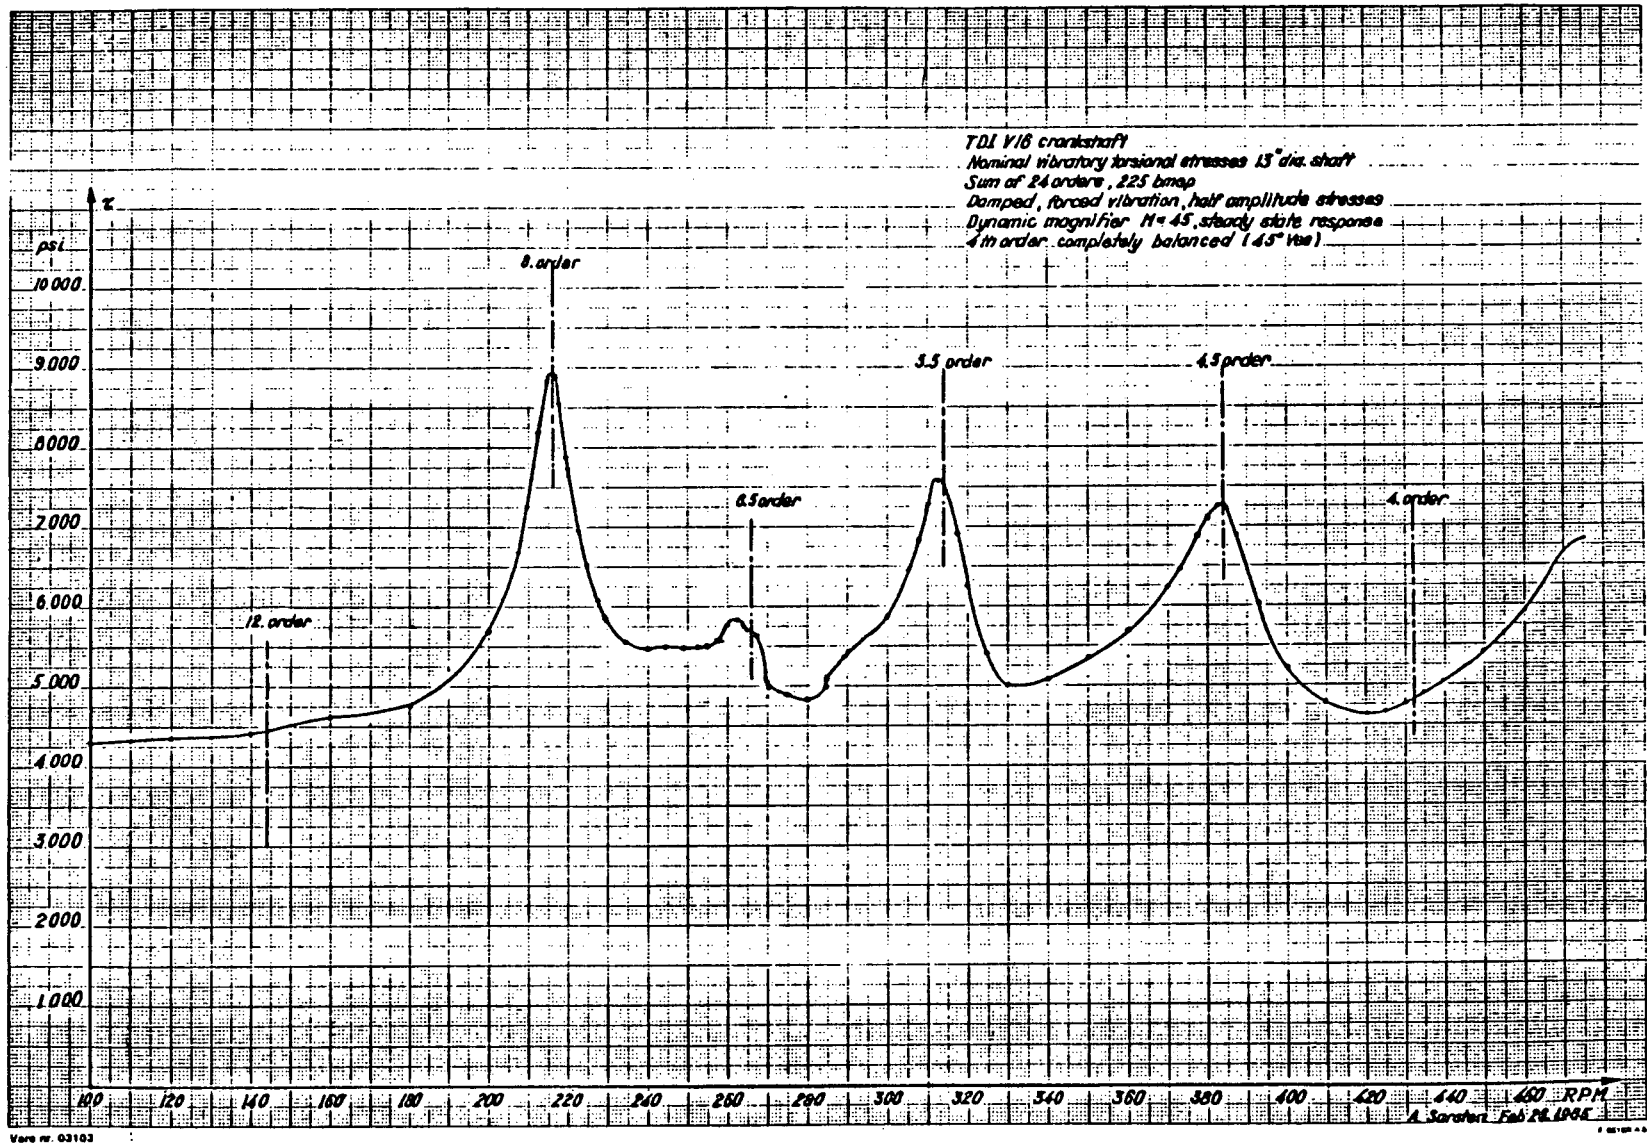
Prof. Sarsten made the following observations on the results summarized in Figures 4.7.1 through 4.7.3:

- The resonant peaks at speeds corresponding to orders 4.5, 5.5, 6.5, and 8 are not closely spaced, and therefore would not be expected to augment each other during engine startup. The vibratory conditions associated with these resonances are acceptable for engine acceleration through this speed range. No significant resonances of higher modes were detected in the speed range investigated.

- No responses are shown for the 4th and 12th orders, because these orders vanish under the assumptions used in the analysis. The excitations of these orders from one bank of the V-engine cancel the excitations from the other bank, assuming the cylinders are evenly balanced and disregarding the effect of the articulated connecting rods on piston motion and timing. However, the 4th order in the actual engine is important because it occurs within -5% of the rated engine speed. Any lack of uniformity in the pressure diagrams of individual cylinders will excite this order, as will the slightly different piston motions and timing associated with the articulated connecting rods.

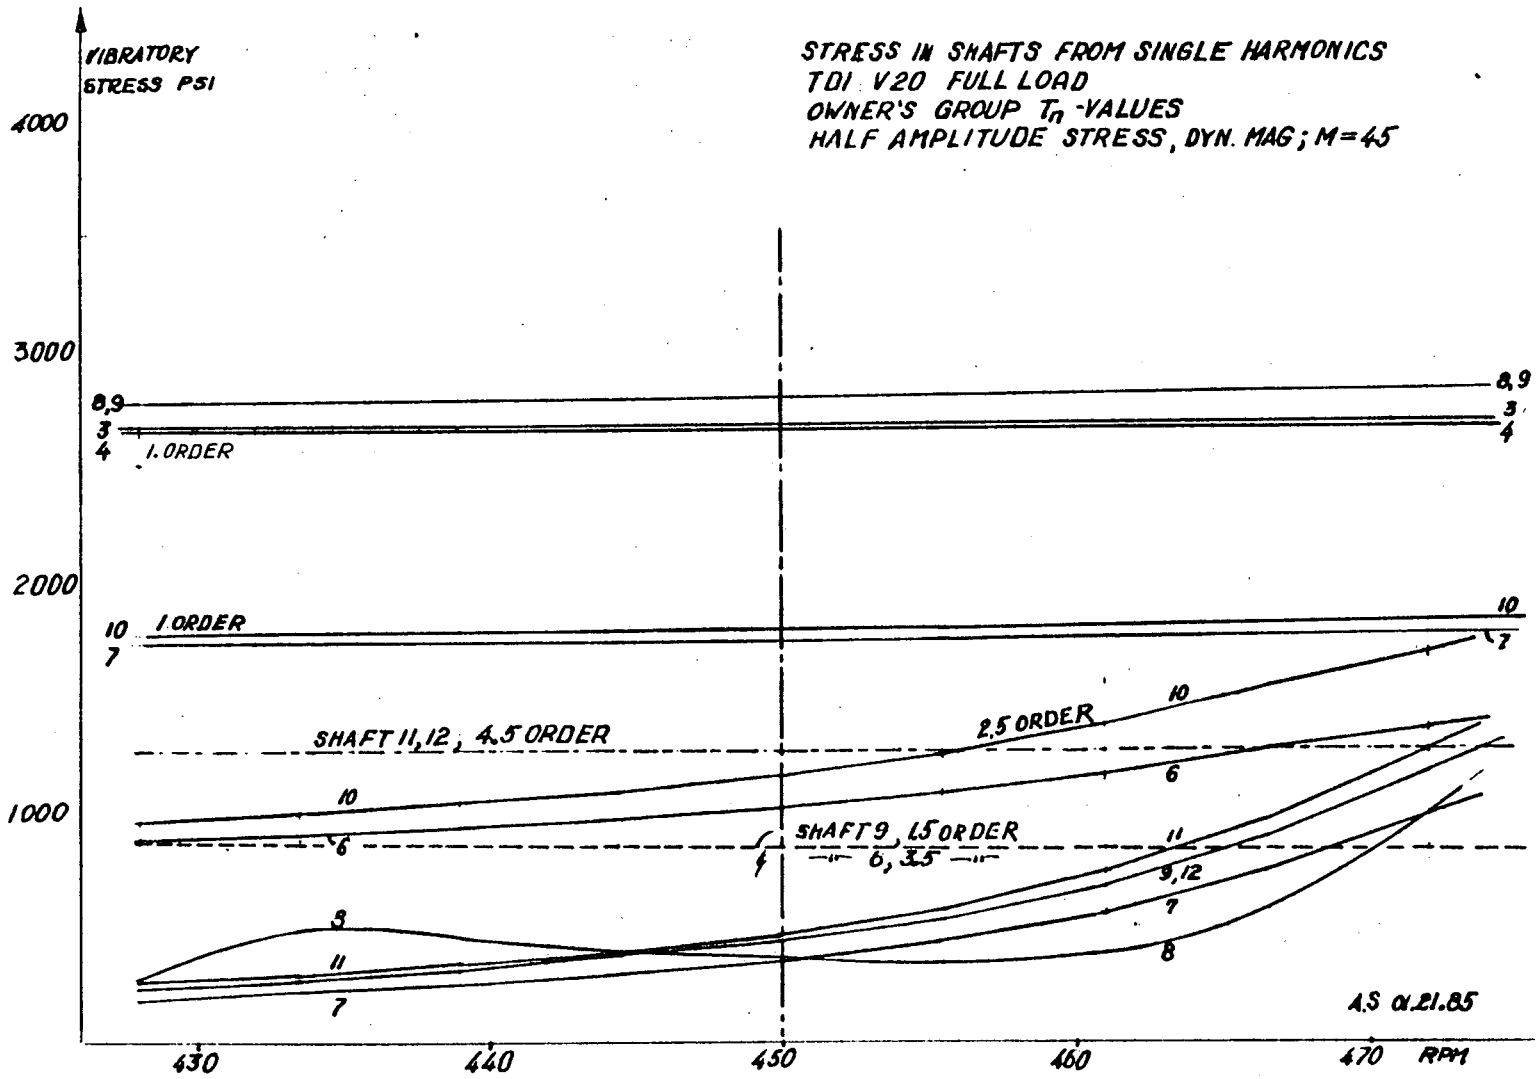
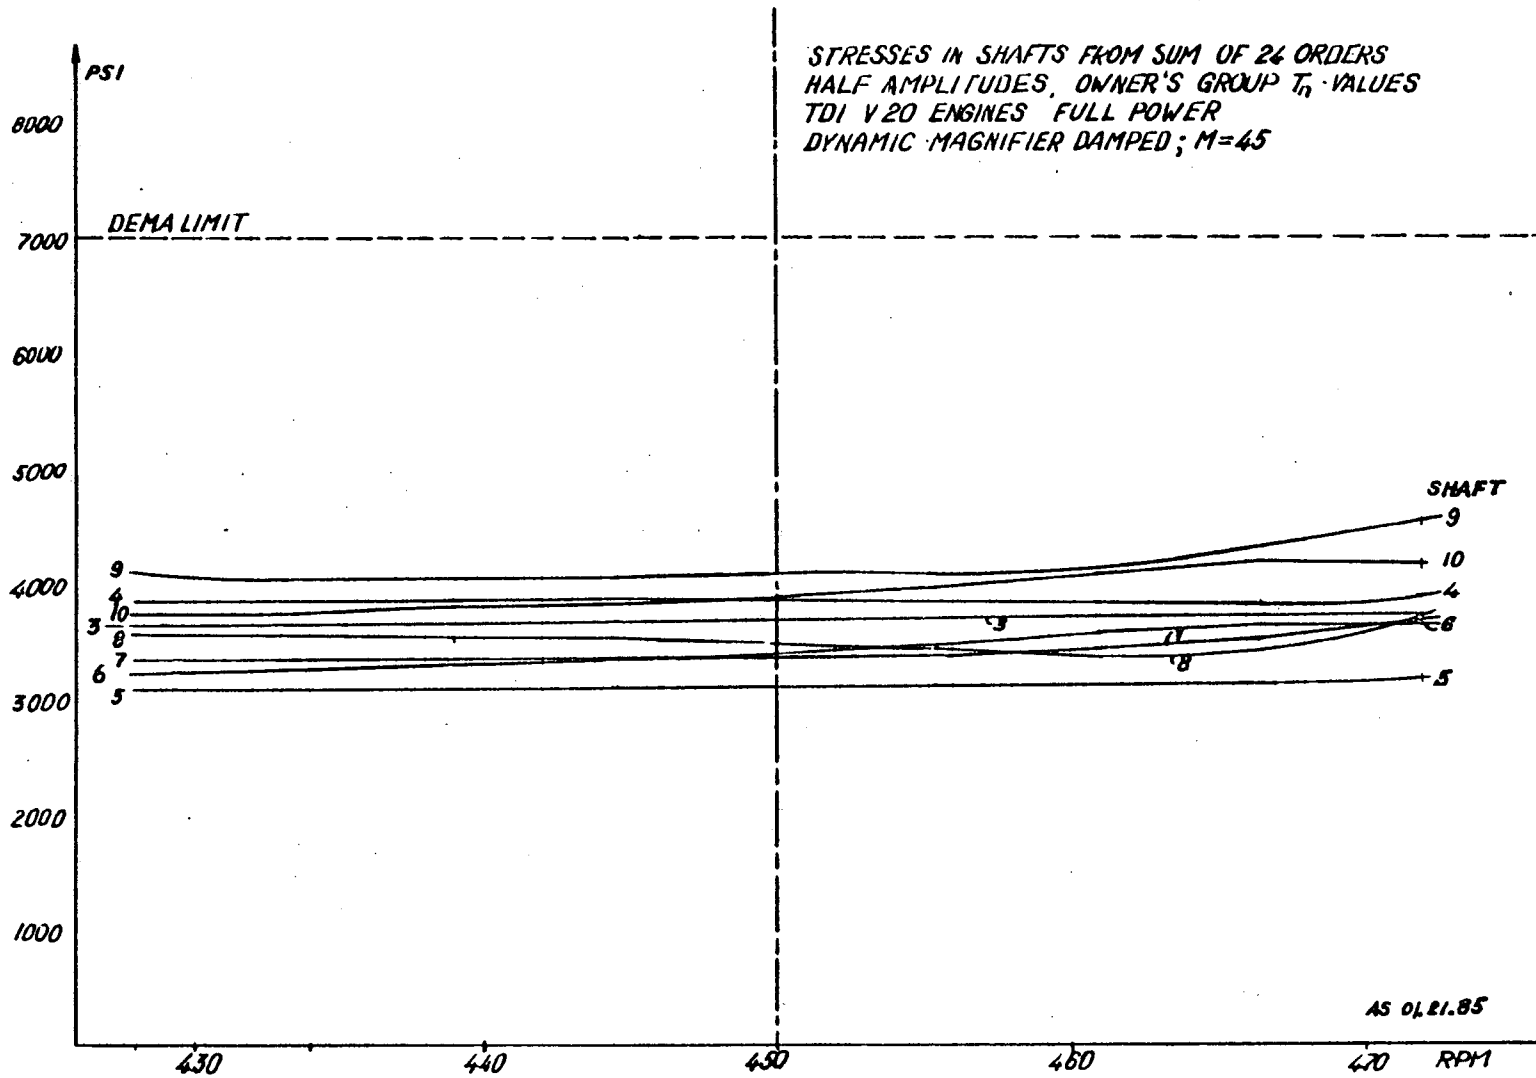
The results of Prof. Sarsten's analysis are summarized in Figure 4.8.1 for single orders of vibration, and in Figure 4.8.2 for the sum of 24 orders of

vibration. As shown in these figures, the maximum nominal torsional stresses for single orders and for the sum of 24 orders are 2800 psi and 4550 psi, respectively, and occur at 105% of rated speed. These values are well within the DEMA-recommended limits of 5000 psi for single orders and 7000 psi for combined orders. The dynamic magnifier cited in Figures 4.8.1 and 4.8.2 is a function of the assumed damping, the masses, and the associated natural frequency of the torsional system for first-mode vibration.

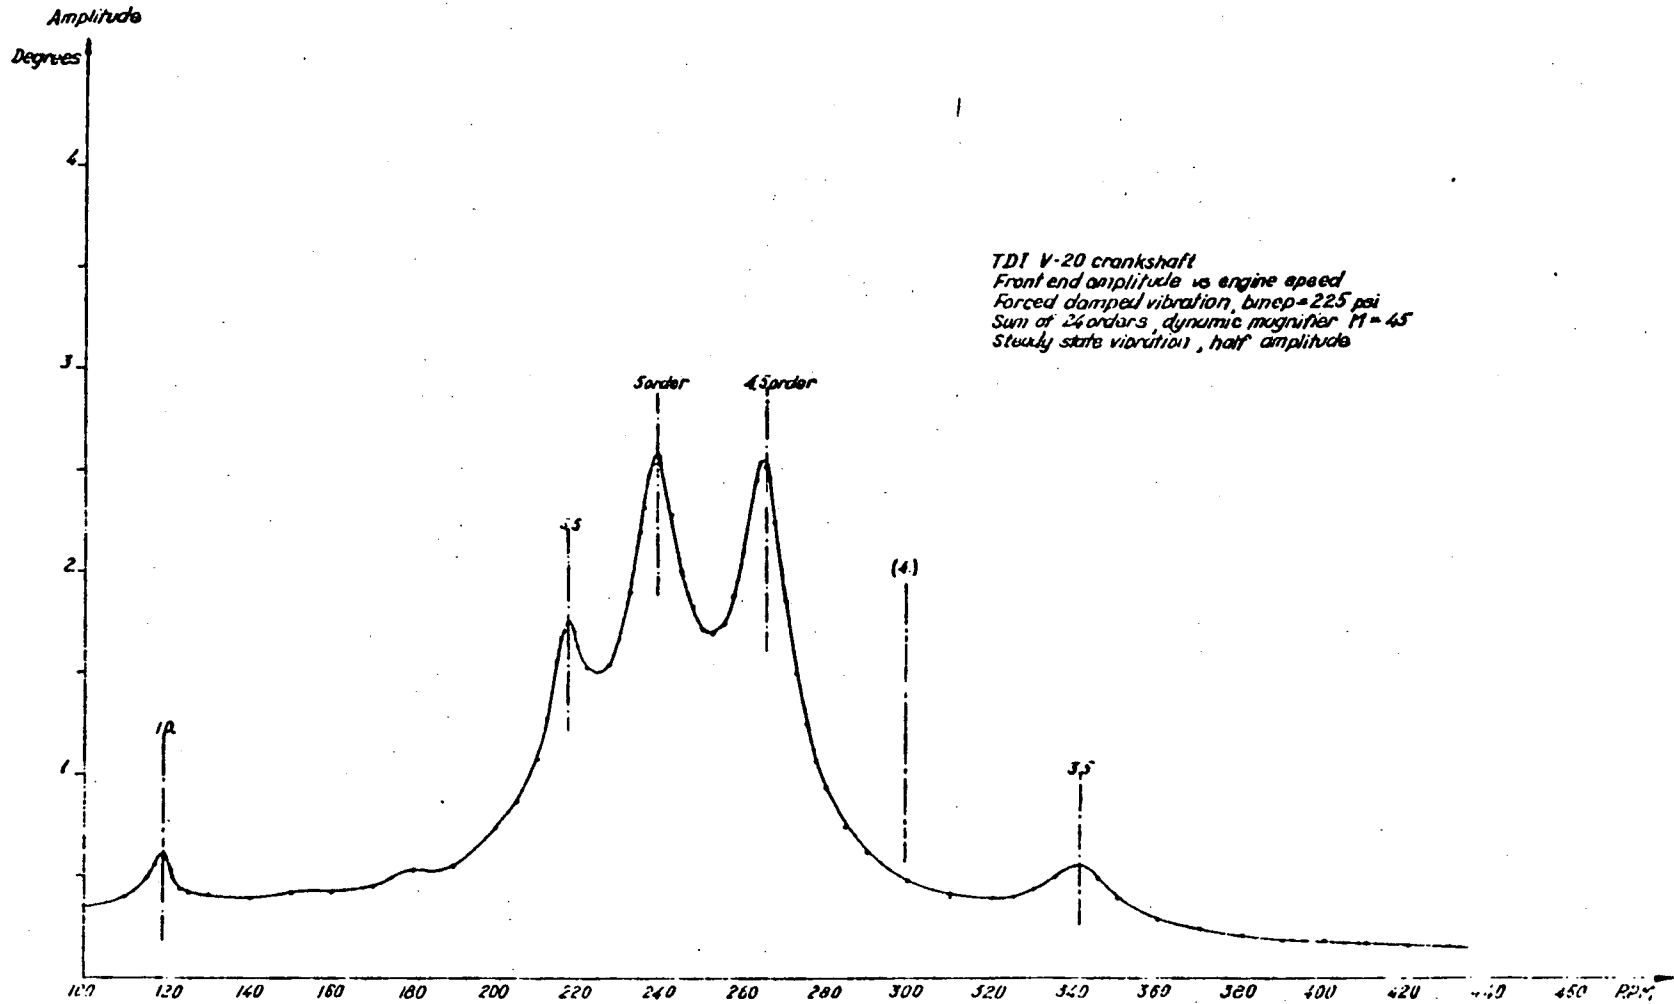
**FIGURE 4.8.3.** Variation of Free-End Crankshaft Vibration with Engine RPM for Sum of 24 orders in TDI DSRV-20-4 Crankshaft

- Main bearing journals No. 9 and 10 are exposed to the highest torsional stresses. Journals No. 8, 11, and 12 are also highly loaded.

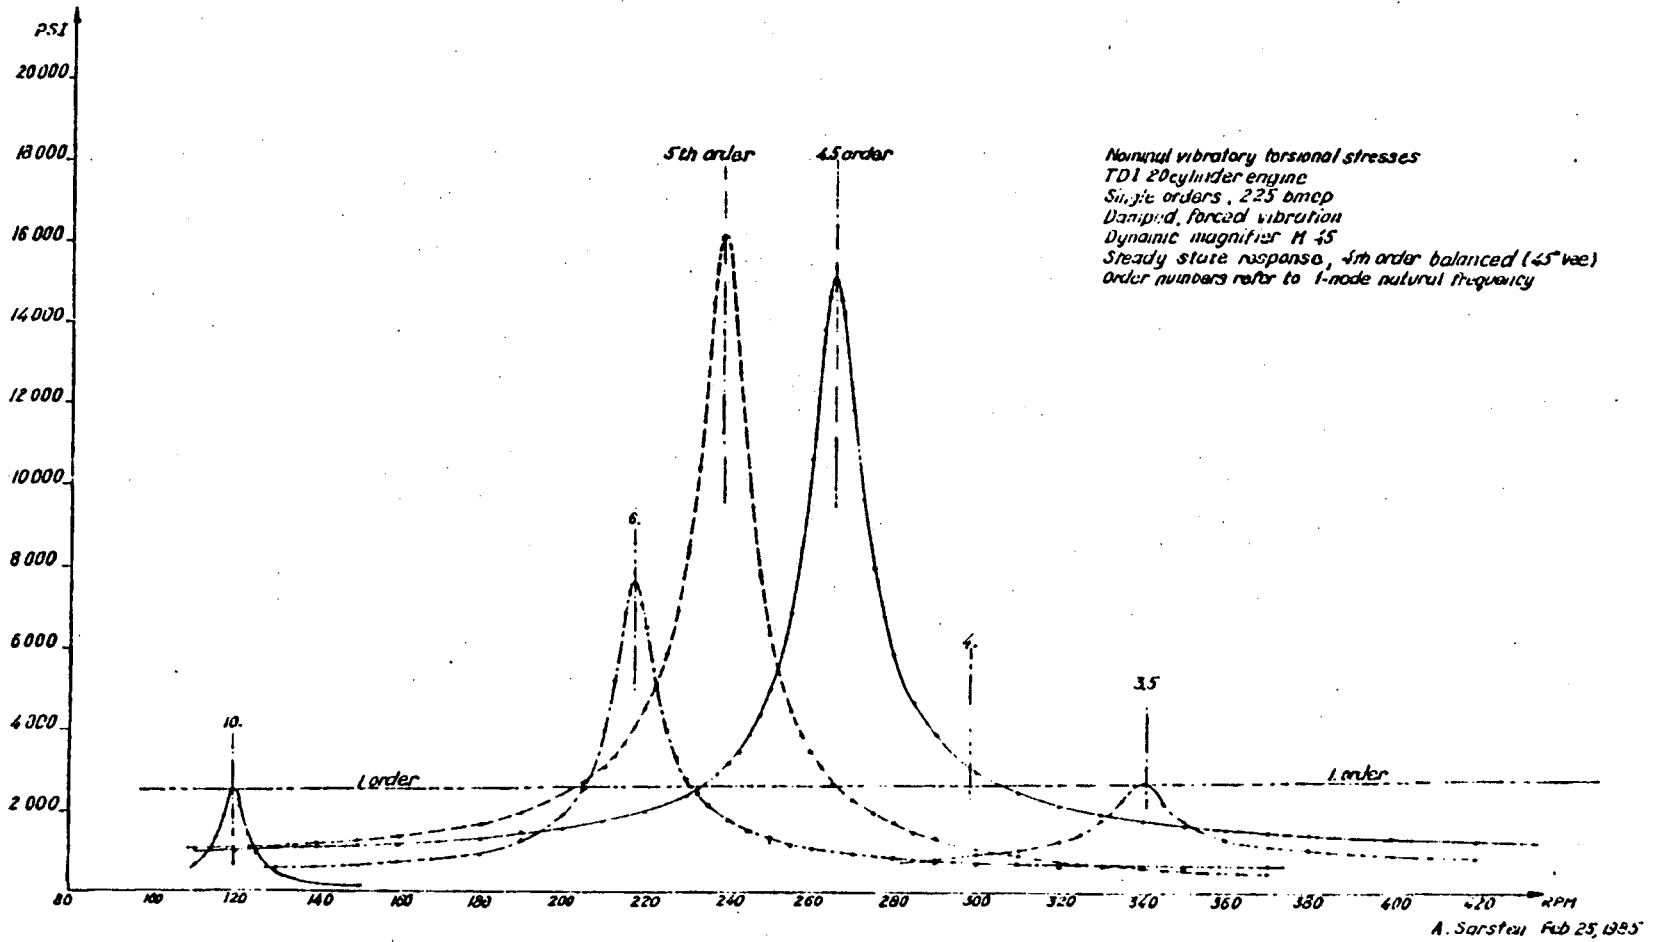
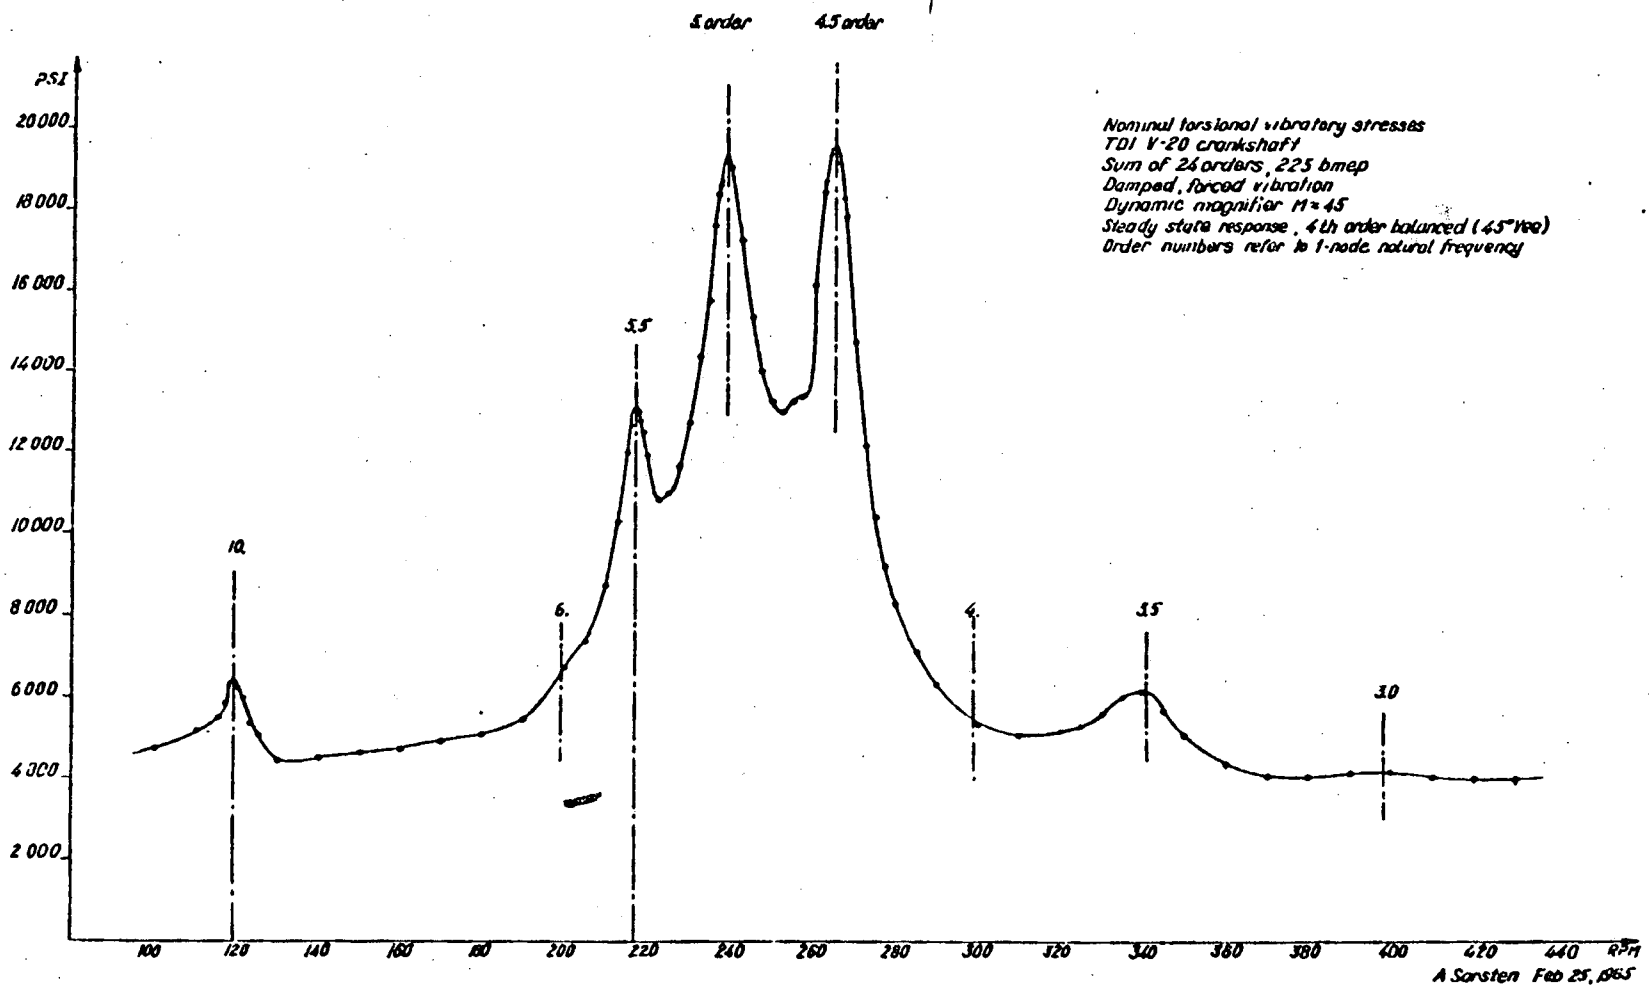
- A slow start would appear to be preferable to a fast start for accelerating through the criticals, for two reasons. First, the peak stresses would be shifted downward because the gas pressure loading would be lower. The advantage of lower stresses should outweigh the disadvantage of the increased number of cycles in the critical speed range. Second, the vibration initiated by one critical would be less likely to augment the vibration initiated by a neighboring critical.
- A transient torsional analysis or an experimental study would be required to quantify the possible benefits of slow starts. A transient analysis might also yield information on a starting position and possibly a speed sequence that would reduce crankshaft stresses when accelerating through the critical speed range.
