L-2013-296  
10 CFR 50.55a

Re: Turkey Point Unit 3  
Docket Nos. 50-250  
Relief Request No. 13

**RELIEF REQUEST No. 13**

Subject: Evaluation of 3-844A Valve Bonnet Leak

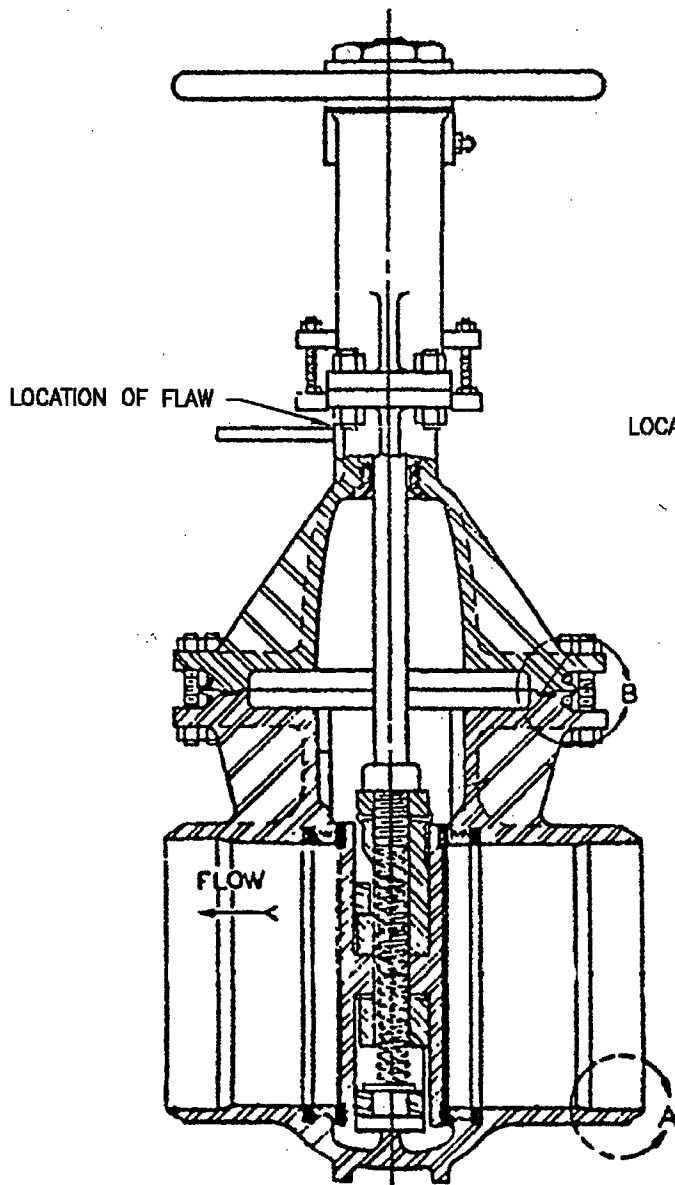
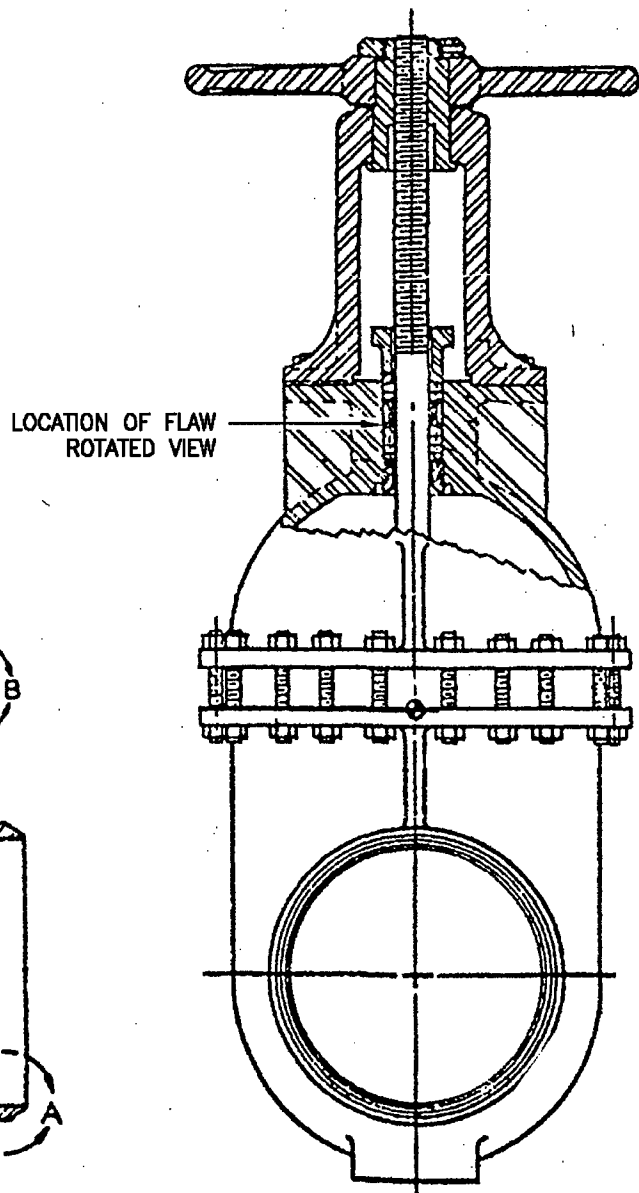
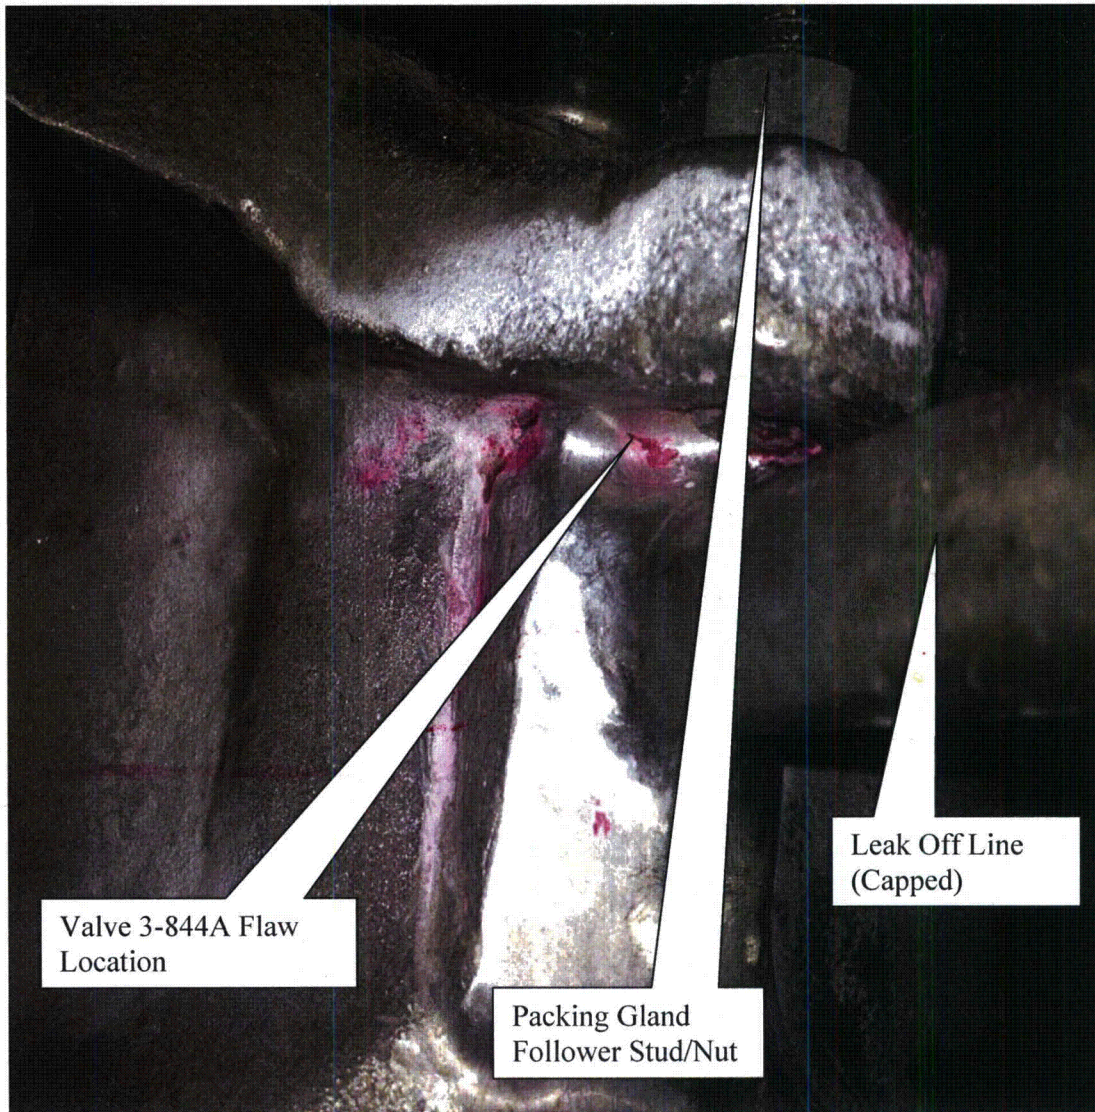
ATTACHMENT 1  
PARTIAL DRAWING OF VALVE 3-844A AND  
THROUGH-WALL FLAW

The through-wall flaw is located on the bonnet near the top of the packing gland of valve 3-844A. This ASME Class 2 valve is in the 8 inch suction line to the "A" Containment Spray Pump. Valve 3-844A can not be isolated from the upstream common supply header of the Containment Spray System without taking both trains of the Containment Spray System out of service. With both trains inoperable, Technical Specifications (TS) Limiting Condition for Operation 3.6.2.1, Action b., would require to restore at least one train to operable status within 1 hour, or to be in at least Hot Standby within the next 6 hours. The Prompt Operability Determination (POD) evaluation concluded that the valve continues to be capable of performing its required safety functions and is not susceptible to sudden or catastrophic failure. Performing a Code repair/replacement activity now to correct the flaw would create a hardship based on the potential risks associated with unit shutdown, thermal stress cycling of plant components, and emergent equipment issues incurred during shutdown and startup evolutions, with no compensating increase in the level of quality and safety gained by immediate repair of the flaw.

Valve 3-844A Flaw  
Location

- (h) FPL will repair or replace manual valve 3-844A during the next scheduled Turkey Point Unit 3 Refueling Outage currently planned to begin in March 2014, or forced outage of sufficient duration requiring entry into Mode 5, whichever occurs earlier.

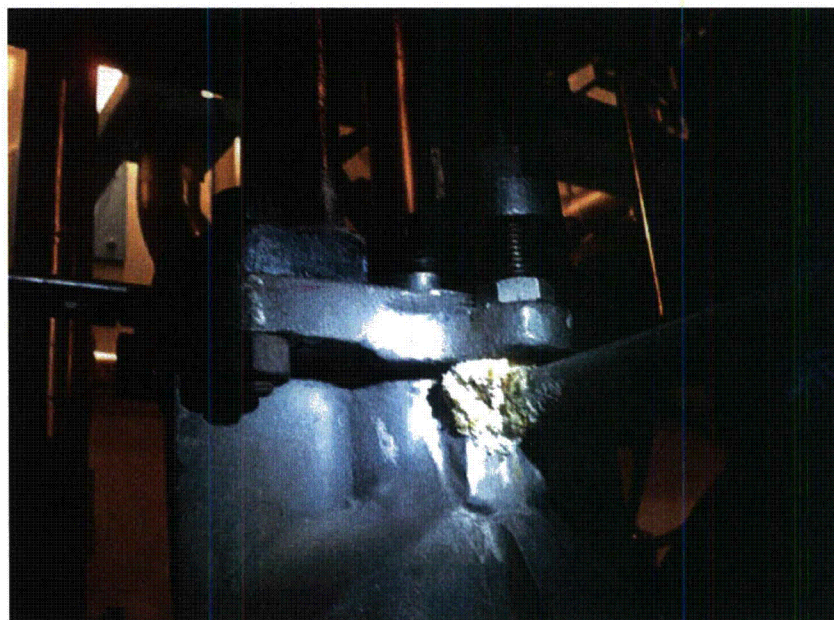
A through-wall leak was recently discovered in the 3-844A valve bonnet of the Containment Spray System at the Turkey Point Unit 3 Nuclear Power Plant. NDE inspection performed on 9/17/13 after cleaning off the boric acid buildup (as shown in Figure 1) identified a through-wall flaw in the valve bonnet above the packing leakoff line. No observable leakage was present. The flaw appears to be due to an original casting defect based on its void like appearance. The specific location of the flaw is in the valve bonnet above the packing as shown in Figure 2. The flaw noted herein appears localized to the area of the bonnet just under the bonnet to yoke flange.

Figure 1: Boric Acid Buildup Identified on 3-844A Valve Bonnet

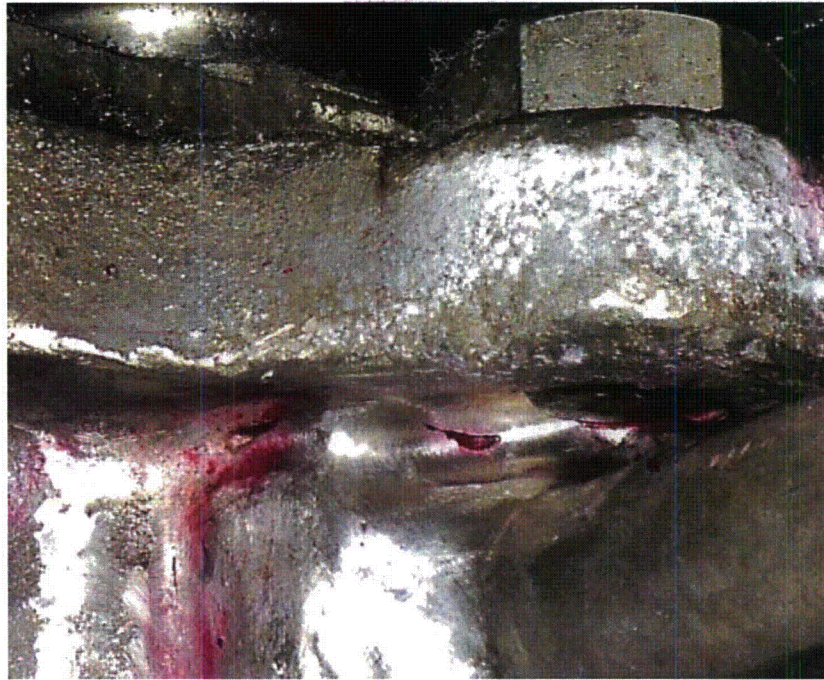
**Figure 2: Photograph of Indication Locations at 3-844A Valve**
