LICENSEE: Southern California Edison Company

FACILITY: San Onofre Unit No. 1

SUBJECT: REPORT OF JULY 10, 1980 MEETING TO DISCUSS THE RESULTS OF STEAM GENERATOR INSPECTIONS AND CORRECTIVE ACTIONS FOR SAN ONOFRE UNIT 1

SCE - NRC
MEETING ON STEAM GENERATORS
JULY 10, 1980

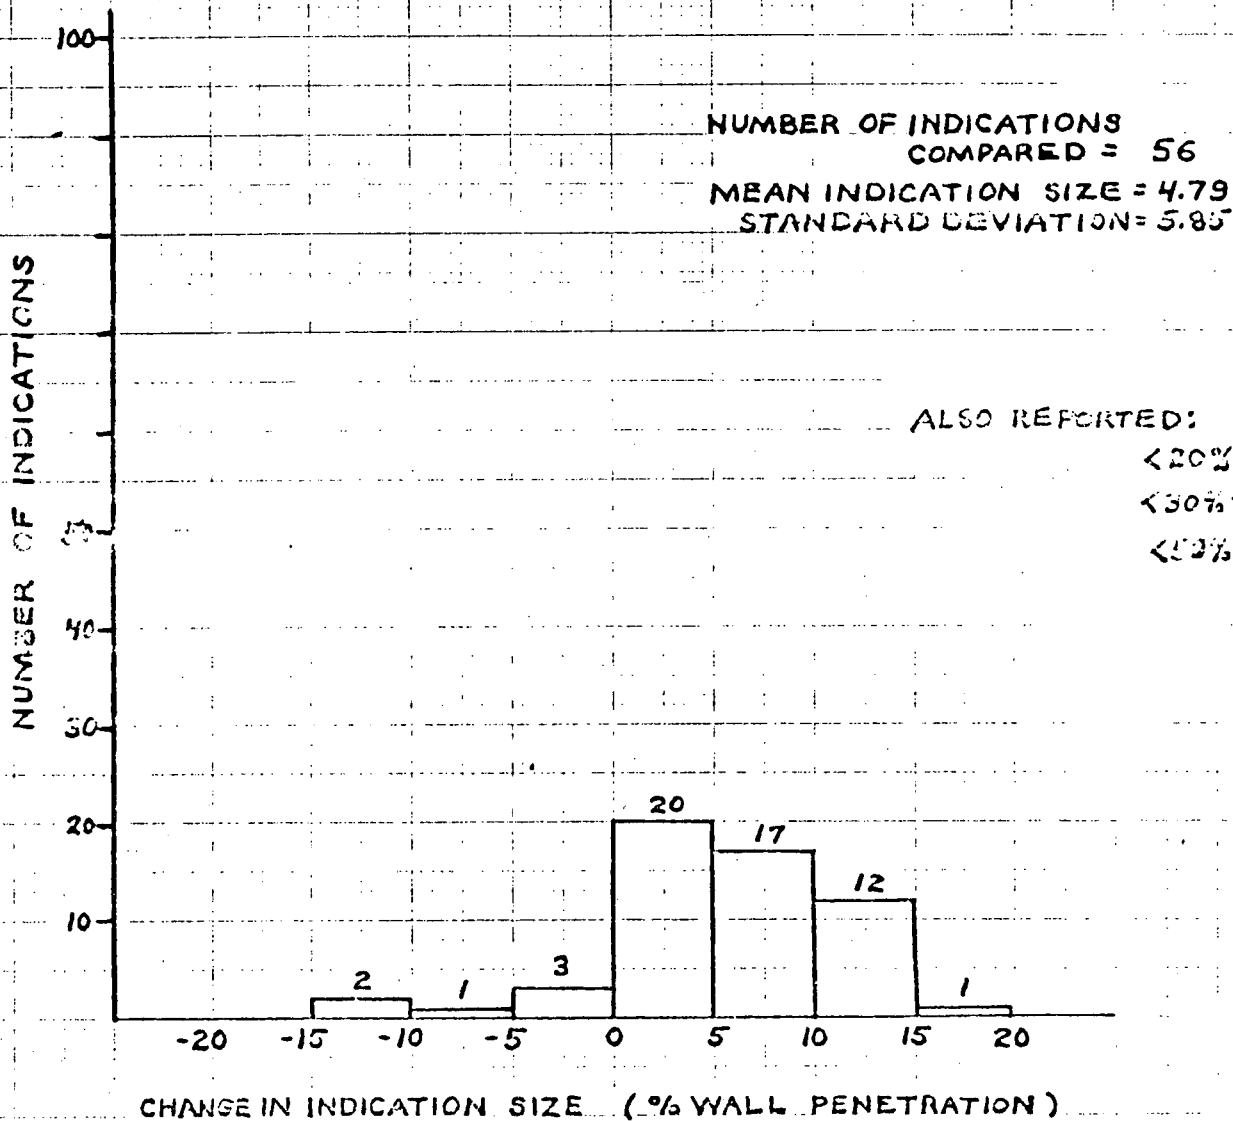
DISTRIBUTION OF THE CHANGE IN AVB WEAR INDICATIONS RECORDED AS $\geq 20\%$ AT BOTH THE 10/78 AND 5/80 INSPECTIONS
SAN ONOFRE UNIT 1
STEAM GENERATOR A

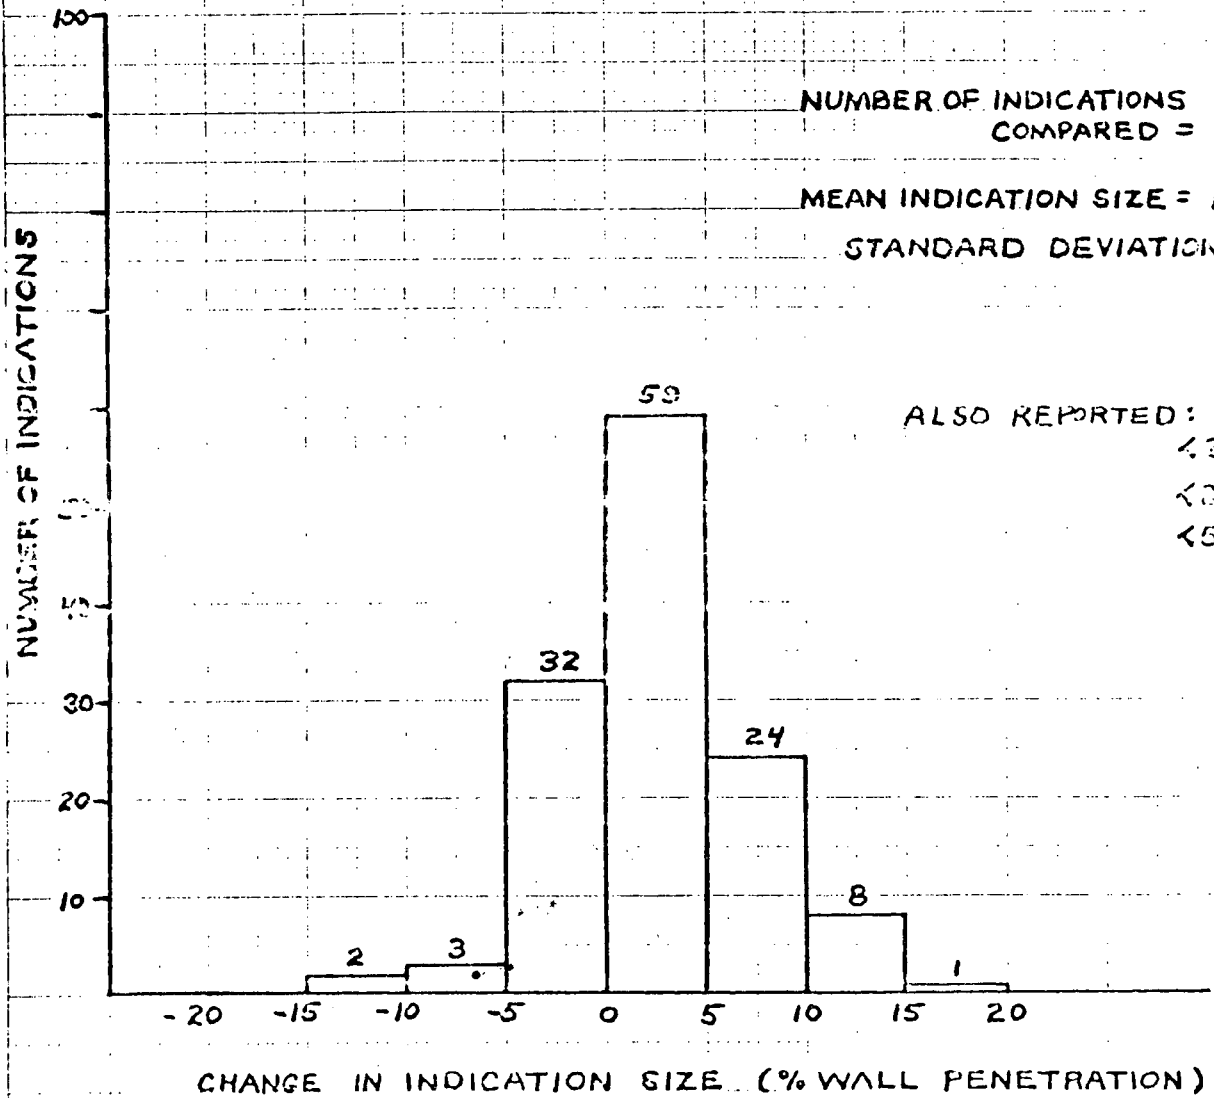
DISTRIBUTION OF THE CHANGE IN AVB WEAR INDICATIONS RECORDED AS $\geq 20\%$ AT BOTH THE 10/78 AND 5/80 INSPECTIONS

SAN ONOFRE UNIT 1
STEAM GENERATOR B

NUMBER OF INDICATIONS COMPARED = 129

MEAN INDICATION SIZE = 1.98 %
STANDARD DEVIATION = 4.02

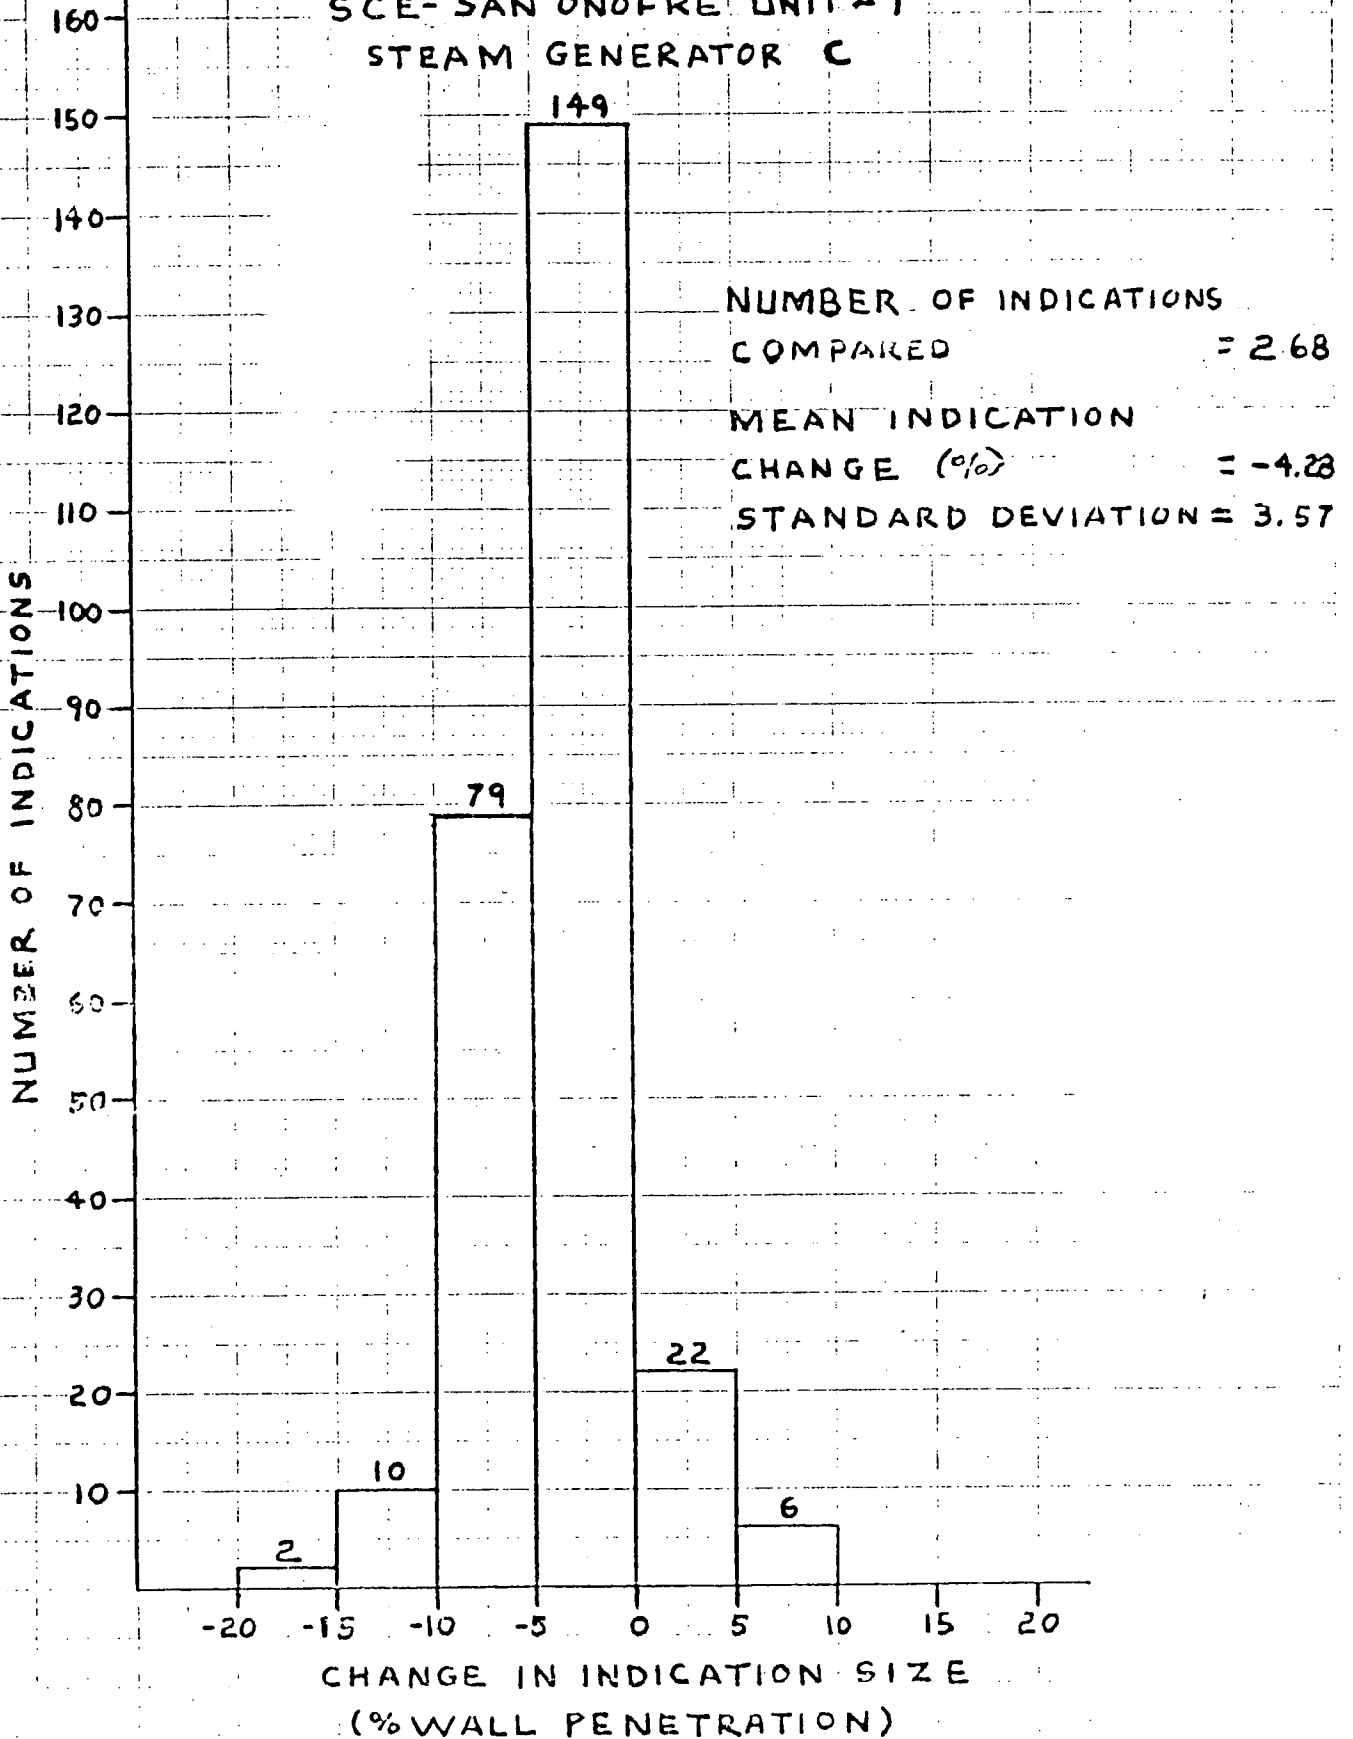
DISTRIBUTION OF THE CHANGE IN AVB WEAR INDICATIONS RECORDED AS $\geq 20\%$ AT BOTH THE 10/78 AND 5/80 INSPECTIONS
SCE-SAN ONOFRE UNIT #1
STEAM GENERATOR C

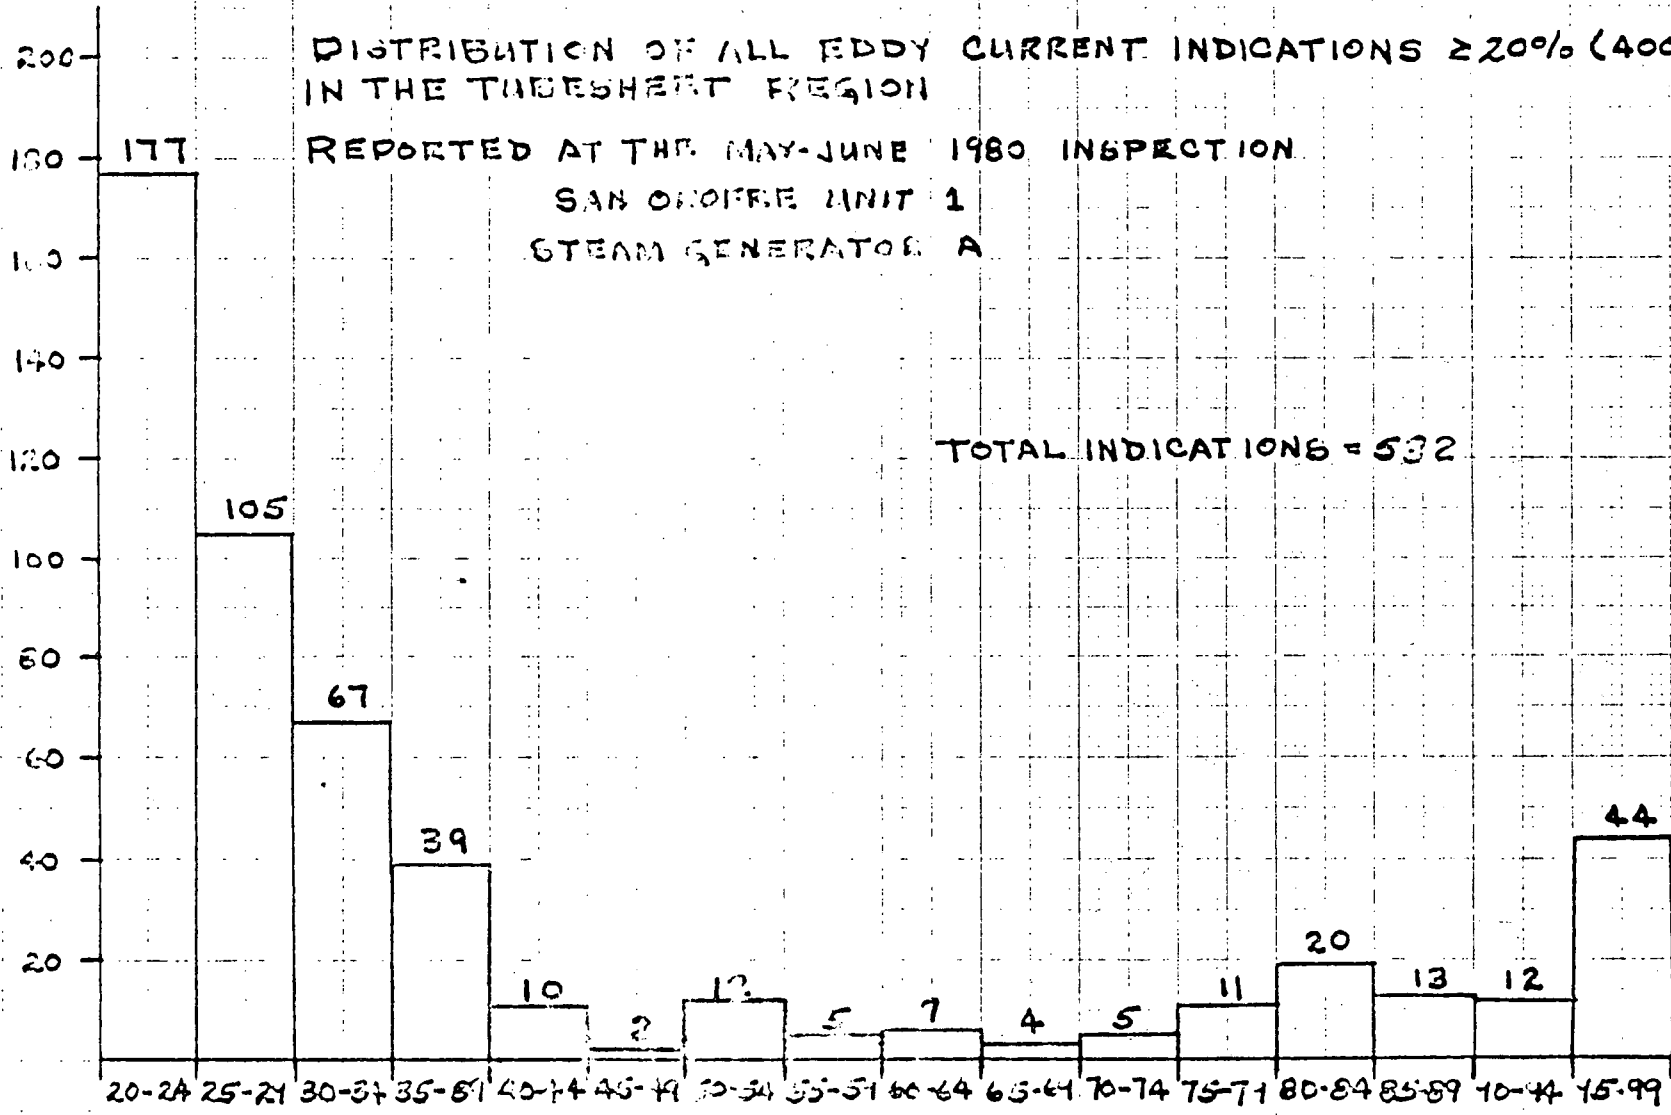
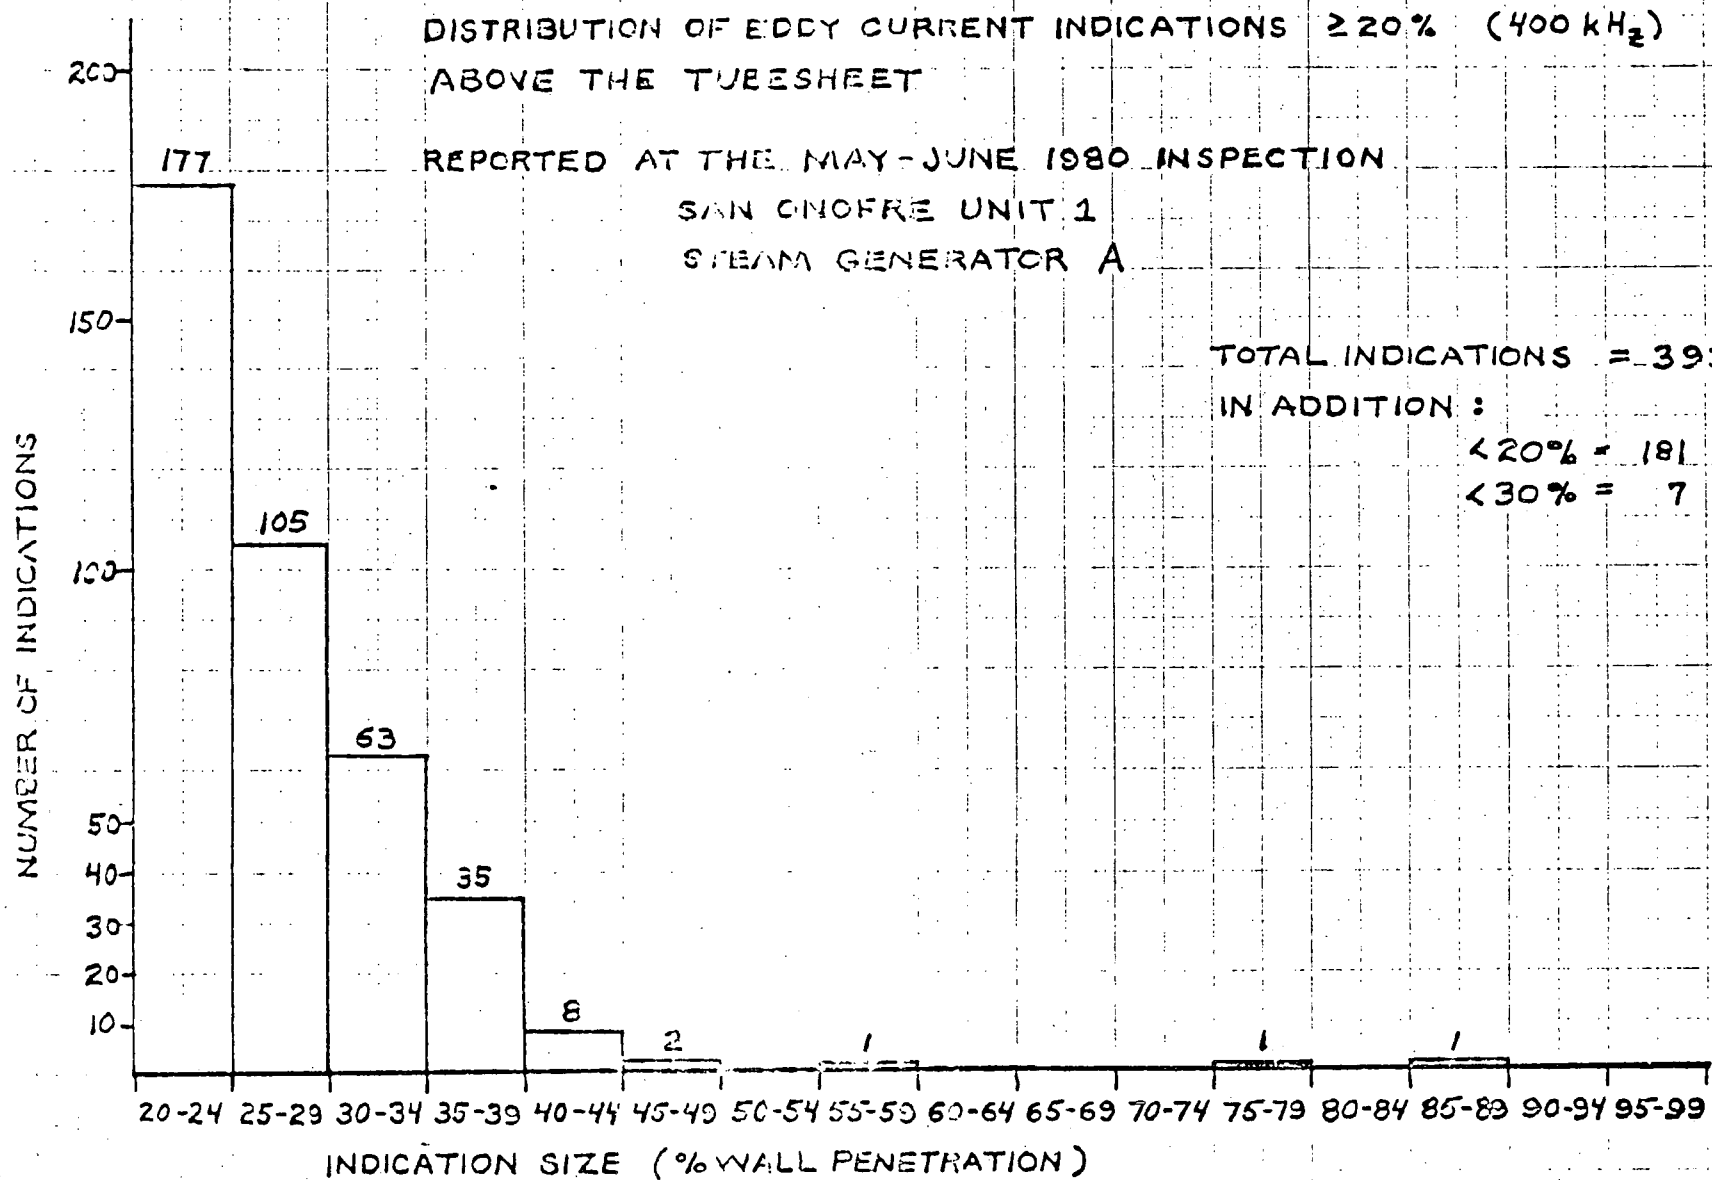
DISTRIBUTION OF ALL EDDY CURRENT INDICATIONS $\geq 20\%$ (400 KHZ)
IN THE THRESHOLD REGION

REPORTED AT THE MAY-JUNE 1980 INSPECTION

SAN ONOFRE UNIT 1
STEAM GENERATOR A

TOTAL INDICATIONS = 532

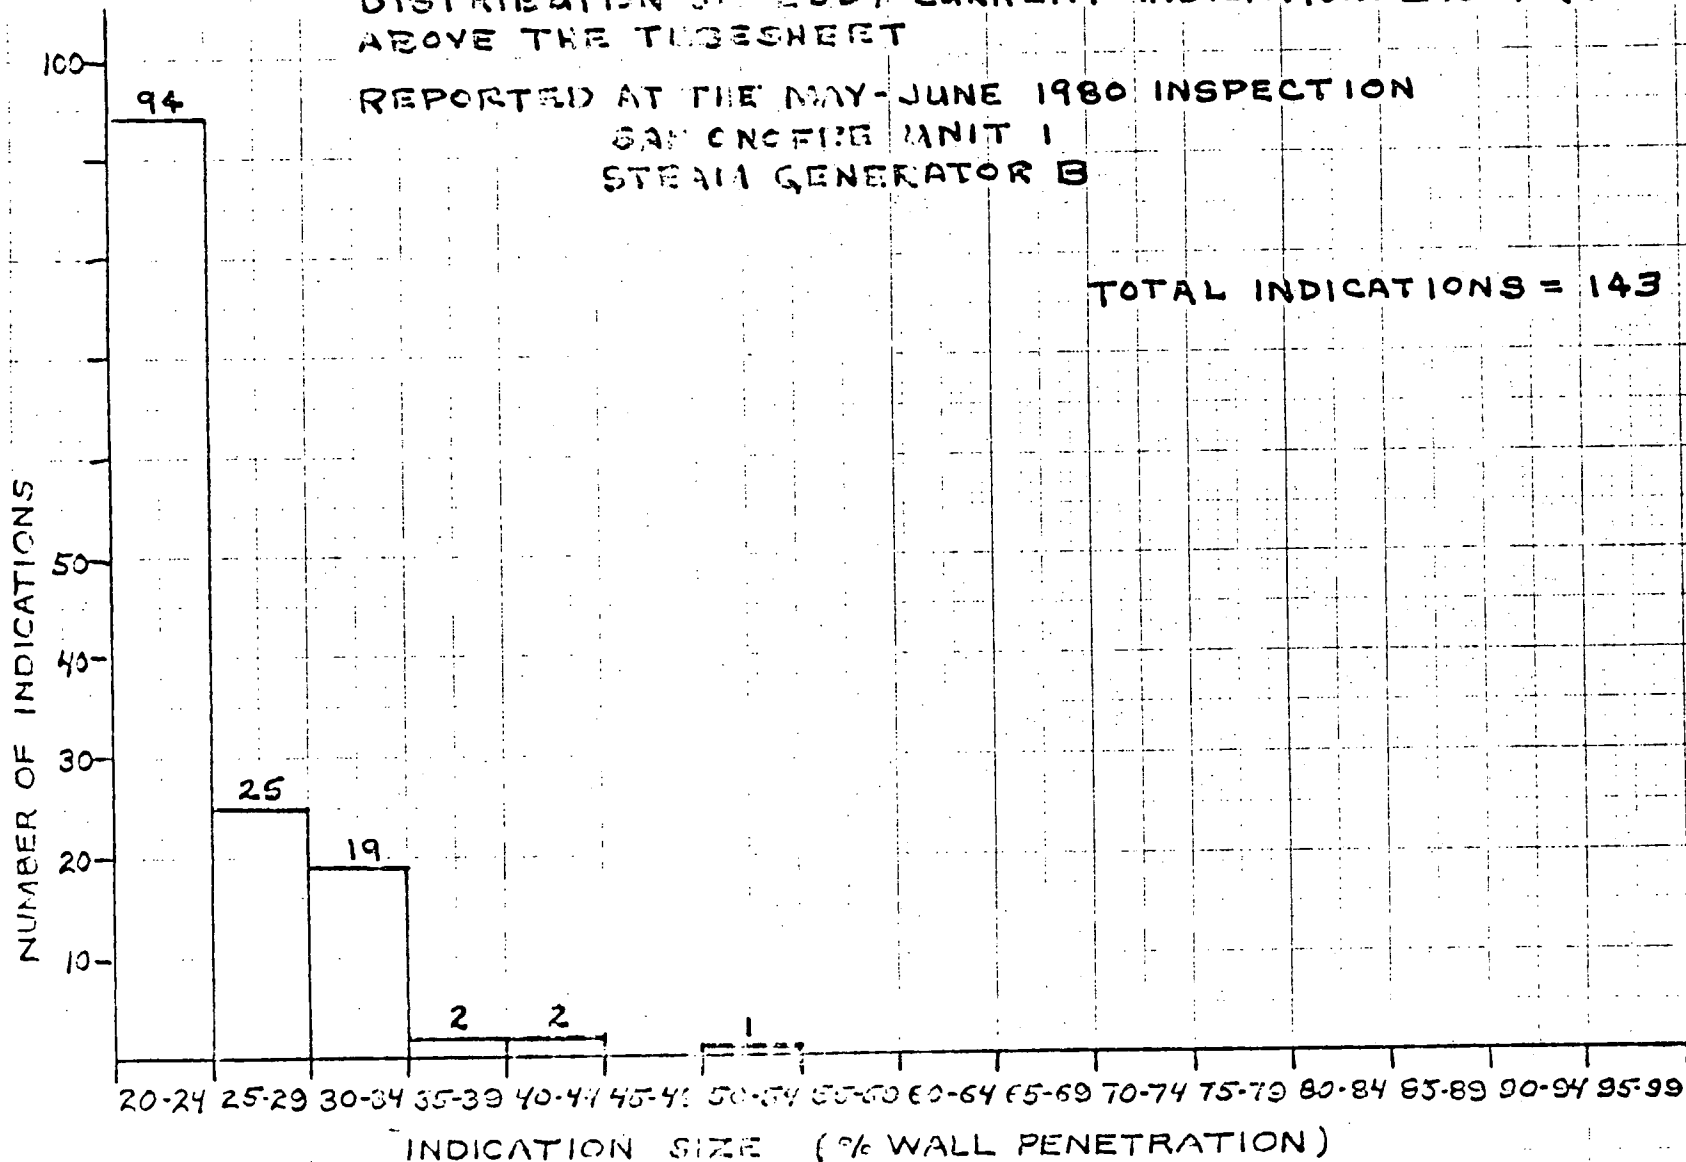
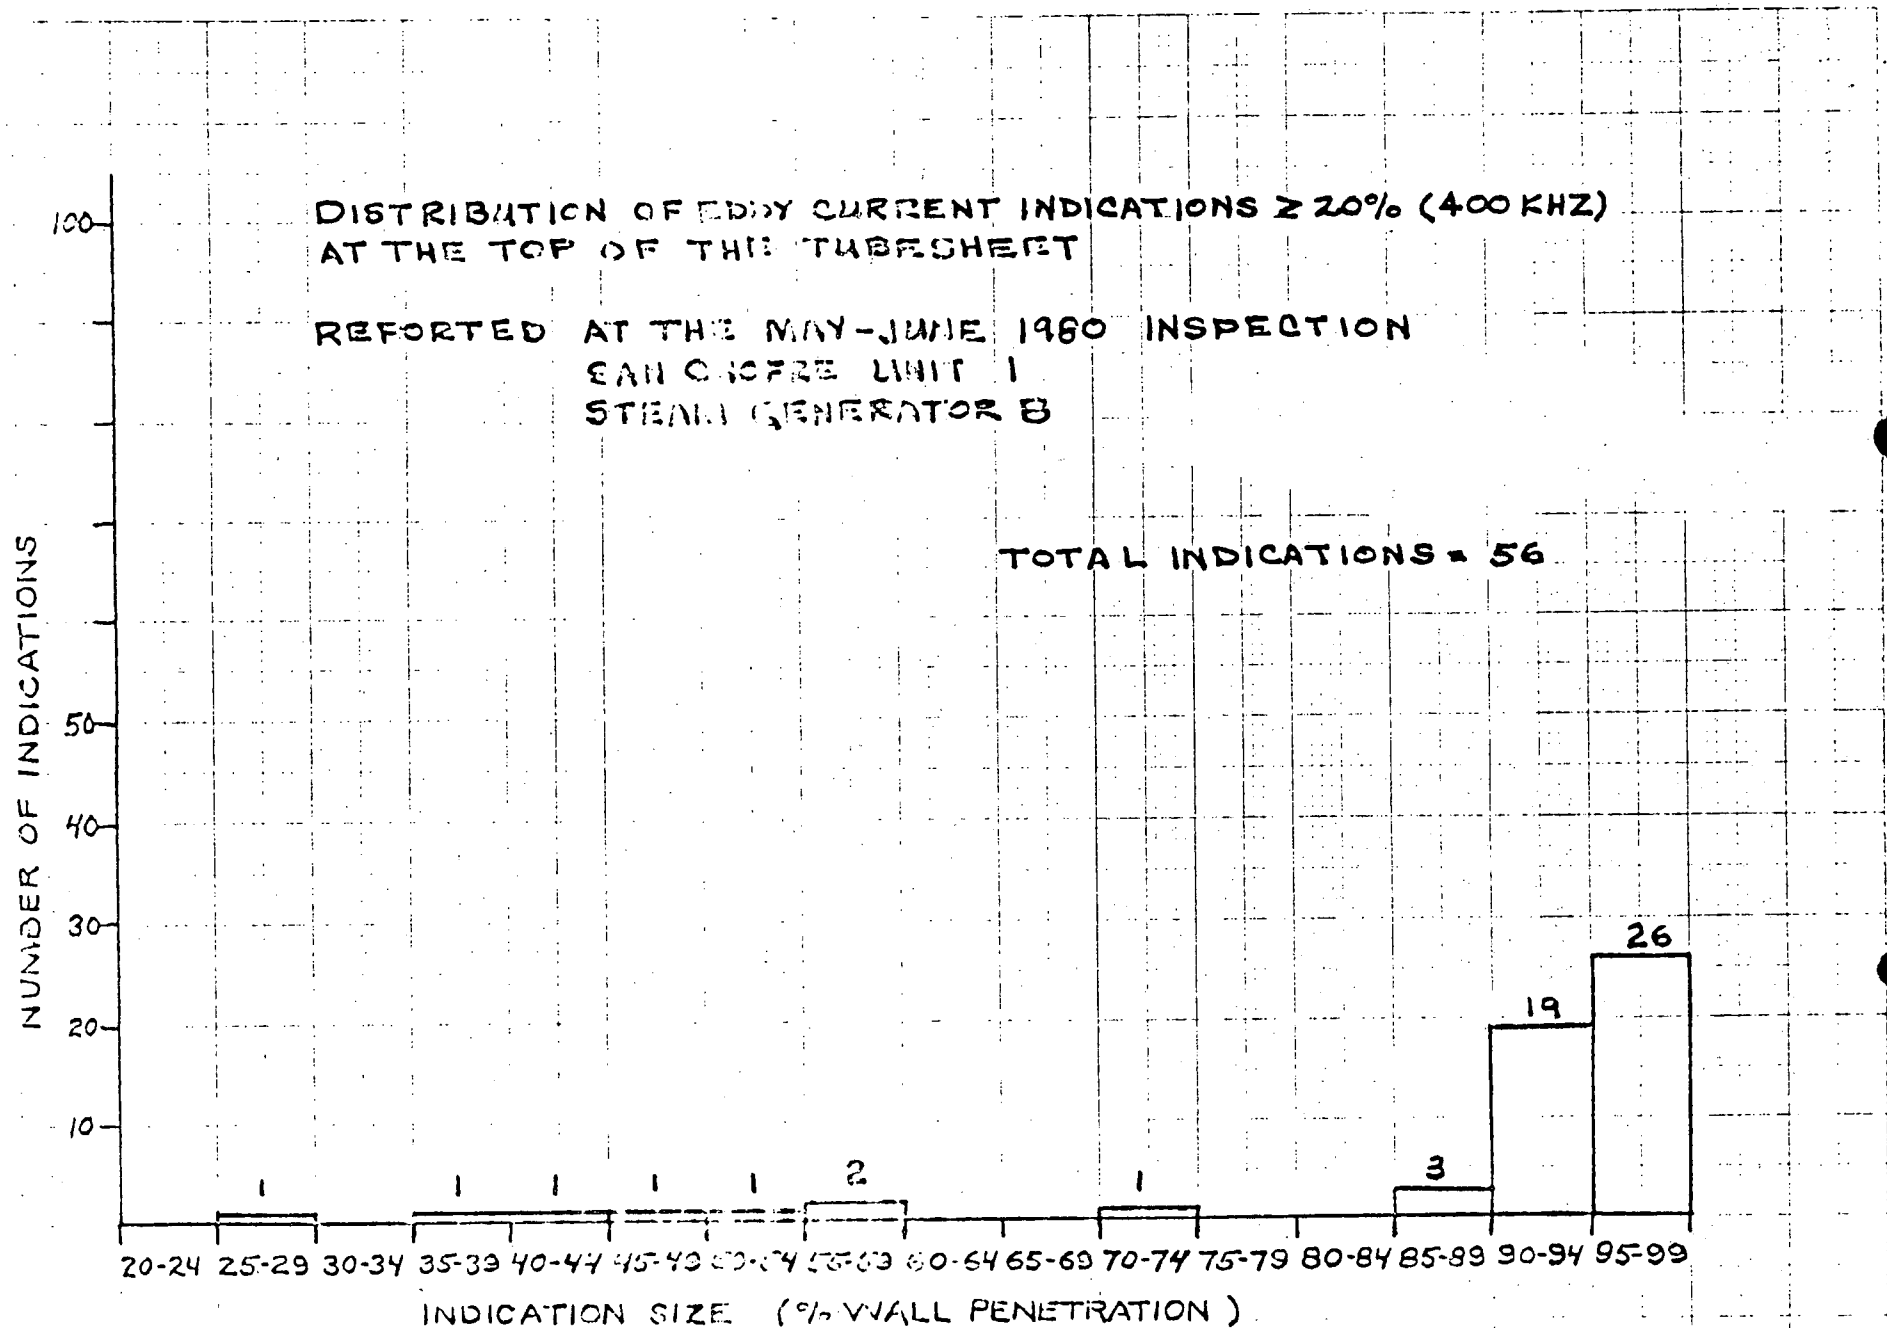
DISTRIBUTION OF EDDY CURRENT INDICATIONS $\geq 20\%$ (400 KHZ)
 ABOVE THE TUBESHEET

REPORTED AT THE MAY-JUNE 1980 INSPECTION
 SAN ONCE UNIT 1
 STEAM GENERATOR B

TOTAL INDICATIONS = 143

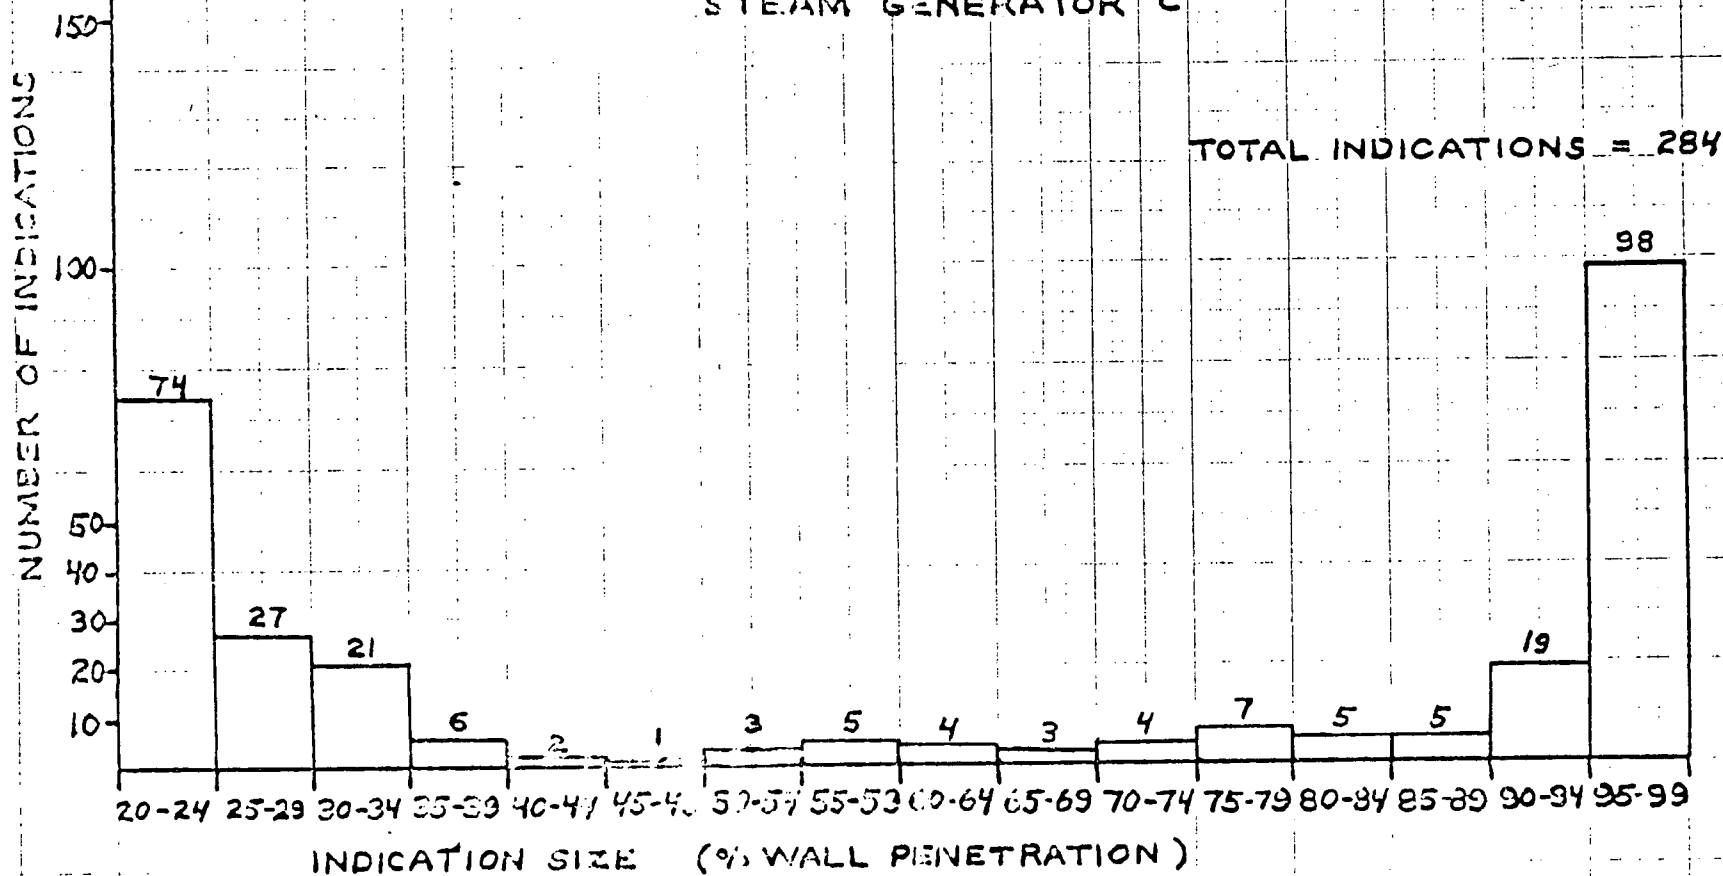
DISTRIBUTION OF ALL EDDY CURRENT INDICATIONS $\geq 20\%$ (400 kHz)
AT THE TUBESHEET REGION

REPORTED AT THE MAY-JUNE 1980 INSPECTION
SAN ONOFRE UNIT 1
STEAM GENERATOR C

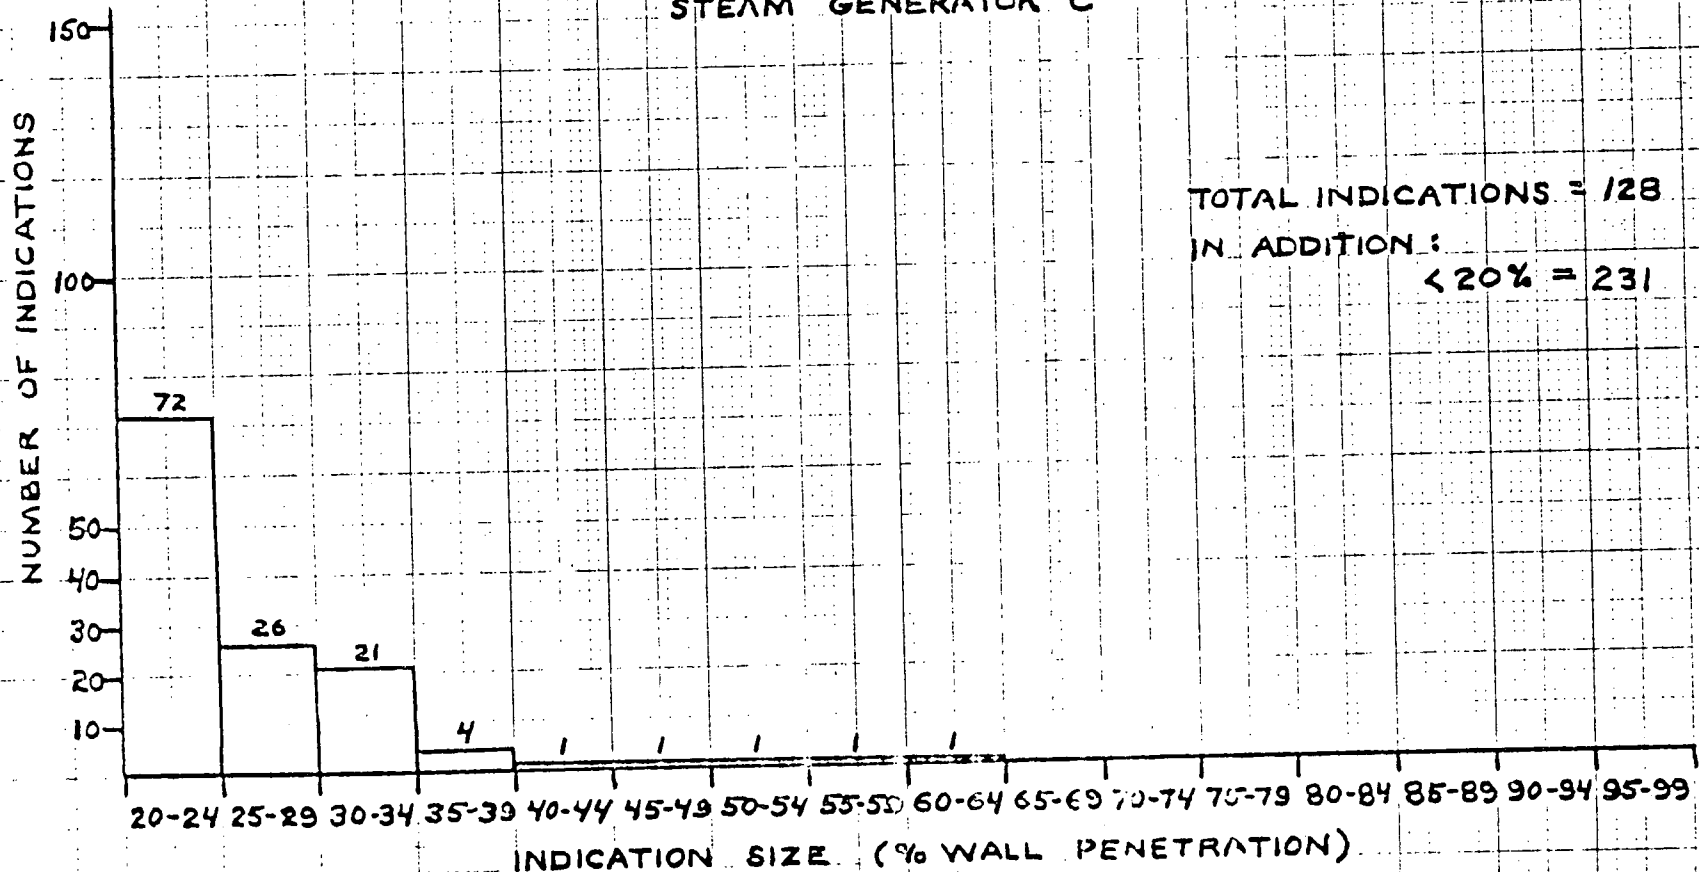
DISTRIBUTION OF EDDY CURRENT INDICATIONS $\geq 20\%$ (400 kHz)
ABOVE THE TUBESHEET

REPORTED AT THE MAY-JUNE 1980 INSPECTION
SAN ONOFRE UNIT 1
STEAM GENERATOR C

TOTAL INDICATIONS = 128
IN ADDITION:
 $< 20\% = 231$

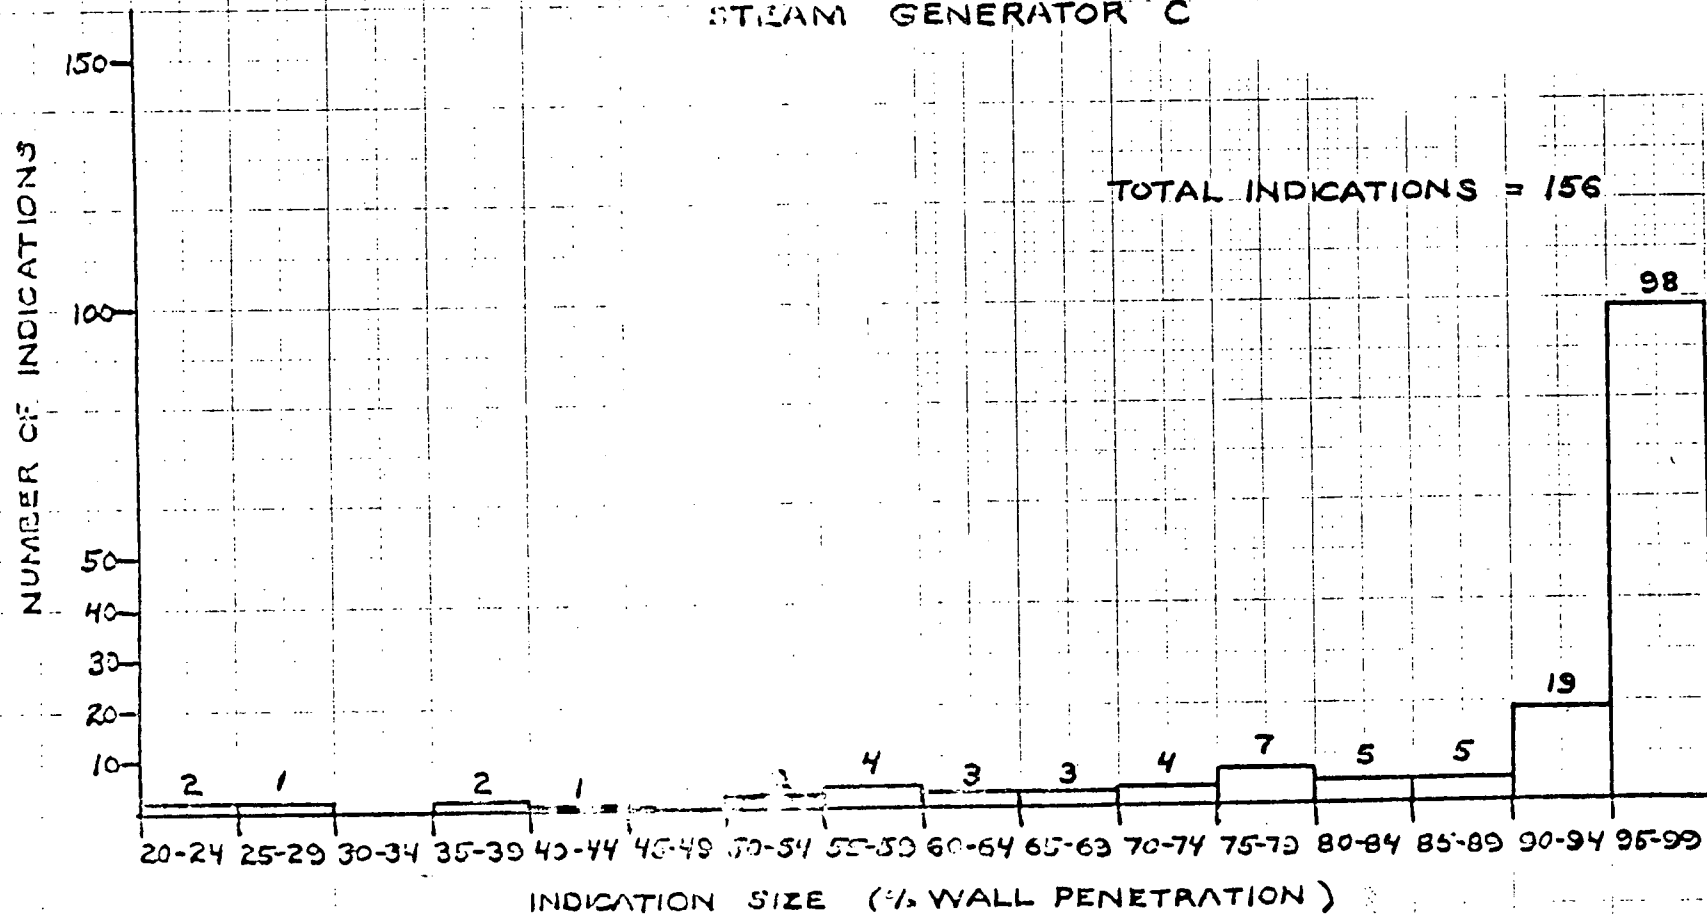
DISTRIBUTION OF EDDY CURRENT INDICATIONS $\geq 20\%$ (400 KHz) AT THE TOP OF THE TUBESHEET

REPORTED AT THE MAY-JUNE 1980 INSPECTION
 SAN ONOFRE UNIT 1
 STEAM GENERATOR C

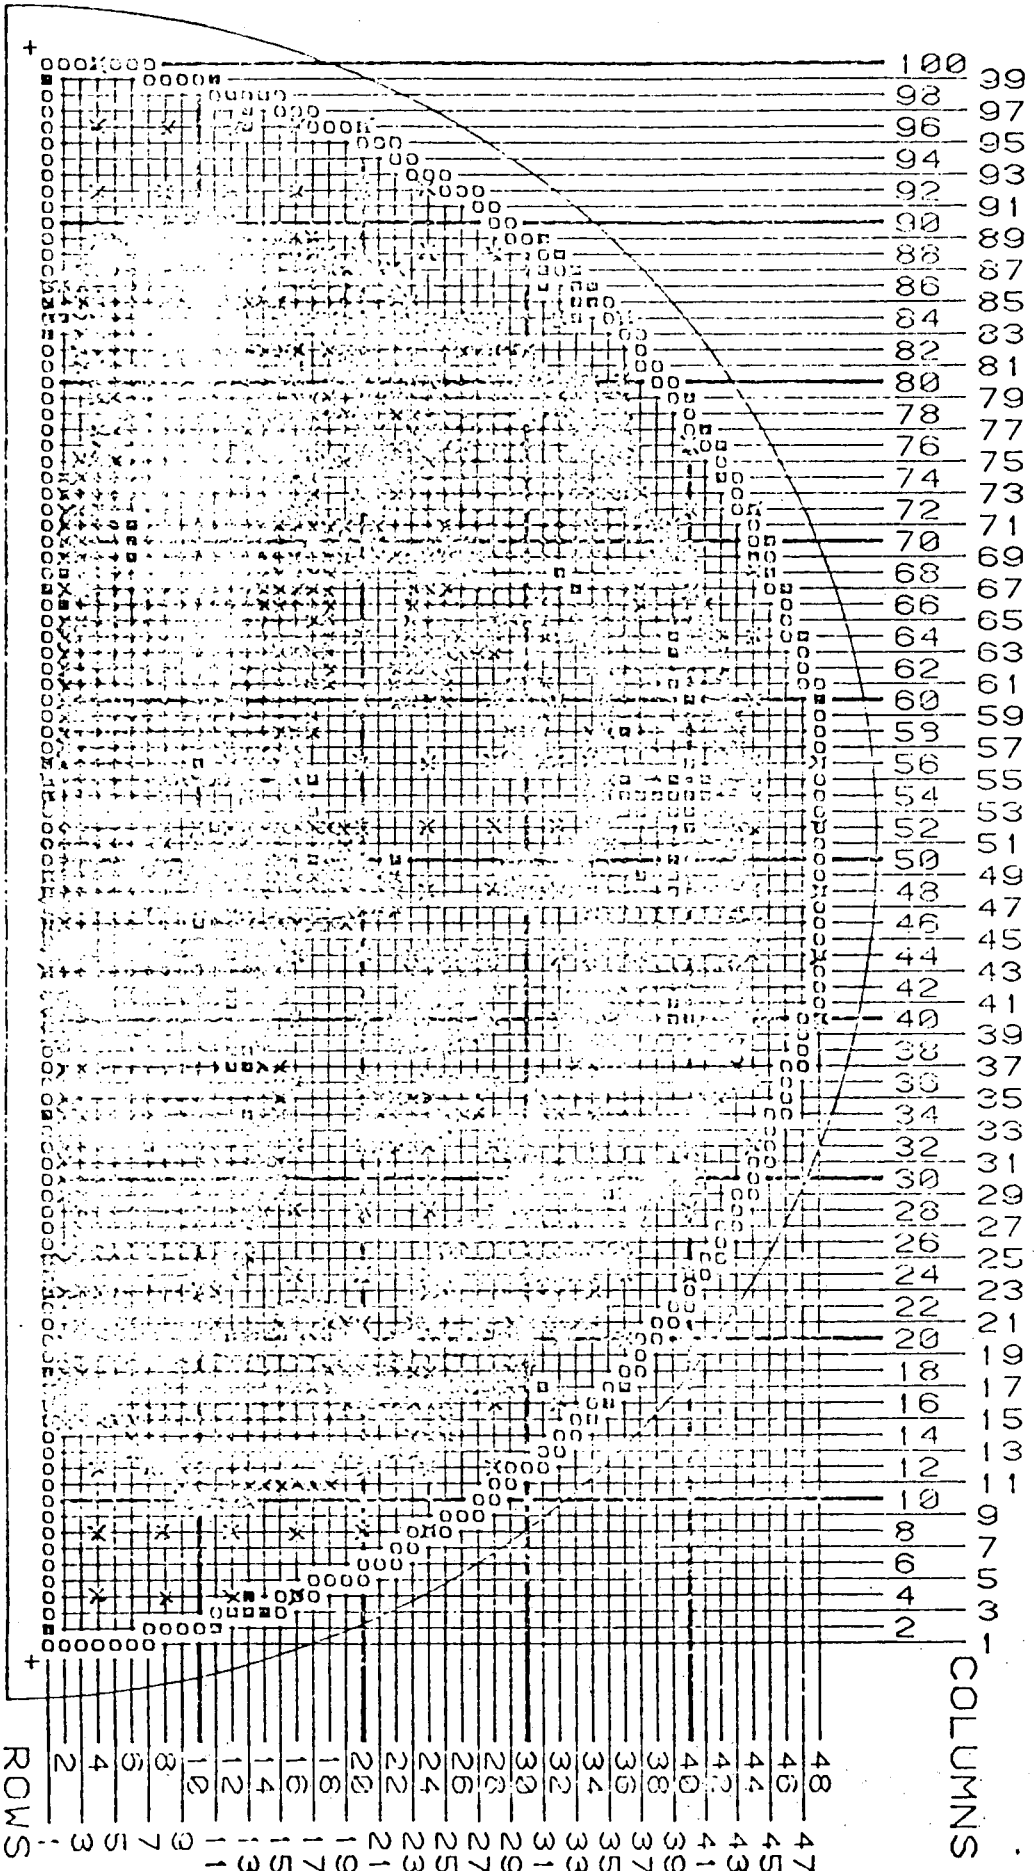
Inspection program based on non-routine 100 kHz signal patterns from conventional EC data plus one apparently normal tube around the "red dots" calls for 2270 tubes to be tested with the Rotating Pancake Coil (RPC) probe in Steam Generator A.

ROTATING PANCAKE COIL

INSPECTION PROGRAM
